ATSB TRANSPORT SAFETY REPORT Occurrence Investigation Report AO-2008-063 Final

Controlled flight into terrain 56 km NNE of Scone Airport, NSW 14 September 2008 VH-JDO Cessna Aircraft Co. U206A

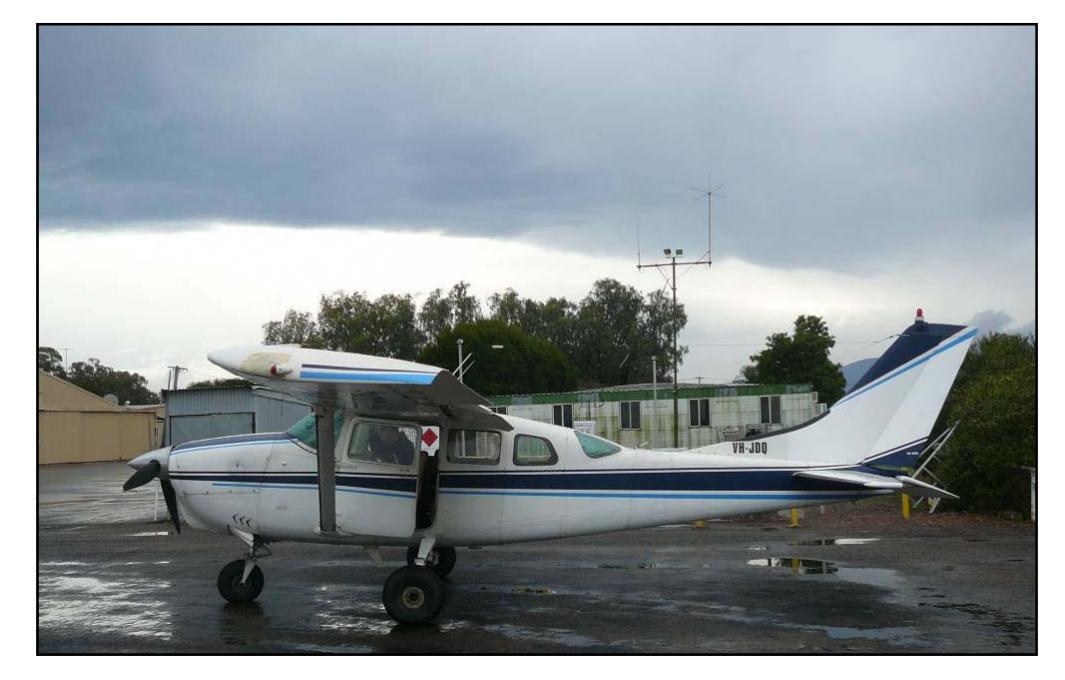
Figure 1: VH-JDQ at Scone Airport

A picture of the aircraft was taken showing the weather in the approximate direction of the accident flight in the background, shortly before the aircraft departed (Figure 1).

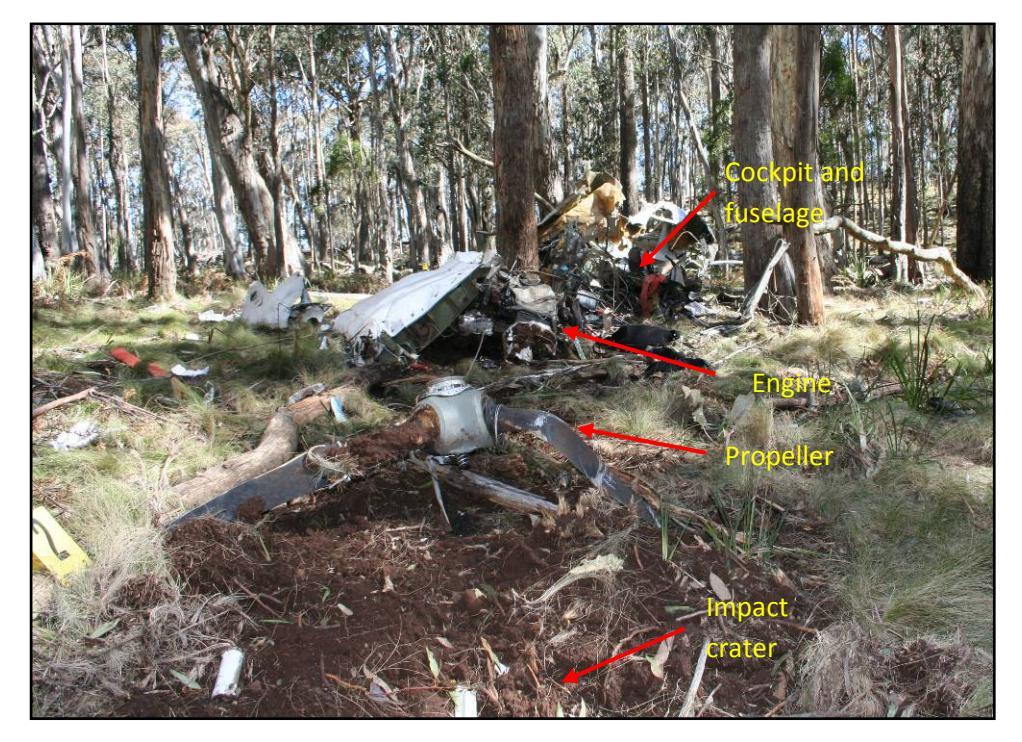
Figure 5: Main wreckage

Figure 5 shows the impact crater and propeller in the foreground, with the engine and the fuselage assembly in the background. The picture was taken looking in the approximate direction of flight at impact.

Examination of the wreckage at the accident site accounted for all the major parts of the aircraft, including all flight control surfaces. All structural fracture surfaces were examined on site and there was no evidence of any pre-existing defect with the aircraft that would have contributed to the accident. Considerable disruption to the wreckage precluded a check for continuity of the engine and flight controls. However, the engine and flight control cables and push-pull tubes were inspected at their fracture points, with no pre-impact defects identified.

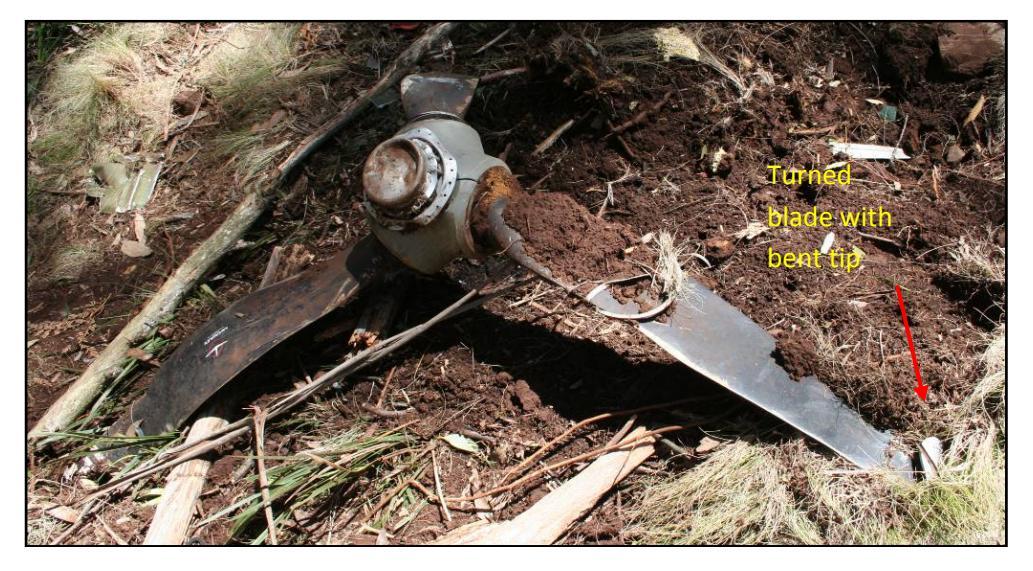
Figure 6: Propeller assembly

The propeller fractured and separated at the rear of the propeller hub. All of the propeller blades showed signs of rotational damage and one of the blades was turned around 180 degrees, indicating a broken internal actuator linkage; it was also bent around on itself at its tip (Figure 6).

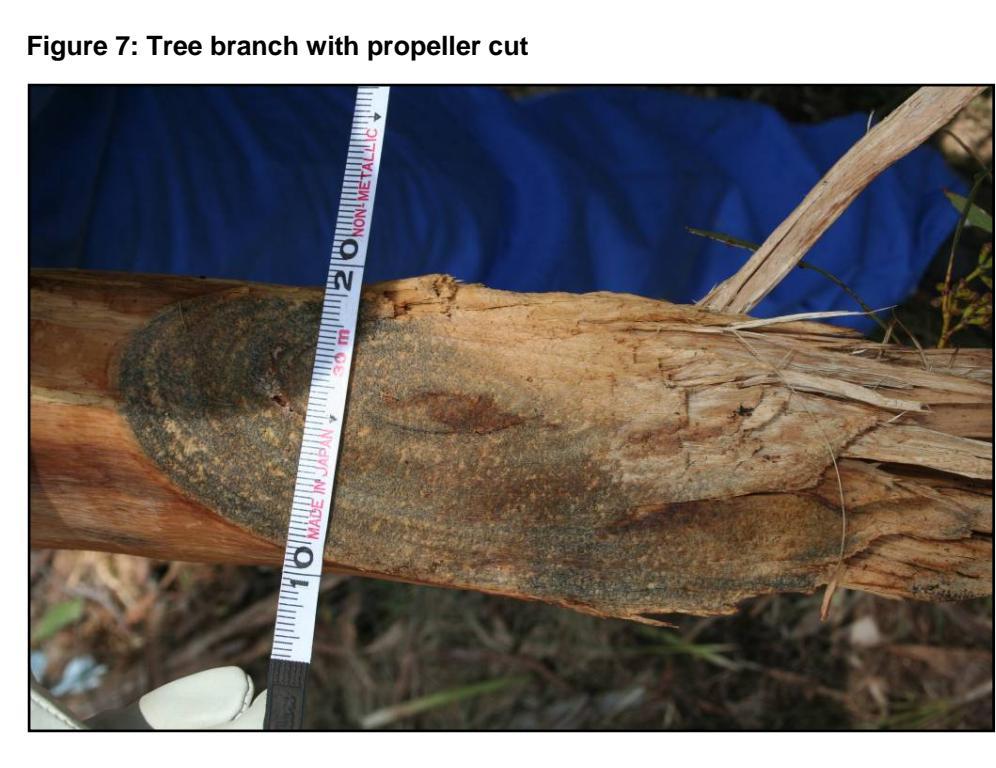
A large branch with a propeller cut was located approximately 100 m into the wreckage trail (Figure 7). The hardwood branch measured 10 cm across. It had propeller paint transfer marks through the majority of the cut which corresponded with marks on one of the propeller blades. Several other smaller tree branches with evidence of propeller blade strikes were located along the wreckage trail. The damage to the propeller and the cut tree branch indicated that the engine was producing significant power at the time of the accident.

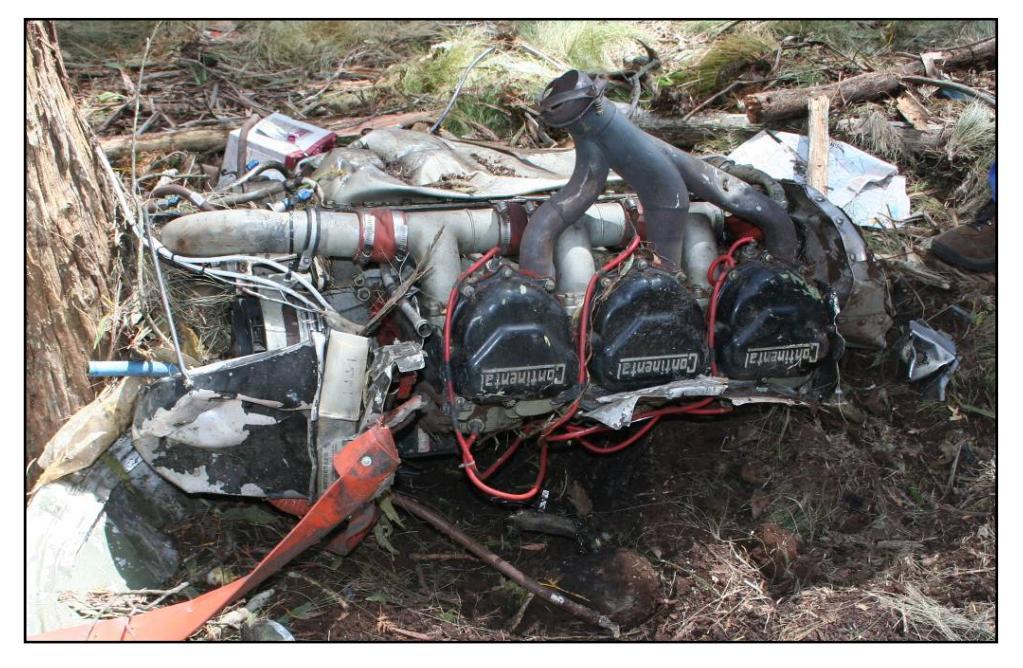
Figure 8: Engine assembly

The engine (Figure 8) was inspected externally for damage, with no pre-impact defects identified. The engine-mounted vacuum pump was removed and inspected. The pump had seized, but the drive had not sheared, indicating that it was operating to the point of impact.

Given that the onsite evidence indicated the engine was supplying significant power to the propeller at the time of the accident, no further testing or inspection of the engine was considered necessary.
