ATSB rail safety investigation: key lessons learnt

Abstract

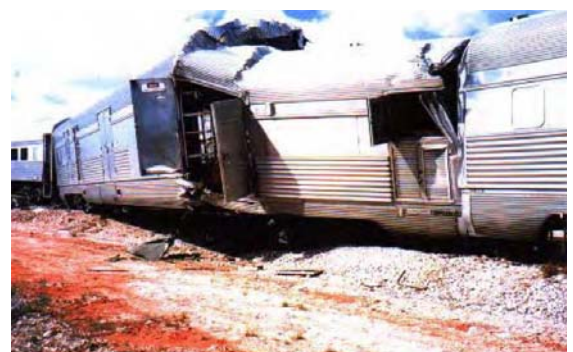
Figure 1: Carriages damaged at Zanthus

On 18 August 1999, just after 5 pm, the Indian Pacific passenger train travelling from Adelaide to Perth was inadvertently directed onto a loop line at Zanthus, where it collided with a stationary freight train. Seventeen passengers and four train crew required medical treatment, and there was significant damage to the locomotives and carriages.

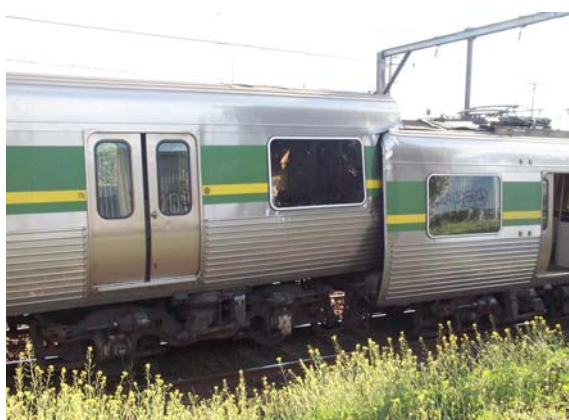
Figure 3: Footscray, Victoria

There was strong evidence that the performance of the driver of the empty train was impaired by a medical condition that led to him being unable to recall the events in the minutes before the collision. The driver was taking a course of prescribed medication, which combined with an

early start for work that day and a history of chronically disturbed sleep, may have resulted in him falling asleep for a short period while he was driving the train.

While there were safeguards in place to protect the safety of the system from such an eventuality, on this occasion they did not prevent the accident. A number of defences in the system were identified as being inadequate in terms of design or application. For example, one defence that was inadequate was the 'dead-man's handle' or vigilance device (in this case a foot pedal) designed to automatically apply the train brakes if there was any variation in applied pressure due to driver incapacitation. The ATSB's investigation found that in some circumstances the pressure on the foot pedal could be correctly maintained just by the weight of the driver's lower leg, regardless of whether or not he was incapacitated.

The alertness and fitness of drivers to perform their duties is also a defence against accidents. In the Footscray collision, the investigation found serious defects in the monitoring of the driver's health and fitness. It also found that the health standards used to assess driver fitness were deficient. As a result, although the driver was skilled and experienced, he was not medically fit to operate the train.

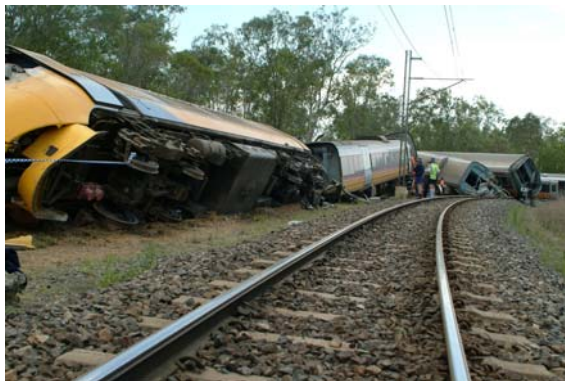
Figure 4: Derailed Cairns tilt Train

The principal cause of the derailment was excessive speed. From a systemic point of view, the accident was complex and although the principal causal factor related to 'human performance', better organisational controls may have prevented it.

ATSB-led investigations in Queensland included the Cairns Tilt Train derailment on 15 November 2004. The train derailed at a speed of 112 km/h north of Berajondo on the Bundaberg to Gladstone line with 150 passengers, two drivers and five passenger service staff onboard. Some of the people on the train were severely injured but fortunately there were no fatalities.

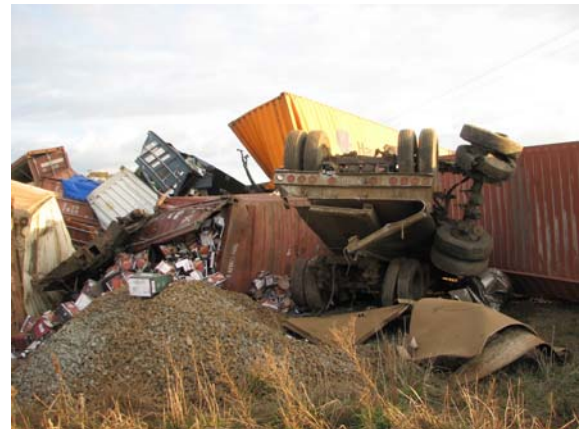
Figure 5: Lismore, Victoria

On 25 May 2006, a tipper truck and trailer carrying a load of 30 tonnes of citrus pulp collided with a freight train near Lismore in Victoria. The driver of the truck was fatally injured. Two locomotives and 41 of the train's 64 wagons derailed with the estimated direct cost of the collision upwards of \$13.5 million.

At the time of the accident the area surrounding the level crossing was enveloped in very thick fog, with visibility less than 50 m. The investigation found that the truck was not being driven in accordance with these conditions, and that the performance of the truck driver may have been affected by fatigue. In addition, the level crossing approach signage and sighting distances were not in accordance with the relevant Australian standards.

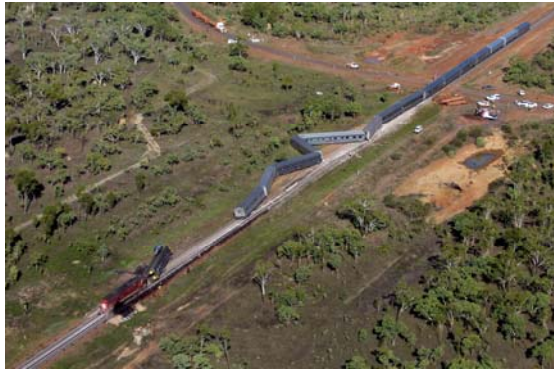
Figure 6: Ban Ban Springs, NT

On 12 December 2006, a double trailer road-train drove into the path of *The Ghan* passenger train at a level crossing near Ban Ban Springs in the Northern Territory. As a consequence, two locomotives, a wagon used for carrying passengers' vehicles and nine passenger carriages derailed. While there were no fatalities, the road-train driver and a female passenger were hospitalised and several other passengers and crew sustained minor injuries.

The investigation concluded that the truck was driven through the 'Stop' sign at the level crossing at a speed of about 50 km/h. The driver was very familiar with the crossing and had a habit of slowing rather than stopping at the crossing. He may have been influenced by the expectation that a train would not be present and by the

operational constraints of road-train vehicles. In addition, he may not have heard the warning of the train horn because of his severe hearing loss.

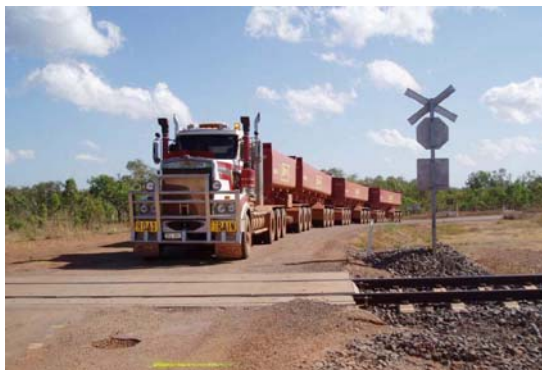
Large heavy road vehicles can take a long time to stop and to get going again. As part of the ATSB investigation, trials were conducted at the Ban Ban Springs level crossing to see how long it would take a large road train to traverse the crossing under different conditions. The results showed, in certain circumstances, the time taken for the test vehicle to clear the level crossing from a standing start was longer than the standard time used to calculate sighting distances. The results of the ATSB's trials, detailed in the investigation report, have wider implications in relation to the adequacy of the current standards for sighting distances at level crossings.

Figure 7: Road-trains can take a long time to stop and get going again
