## **SUMMARY**

The Robinson R22 light two-place helicopter is used extensively in northern Australia for aerial cattle mustering. The Australian Transport Safety Bureau (ATSB) is concerned that the usage spectrum of this role may have structural component life effects that were not addressed in the certification of this rotorcraft.

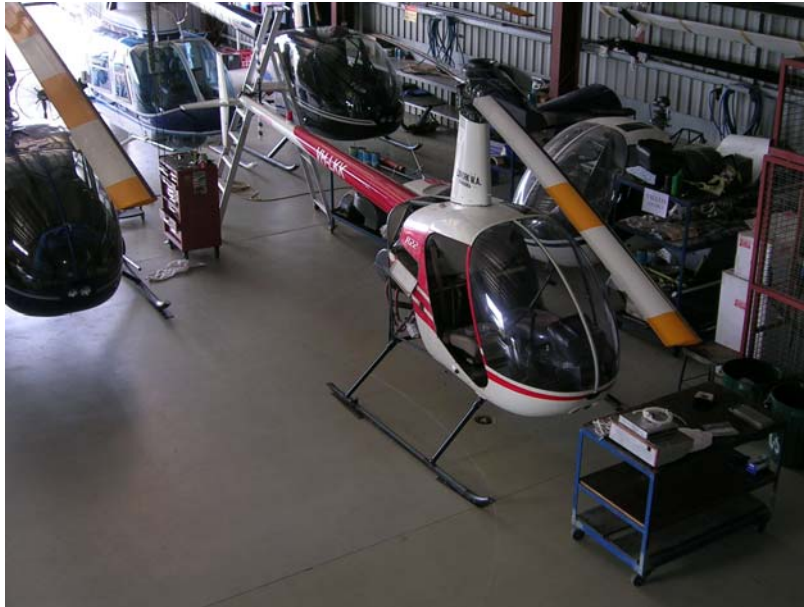
**Figure 2.1: The Usage Survey Helicopter**

- 2.1. The Robinson R22 series of helicopters is certified under Federal Aeronautical Regulation 14 Part 27 dated 1 February 1965. The helicopter provided for the aerial mustering usage trial was a Robinson R22 Beta helicopter, registration VH-LKK (see Figure 2.1), serial number 1625, owned and operated by Heliwork Pty Ltd, Kununurra Airport, Kununurra, WA. The R22 Beta helicopter is a light, two-place helicopter powered by a Lycoming O-320-B2C engine.

- 2.2. The trial helicopter was fitted with the optional auxiliary tank, increasing its fuel load to 19.8 US gallons in the standard main tank plus 10.9 US gallons in the optional auxiliary tank.
- 2.3. The only other significant modification relevant to this trial was that the main rotor braking system had been removed, resulting in a very gradual main rotor slowdown after engine shutdown. This is typical for the use of an R22 in the cattle mustering role.

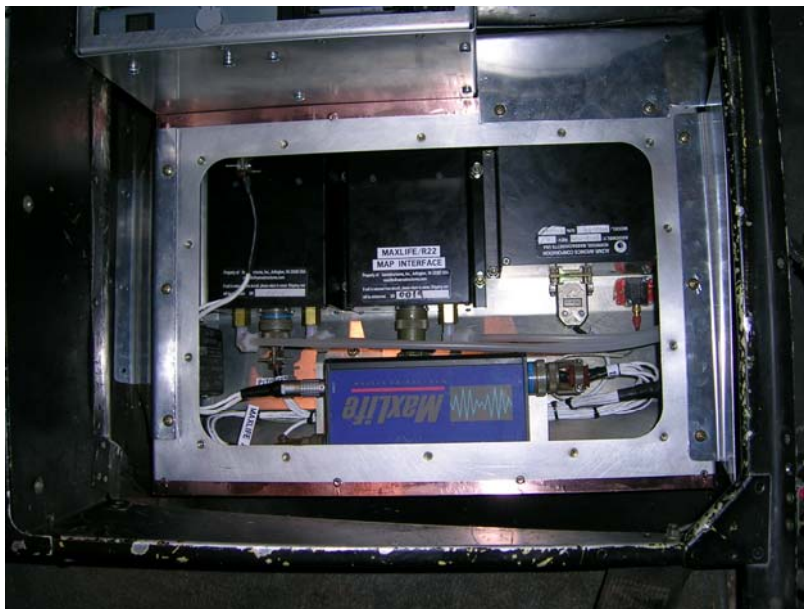
**Figure 3.1: The MaxLife Usage Monitoring System**

- 3.1.1. The MaxLife system was developed for AeroStructures by Altair Avionics Corporation. The system was designed for gathering usage data from United States Navy and United States Coastguard Seahawk and Jayhawk helicopters. It has since been fitted to other aircraft and is intended for use as a general-purpose aircraft usage monitoring system.
- 3.1.2. The standard MaxLife system consists of a main processor, a pitot-static pressure measurement module, a three-axis fibre-optic gyroscope and a memory card writer, plus various external sensors (see Figure 3.1).

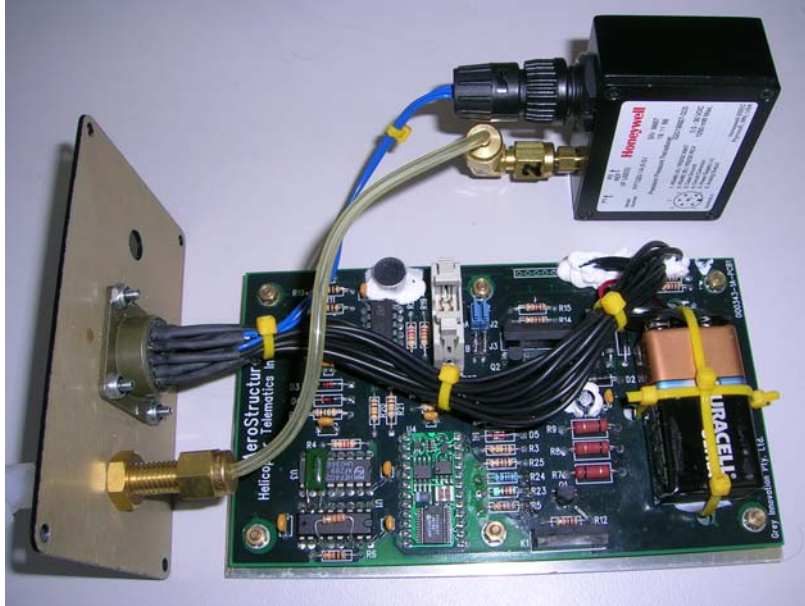
**Figure 3.2: Custom Instrumentation Module for the R22 Usage Survey**

- 3.2.1. The Robinson R22 helicopter posed some installation challenges due to its minimal instrumentation, 13.8 volt electrical bus and internal combustion engine. A special module (see Figure 3.2) was designed for the MaxLife system for this trial to overcome these problems, and further functionality was added at the request of the Civil Aviation Safety Authority (CASA) to maintain a permanent non-volatile record of hours data in the modified MaxLife system.

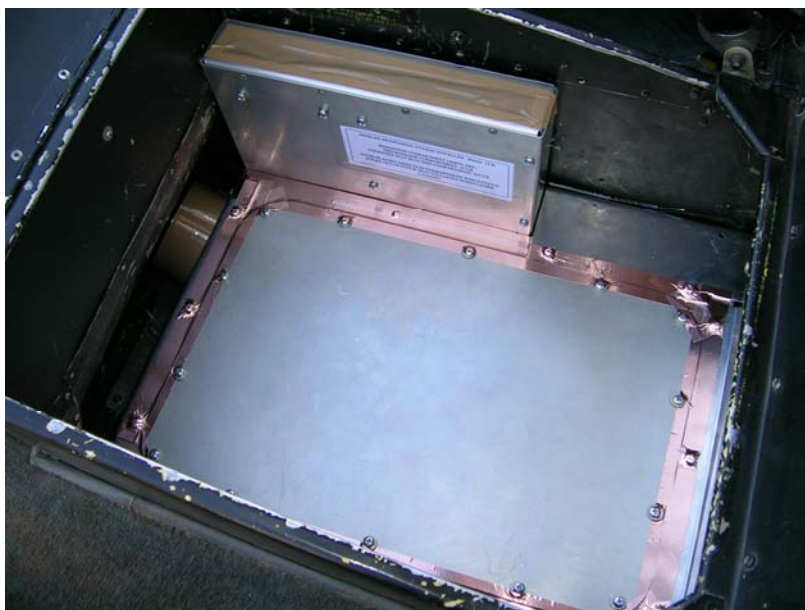
**Figure 3.3: Mechanical Mounting of MaxLife in the R22**

- 3.2.2. A custom mounting system was designed for this application, which mounted the MaxLife system at the base of the left hand baggage compartment (beneath the left hand passenger seat – see Figure 3.3). Existing regulations already prohibited carriage of passengers during aerial mustering operations, so the presence of MaxLife beneath the empty passenger seat did not pose a threat to the crashworthiness of the aircraft during aerial mustering.

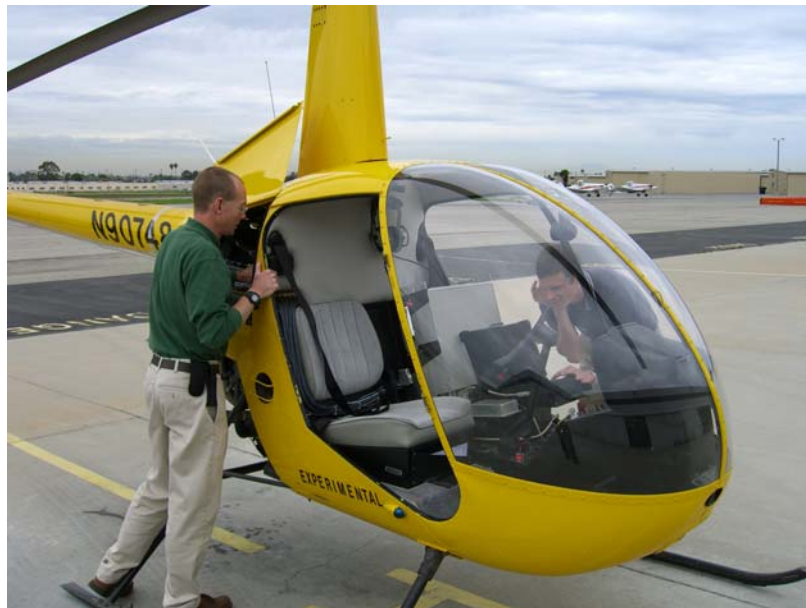
**Figure 7.1: The RHC Strain Gauge Instrumented R22**

7.2.5. The RHC R22 (see Figure 7.1) was an Experimental category aircraft, which allowed RHC to clear the MaxLife temporary modification for flight.

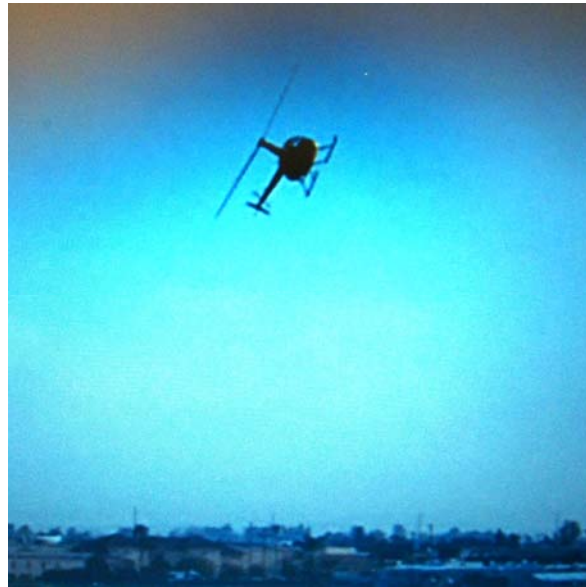
**Figure 7.2: RHC R22 Performing a Hammerhead Turn**

- 7.5.2. The second aerial mustering flight investigation flight took place on 7 April 2006 and consisted of RHC reference manoeuvres and a range of typical aerial mustering manoeuvres (see Figure 7.2). Post flight analysis of the flight data showed that the connectors had remained connected and that the data on these channels was of good quality. Channels affected by noisy slip rings were still affected by this issue.

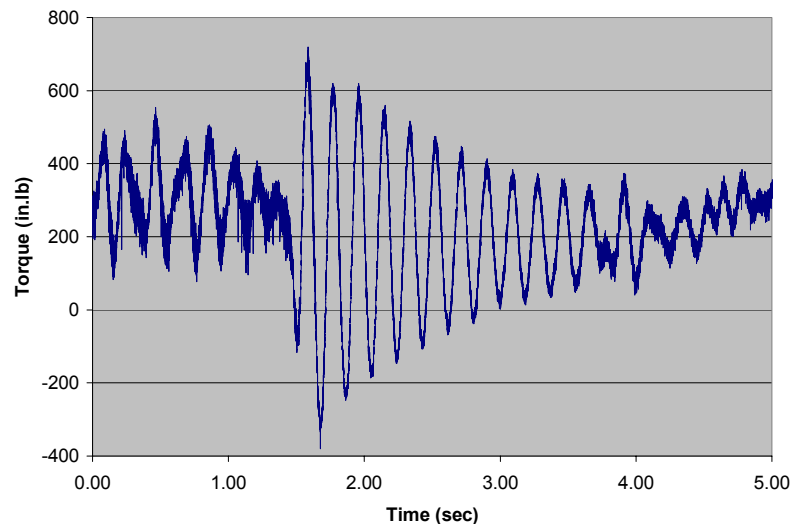
**Figure 8.1: Dynamic Torque Oscillation in the TRDS**

- 8.4.2. The area of concern, demonstrated in the “quick stop”, caused torsional cycles in the TRDS, consisted of a nose-up manoeuvre combined with a change in engine manifold pressure (MAP) from 25.6 to 7.7 inches of Mercury in under one second, a change of 17.9 inches of Mercury. The trace showing this behaviour occurs 115.5 seconds into the RHC Dataq file FLT06-01.WDQ and at 889.9 seconds into the MaxLife data file MAX06-01.XLS. The amplitude of the oscillation starts at 994 in.lb and concludes 11 cycles later when the cycle has decayed to the typical cyclic torque amplitude of about 220 in.lb (see Figure 8.1). Hence the initial amplitude was 4.5 times the typical value during flight.

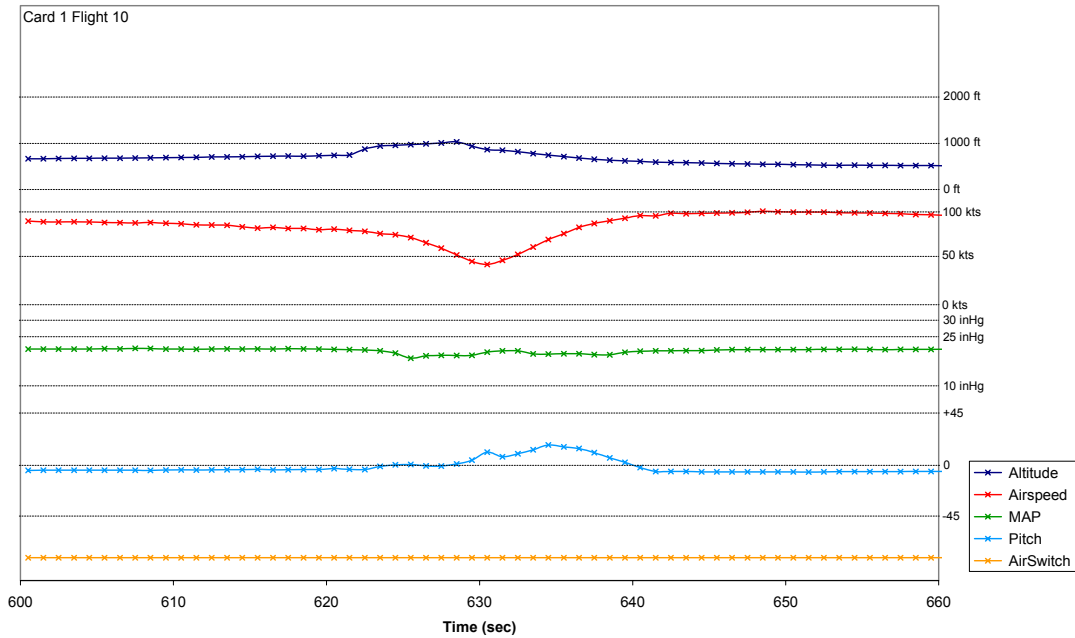
**Figure 8.2: Time Plot of Transit Flight Speed Change**

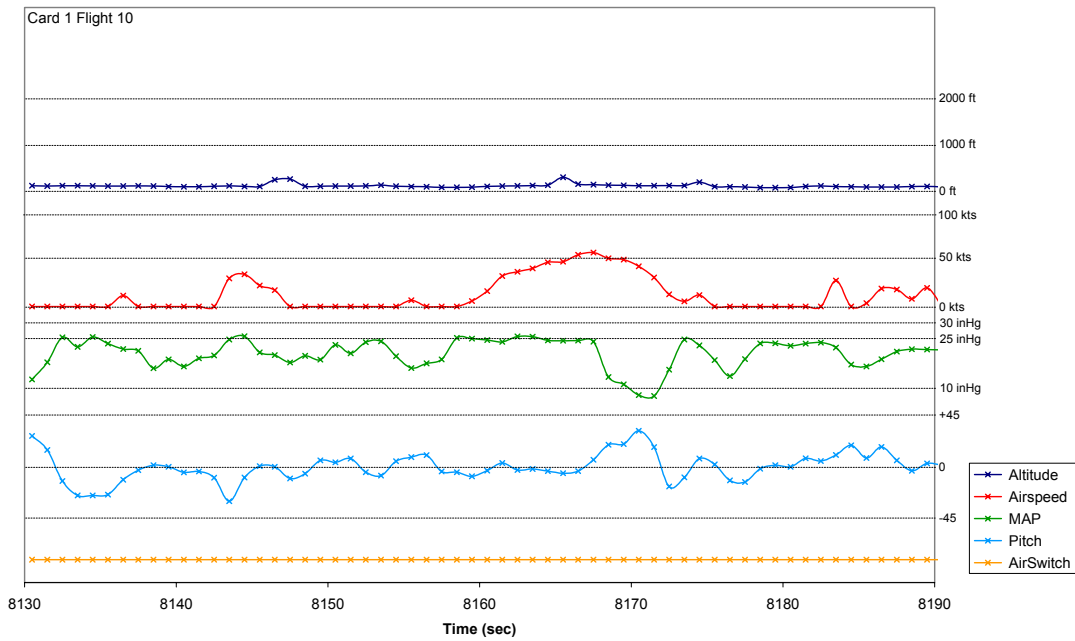
**Figure 8.3: Time Plot of a "Quick Stop" Manoeuvre**

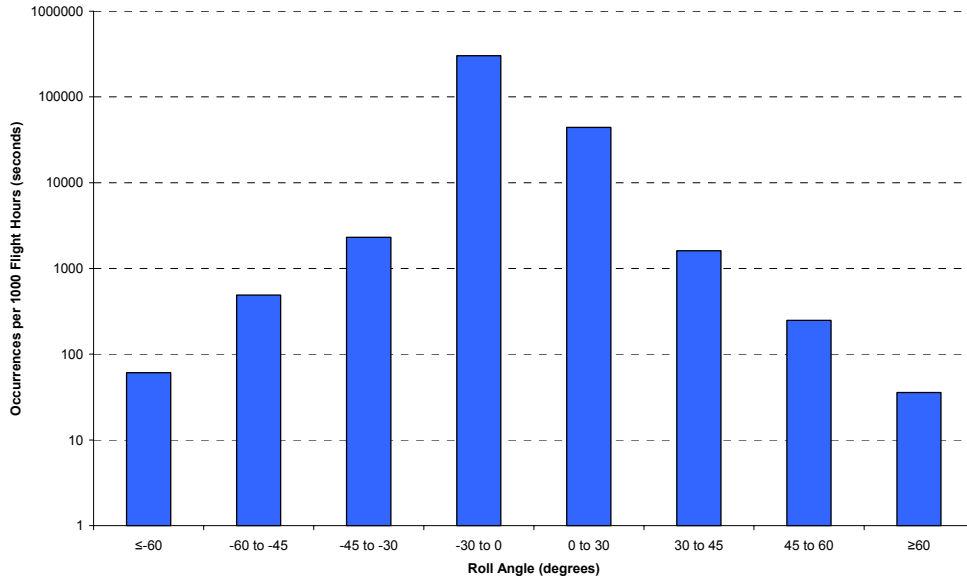
**Figure A.1: Roll Angle Occurrence**

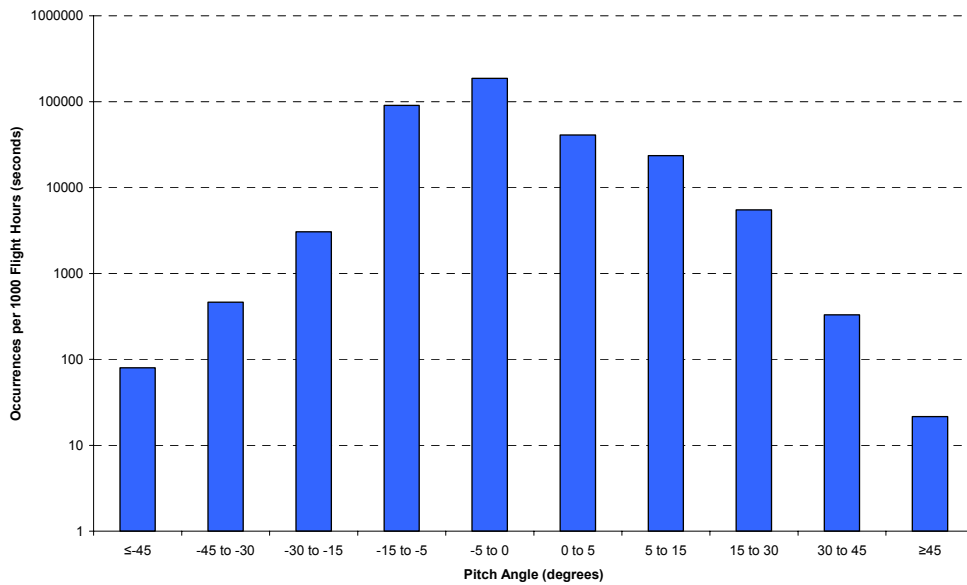
**Figure A.2: Pitch Angle Occurrence**

- 6.11. The R22 specification allocates 1.0 percent of flight time to pull ups and 0.5 percent to push-overs, all performed at a CAS of 90kts. From the Pitch angle distribution in Annex A, the aerial mustering usage is found to include pitch angles greater than 15° for 1.7 percent and less than -15° for one percent of flight time. These figures indicate mustering usage requires more pitch up/push-over events, but these will be carried out at lower speeds than the specification.

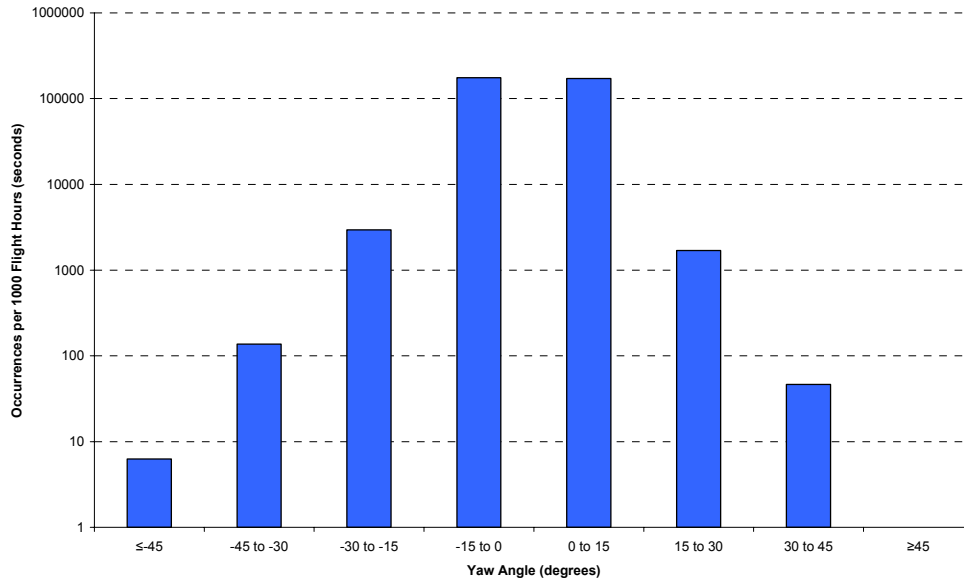
**Figure A.3: Yaw Rate Occurrence**

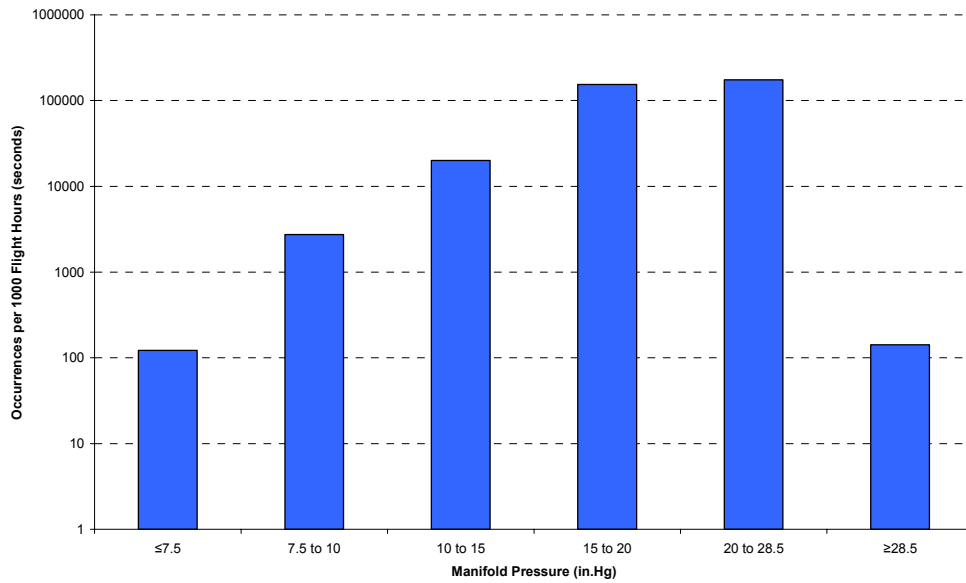
**Figure B.4: MAP Occurrence**

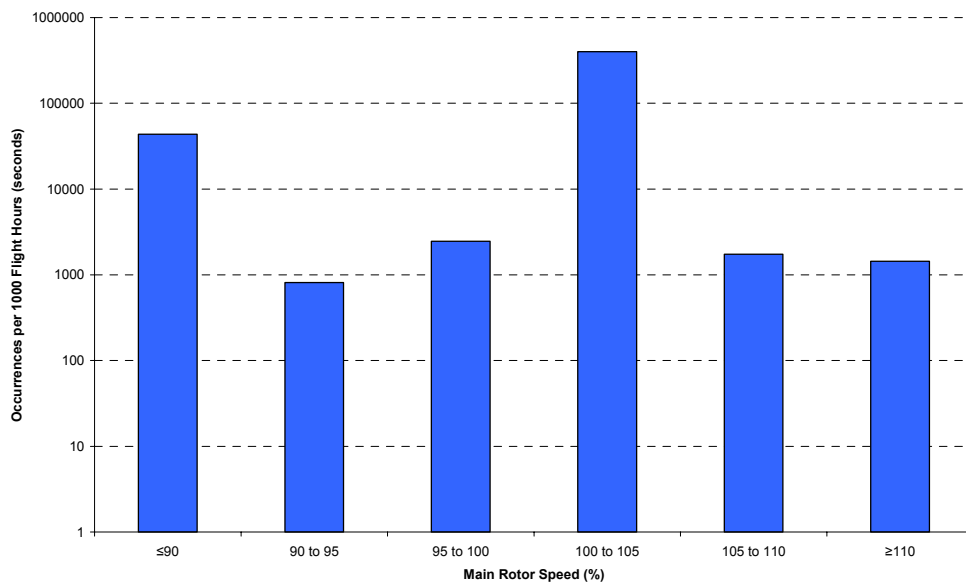
**Figure B.5: Main Rotor Speed Occurrence**

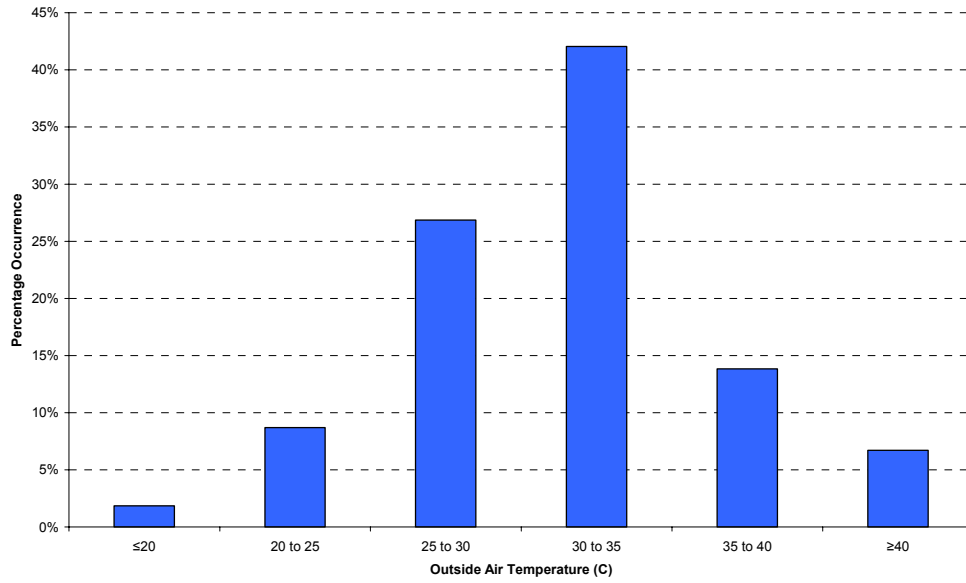
**Figure B.6: OAT Occurrence**

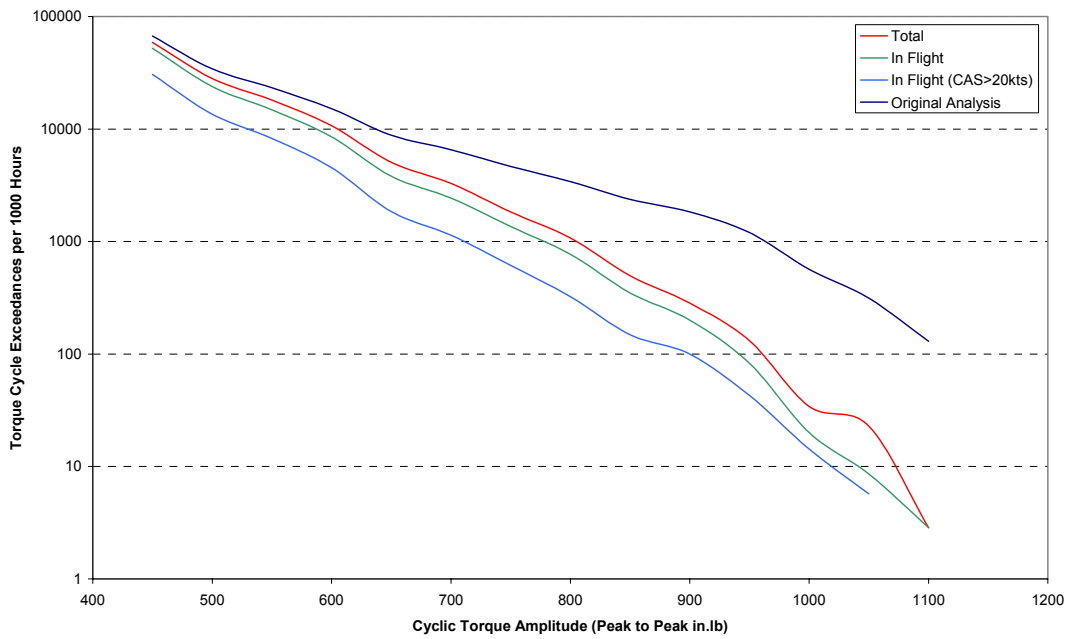
**Figure E.7: TRDS Cyclic Torque Exceedance Spectra**

9.1. RHC was contacted by AeroStructures and asked to investigate the effect of the TRDS torque cycles due to aerial mustering on the R22 TRDS. The TRDS torque cycle spectrum provided to RHC was the one derived during initial analysis. As this spectrum is more severe than those based on valid counts of power chop events, the RHC analysis should provide conservative estimates of relevant component lives.
