# Collision with terrain involving a Bell 206B, VH-BNG

near Mission Beach, Queensland, 20 February 2014

**ATSB Transport Safety Report**  
Aviation Occurrence Investigation  
AO-2014-027  
Final – 8 April 2014

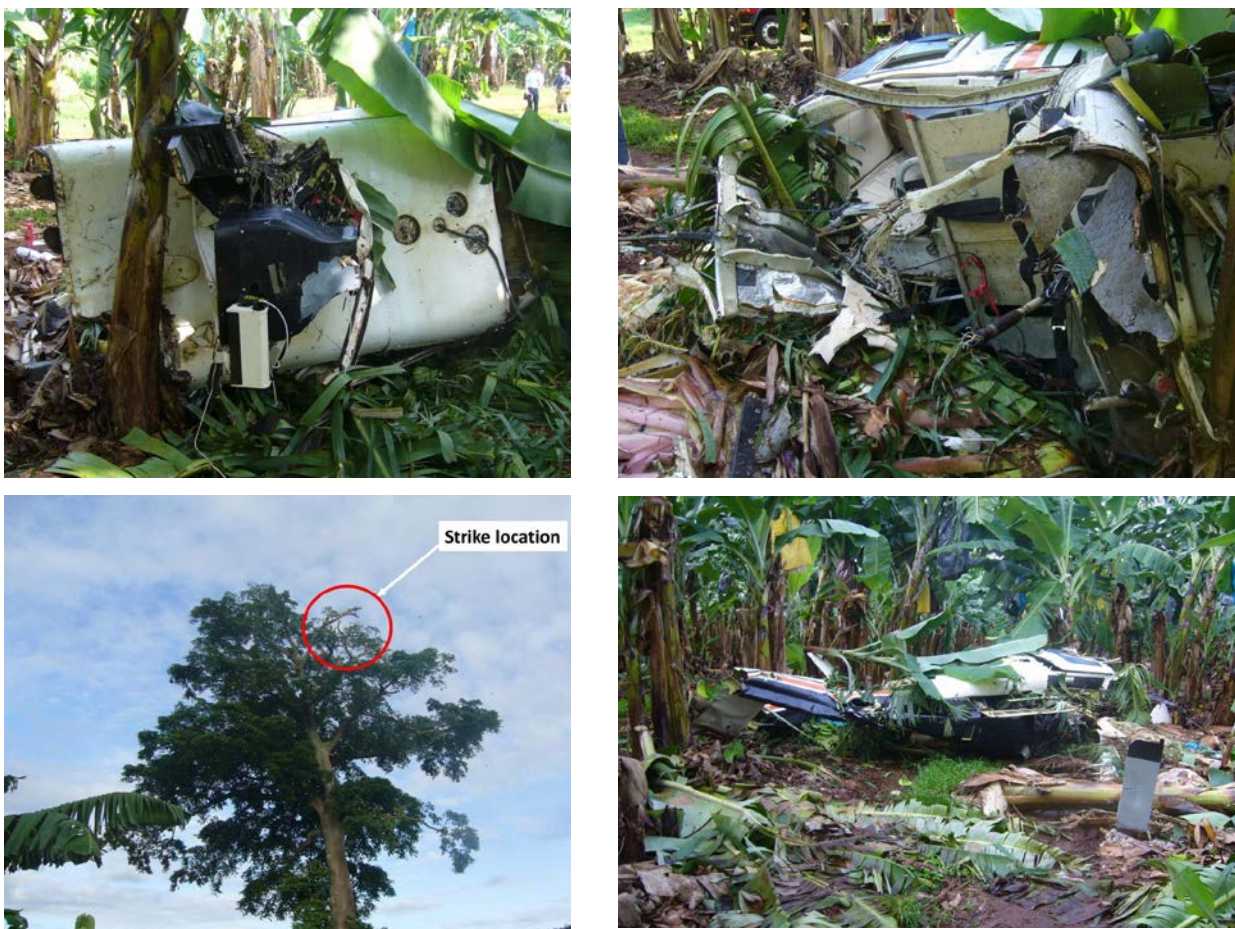
**Figure 1: Damage to VH-BNG and large tree strike**

At about 0615, on descent to the staging area, when at about 150-200 ft AGL, the helicopter rotor blades collided with a tree, dislodged a branch, and the helicopter subsequently collided with terrain. The helicopter was substantially damaged and the pilot sustained serious injuries (Figure 1).

- He did not see the tree at any time.
- The helicopter was in a nose-high attitude on descent to the staging area, which caused a significant blind spot.
- There was some overspray on the windscreen, reducing the visibility through it.
- The helicopter was heading towards the south-east and glare from the rising sun further reduced visibility.
- He had taken off to the west, then turned to the north towards the block to be sprayed, so had not sighted the tree on departure. The return route however put the helicopter directly in line with the tree.

**Damage to VH-BNG**
