Cargo hold smoke event involving a Boeing 737, DQ-FJH

Melbourne Airport, Victoria, 26 April 2014

ATSB Transport Safety Report
Aviation Occurrence Investigation
AO-2014-082
Final - 3 September 2014

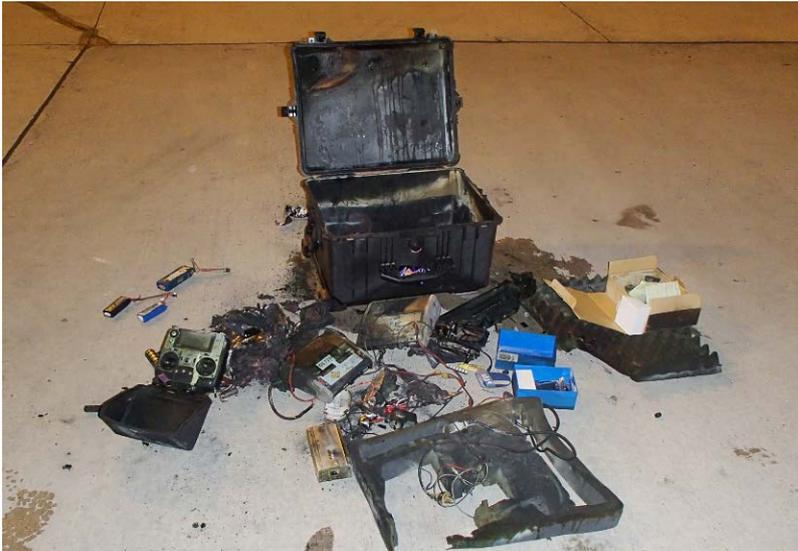
An initial investigation revealed that several lithium-ion polymer batteries and an RPA controller were contained in the case. An electrical short circuit involving the batteries resulted in the initiation of a fire, destroying the contents and damaging the case (Figures 1, 2 and 3). An RPA controller containing other, similar, lithium-ion polymer batteries was found in one of the passenger's other checked-in bags. The fire-damaged case had been screened through the oversized luggage point at Melbourne Airport.

Figure 1: Fire-damaged bag and contents

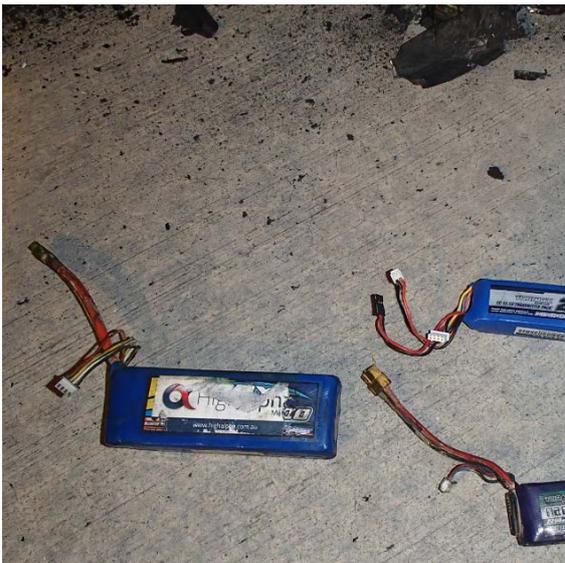
Figure 2: Batteries found in the case

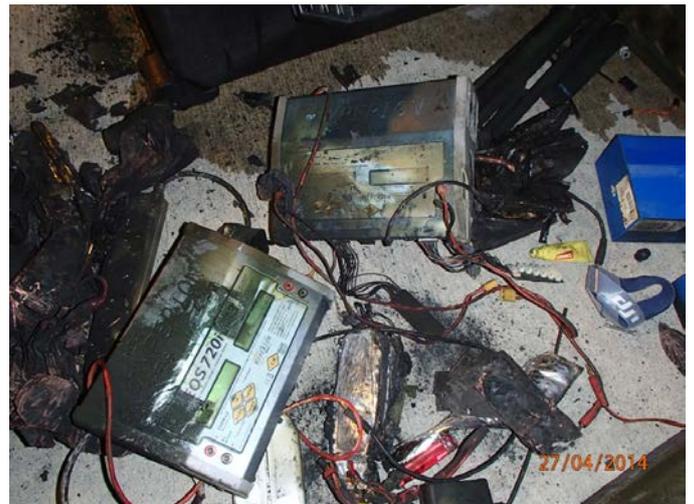
Figure 3: Battery balancers

An analysis conducted by Fiji Airways found that the post-incident images indicated a Lithium-ion Polymer battery fire involving high capacity – high discharge batteries. The battery balancers (shown in Figure 3), are used for charging heavy duty batteries.
