Australian Government
Joint Agency Coordination Centre

MH370 Operational Search Update

10 February 2016

Recovery of deep tow sonar vehicle

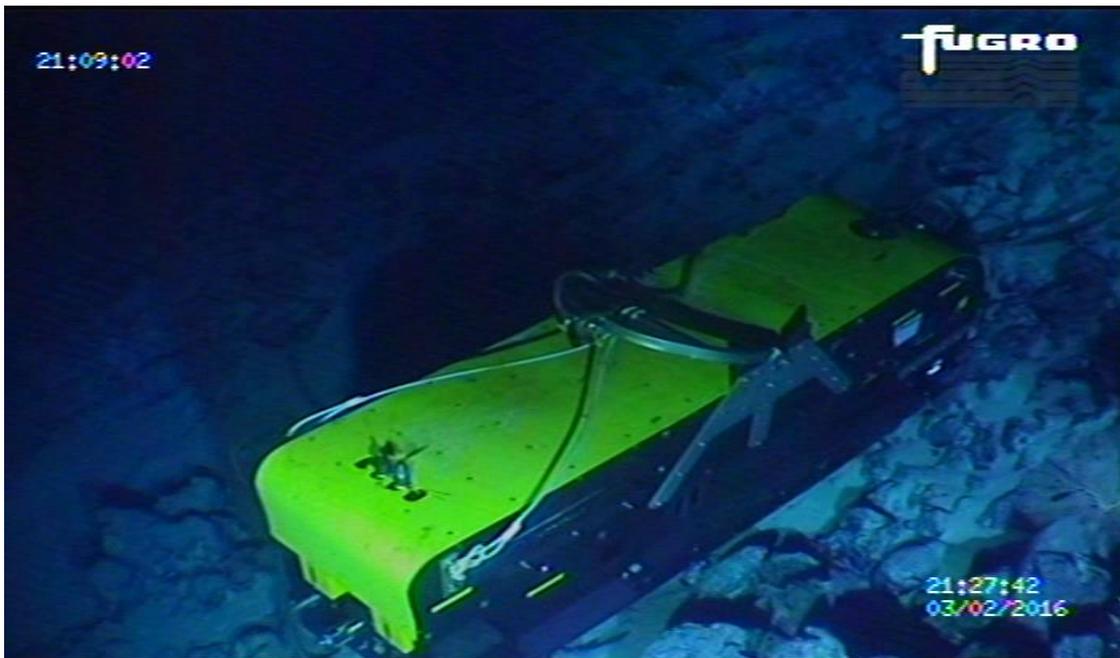
On the evening of 3 February, the crew of the *Havila Harmony* deployed an FCV3000 remotely operated vehicle (ROV) via its umbilical cord to the seafloor. When the ROV reached the seafloor at a depth of around 2,550 m, the towfish was quickly located and the ROV pilots used a cutting tool fitted to the ROV to sever the soft tow connecting the depressor weight to the towfish. A manipulator on the ROV was used to raise the neutrally-buoyant towfish to 2,000 metres. It was then attached to a hook that had been lowered from the crane on board *Havila Harmony*, and raised to the surface for retrieval.

Image of the lost towfish fed from the ocean floor back to the surface by the ROV; source ATSB, photo by John Bethea.

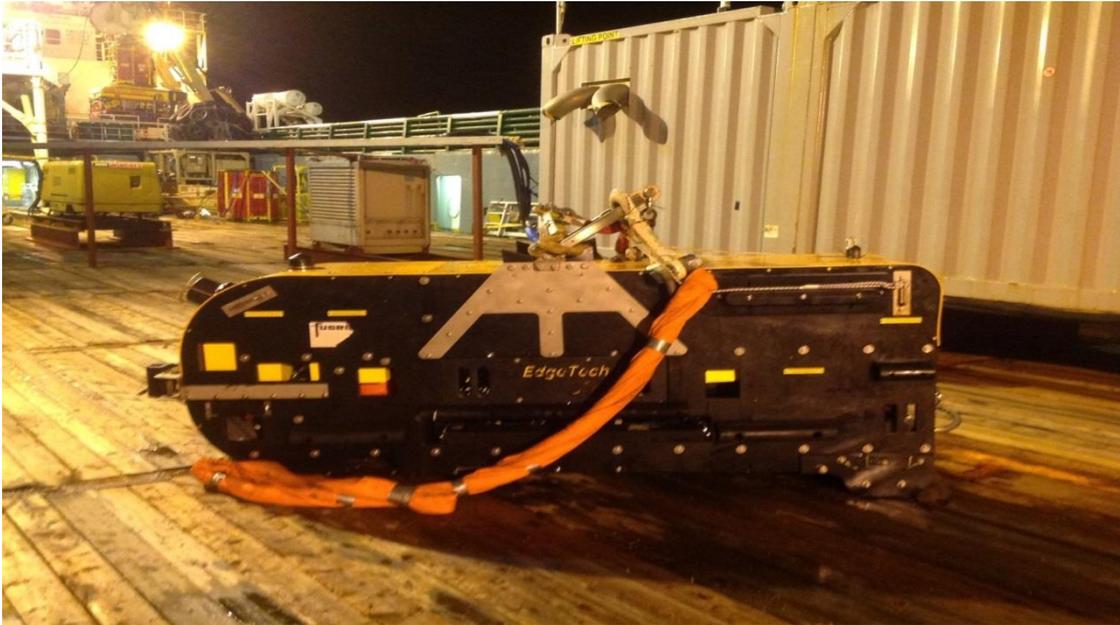
The towfish recovery was executed safely and successfully with little delay to the ongoing search; the entire operation took under four hours. Early examination of the recovered towfish shows minimal external damage.

The recovered towfish on the deck of *Havila Harmony*; source: ATSB, photo by John Bethea.

The towfish has been transferred to *Fugro Discovery* and will be returned to port to receive a full check and test of all systems before it is reinstated in the search. *Fugro Discovery* is currently equipped with a spare towfish.
