# Safe Working irregularity involving Controlled Signal Blocking

Between Allandale and Farley, Hunter Valley, NSW | 30 October 2015

**ATSB Transport Safety Report**  
Rail Occurrence Investigation  
RO-2015-021  
Final – 4 May 2017

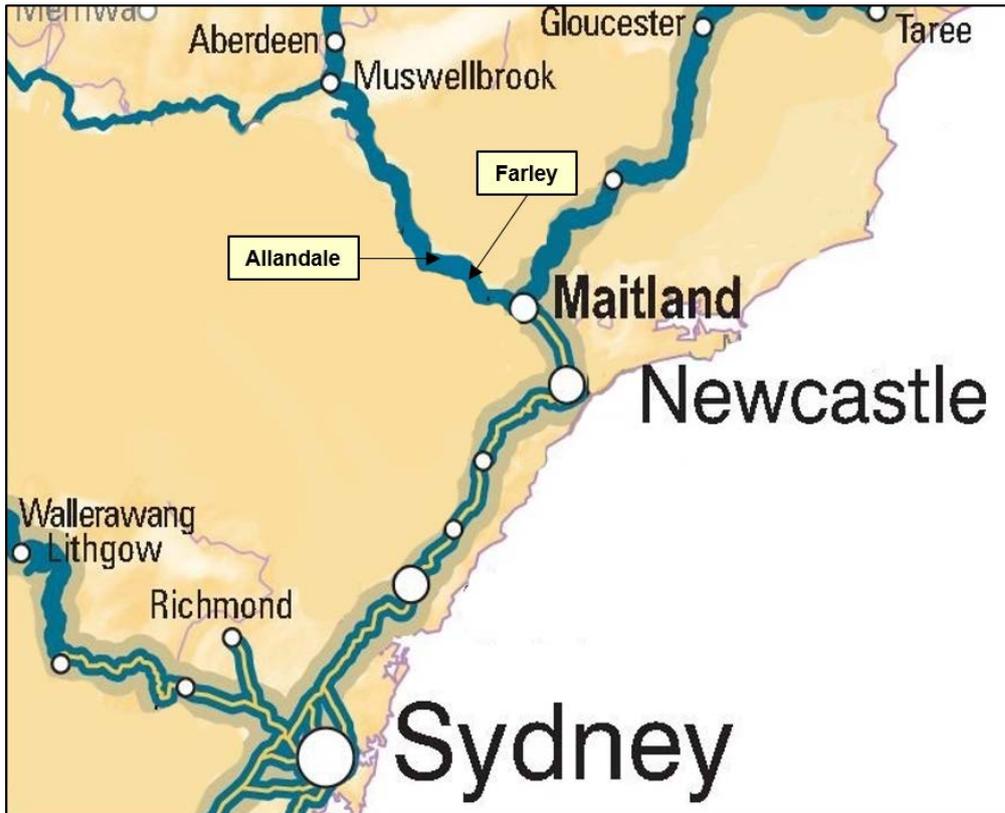
**Figure 1: Location of the Allandale to Farley track section.**

On 30 October 2015, the Australian Rail Track Corporation (ARTC) scheduled track maintenance work (placement of ballast) to occur between Braxton and Farley on the Up main north line, Hunter Valley in NSW. To facilitate the work, the *network controller*<sup>1</sup> at the ARTC network control centre north (NCCN) situated at Broadmeadow issued the *protection officer*<sup>2</sup> a *work on track authority*.<sup>3</sup> The authority excluded rail traffic from the defined track section between Allandale and Farley, permitting safe access for the work to proceed (Figure 1).
