# ATSB rail safety investigation: key lessons learnt

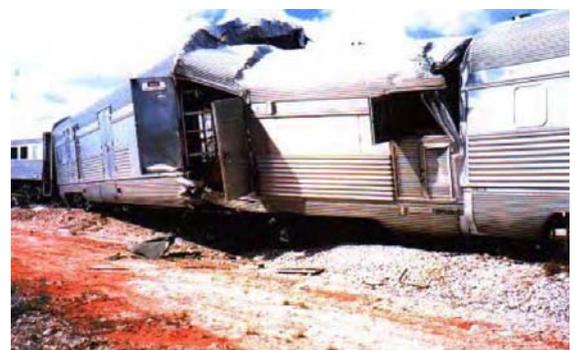
Figure 1: Carriages damaged at Zanthus

On 18 August 1999, just after 5 pm, the Indian Pacific passenger train travelling from Adelaide to Perth was inadvertently directed onto a loop line at Zanthus, where it collided with a stationary freight train. Seventeen passengers and four train crew required medical treatment, and there was significant damage to the locomotives and carriages.

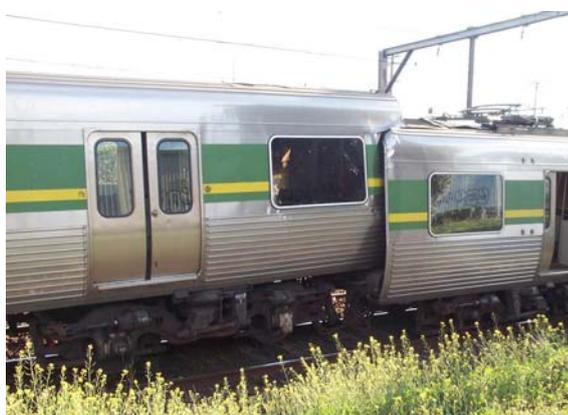
**Figure 3: Footscray, Victoria**

For example, on 5 June 2001, an empty suburban electric express train collided with the back of a suburban passenger train at Footscray station in Victoria. The passenger train had about 20 people on board. The driver of the empty train was injured, and two passengers were taken to hospital for observation.

There was strong evidence that the performance of the driver of the empty train was impaired by a medical condition that led to him being unable to recall the events in the minutes before the collision. The driver was taking a course of prescribed medication, which combined with an

early start for work that day and a history of chronically disturbed sleep, may have resulted in him falling asleep for a short period while he was driving the train.

While there were safeguards in place to protect the safety of the system from such an eventuality, on this occasion they did not prevent the accident. A number of defences in the system were identified as being inadequate in terms of design or application. For example, one defence that was inadequate was the 'dead-man's handle' or vigilance device (in this case a foot pedal) designed to automatically apply the train brakes if there was any variation in applied pressure due to driver incapacitation. The ATSB's investigation found that in some circumstances the pressure on the foot pedal could be correctly maintained just by the weight of the driver's lower leg, regardless of whether or not he was incapacitated.

The alertness and fitness of drivers to perform their duties is also a defence against accidents. In the Footscray collision, the investigation found serious defects in the monitoring of the driver's health and fitness. It also found that the health standards used to assess driver fitness were deficient. As a result, although the driver was skilled and experienced, he was not medically fit to operate the train.

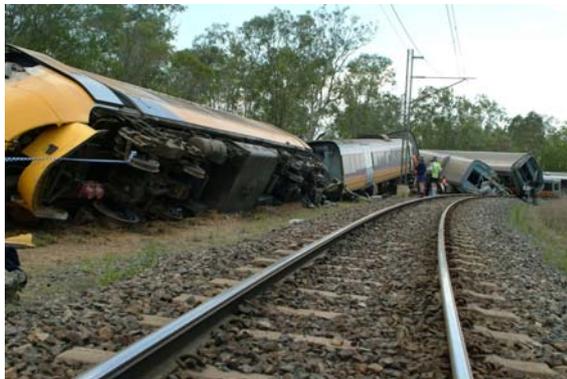
**Figure 4: Derailed Cairns tilt Train**

ATSB-led investigations in Queensland included the Cairns Tilt Train derailment on 15 November 2004. The train derailed at a speed of 112 km/h north of Berajondo on the Bundaberg to Gladstone line with 150 passengers, two drivers and five passenger service staff onboard. Some of the people on the train were severely injured but fortunately there were no fatalities.

The principal cause of the derailment was excessive speed. From a systemic point of view, the accident was complex and although the principal causal factor related to 'human performance', better organisational controls may have prevented it.

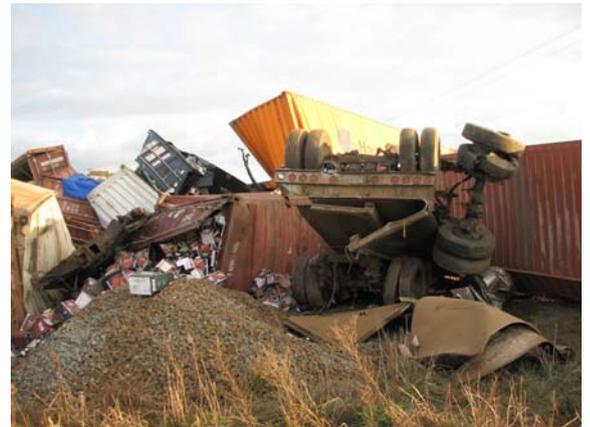
**Figure 5: Lismore, Victoria**

On 25 May 2006, a tipper truck and trailer carrying a load of 30 tonnes of citrus pulp collided with a freight train near Lismore in Victoria. The driver of the truck was fatally injured. Two locomotives and 41 of the train's 64 wagons derailed with the estimated direct cost of the collision upwards of \$13.5 million.

At the time of the accident the area surrounding the level crossing was enveloped in very thick fog, with visibility less than 50 m. The investigation found that the truck was not being driven in accordance with these conditions, and that the performance of the truck driver may have been affected by fatigue. In addition, the level crossing approach signage and sighting distances were not in accordance with the relevant Australian standards.

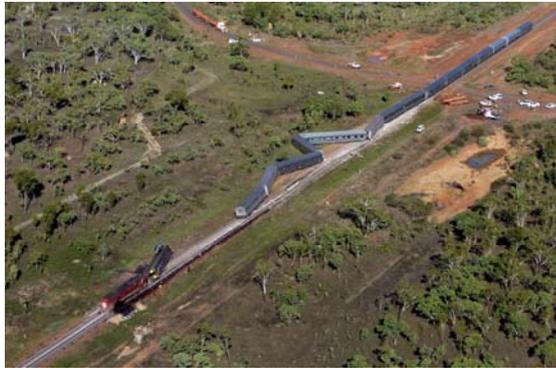
**Figure 6: Ban Ban Springs, NT**

On 12 December 2006, a double trailer road-train drove into the path of *The Ghan* passenger train at a level crossing near Ban Ban Springs in the Northern Territory. As a consequence, two locomotives, a wagon used for carrying passengers' vehicles and nine passenger carriages derailed. While there were no fatalities, the road-train driver and a female passenger were hospitalised and several other passengers and crew sustained minor injuries.

The investigation concluded that the truck was driven through the 'Stop' sign at the level crossing at a speed of about 50 km/h. The driver was very familiar with the crossing and had a habit of slowing rather than stopping at the crossing. He may have been influenced by the expectation that a train would not be present and by the

operational constraints of road-train vehicles. In addition, he may not have heard the warning of the train horn because of his severe hearing loss.

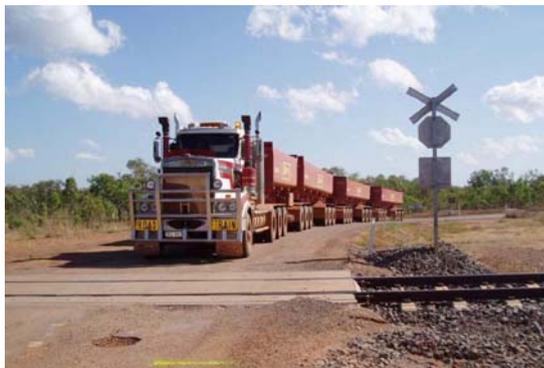
Large heavy road vehicles can take a long time to stop and to get going again. As part of the ATSB investigation, trials were conducted at the Ban Ban Springs level crossing to see how long it would take a large road train to traverse the crossing under different conditions. The results showed, in certain circumstances, the time taken for the test vehicle to clear the level crossing from a standing start was longer than the standard time used to calculate sighting distances. The results of the ATSB's trials, detailed in the investigation report, have wider implications in relation to the adequacy of the current standards for sighting distances at level crossings.

**Figure 7: Road-trains can take a long time to stop and get going again**
