Debris examination – update No. 2

Missing aircraft, Boeing 777, 9M-MRO, 8 March 2014

**Identification of two items of debris
recovered from beaches in South Africa
and Mauritius**

AE-2014-054

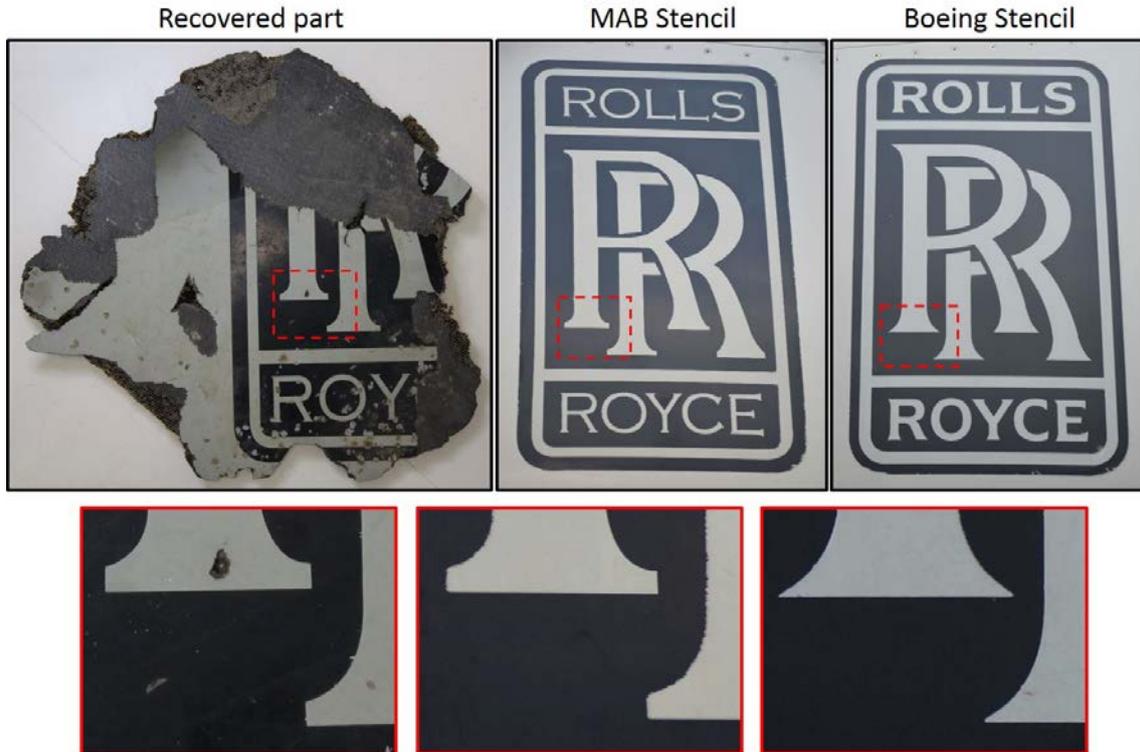
Figure 1: Comparison of Boeing 777 engine cowling stencils

Part number 3 was initially identified from the partial Rolls-Royce stencil as a segment from an aircraft engine cowling. The panel thickness, materials and construction conformed to the applicable drawings for Boeing 777 engine cowlings.

There were no identifiers on the engine cowling segment that were unique to 9M-MRO, however the Rolls-Royce stencil font and detail did not match the original from manufacture. The stencil was consistent with that developed and used by Malaysian Airlines and closely matched exemplar stencils on other MAB Boeing 777 aircraft (Figure 1).

Note the thickness of the “ROYCE” lettering and the serif geometry on the main ‘R’s (enlarged for ease of comparison).

There were identical inboard and outboard stencils present on the cowlings of each of the engines and the location of the stencils was found to vary between engines. Taking that into consideration, there were no significant differentiators on the cowling segment to assist in determining whether the item of debris was from the left or right side of the aircraft, or the inboard or outboard side the cowling.

- Part No. 3 was a Malaysian Airlines Boeing 777 engine cowling segment, almost certainly from the aircraft registered 9M-MRO.
- Part No. 4 was a Malaysian Airlines Boeing 777 panel segment from the main cabin, associated with the Door R1 closet, almost certainly from the aircraft registered 9M-MRO.

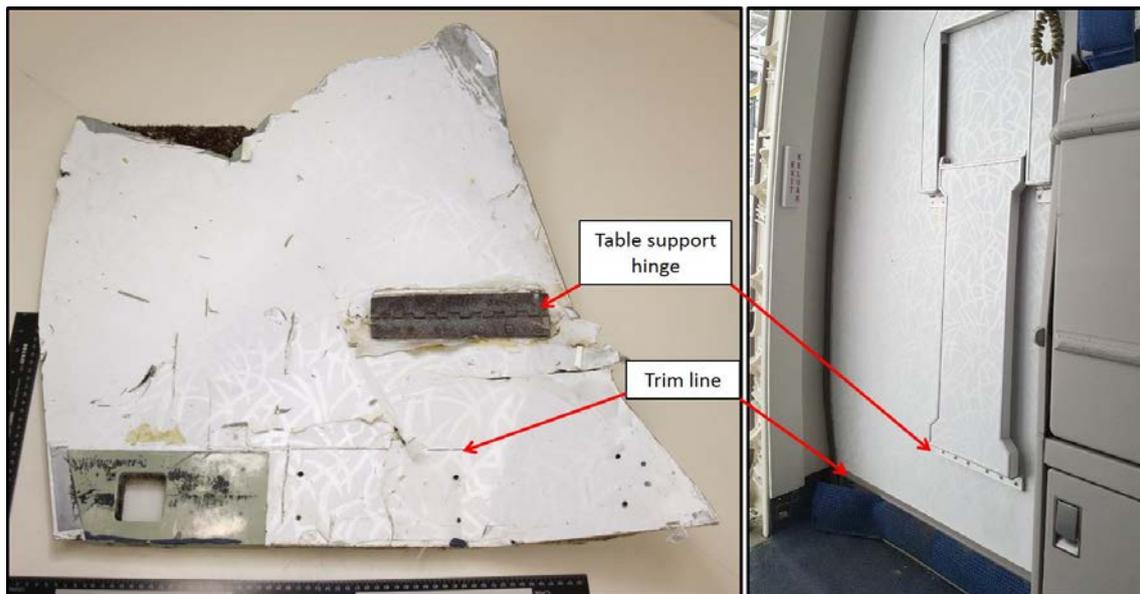
Figure 2: Comparison of recovered item with MAB Boeing 777 Door R1 panel assembly

Part number 4 was preliminarily identified by the decorative laminate as an interior panel from the main cabin. The location of a piano hinge on the part surface was consistent with a work-table support leg, utilised on the exterior of the MAB Door R1 (forward, right hand) closet panel (Figure 2). The part materials, dimensions, construction and fasteners were all consistent with the drawing for the panel assembly and matched that installed on other MAB Boeing 777 aircraft at the Door R1 location.

There were no identifiers on the panel segment that were unique to 9M-MRO, however the pattern, colour and texture of the laminate was only specified by MAB for use on Boeing 747 and 777 aircraft. There is no record of the laminate being used by any other Boeing 777 customer.
