# Separation issues involving a Cessna 404 and an American Champion 8KCAB

8 NM south-east of Moorabbin Airport, Vic., on 3 November 2022

**ATSB Transport Safety Report**

AB-2022-017

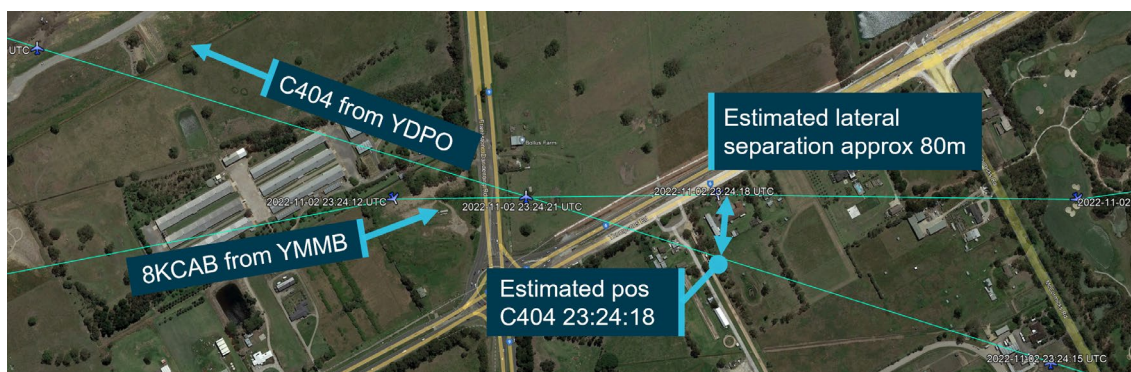
**Figure 1: Image showing both aircraft tracks**

The flight tracks show that both aircraft were in the descent when the Cessna 404 pilot became visual with the American champion 8KCAB. The pilot estimated the other aircraft to be about 300 ft above and slightly right of track at the point of becoming visual.
