Derailment of freight train 4PM9

Inverleigh, Victoria, on 14 November 2022

ATSB Transport Safety Report

RO-2022-013

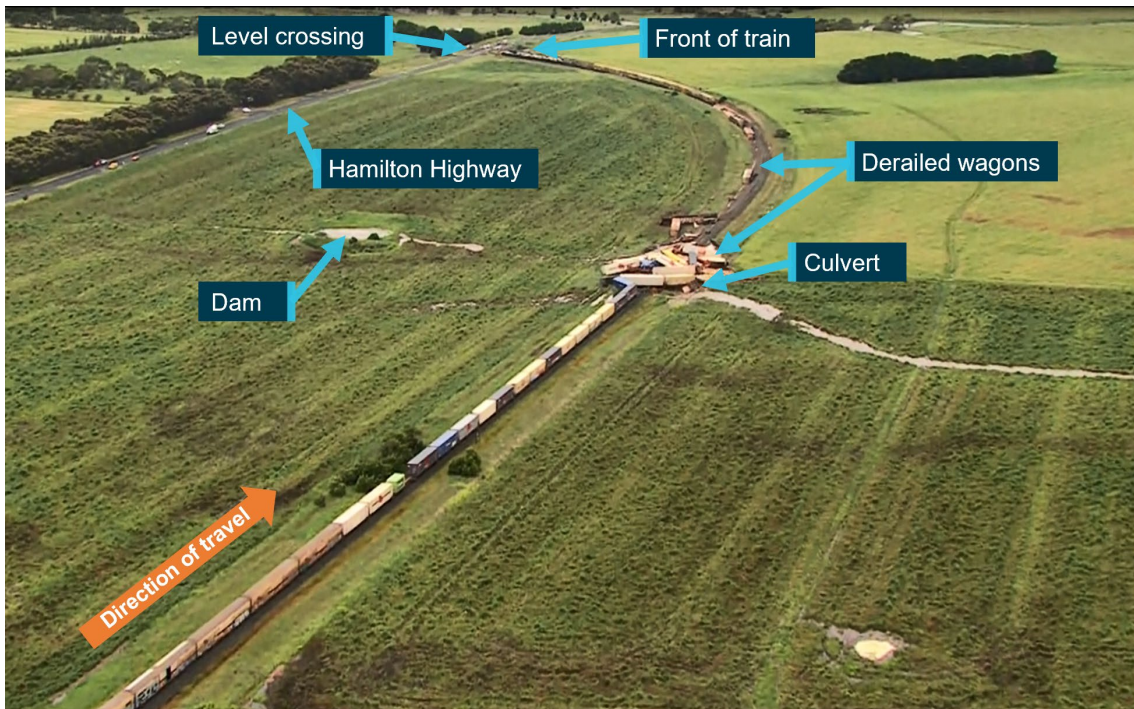
Figure 2: Aerial view of derailed train 4PM9

At about 0450 on 14 November, train 4PM9 travelling at about 80 km/h passed over a culvert located to the east of the township of Inverleigh. Soon after, there was a loss of brake pipe pressure³ and the leading end of the train came to a stop across the Hamilton Highway level crossing. Ten of the original 55 wagons were still attached to the leading 5 locomotives. The next 16 wagons were derailed including 7, 5-pack articulated wagons (Figure 2).
