# Unforecast weather and flight below minimum altitude involving Fokker Aircraft F100, VH-NHV

Paraburdoo Airport, Western Australia, on 22 November 2021

## **ATSB Transport Safety Report**

AO-2021-048

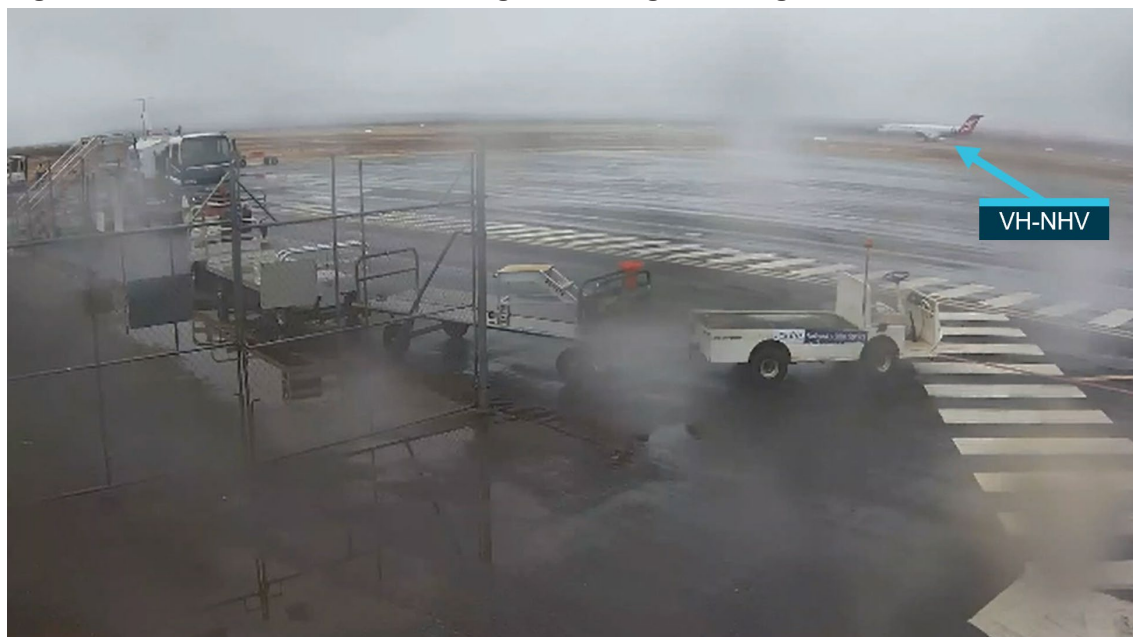
**Figure 2: Weather at Paraburdoo during the landing roll of flight QF1616**

At 0843:23, the aircraft landed without further incident. During the landing roll, the captain recalled noting that their fuel on board indicated 0.96 tonne.<sup>24</sup> Following the landing, the PM made a CTAF broadcast that there were some very low patches of cloud at 250-300 ft above ground level. Figure 2 depicts the weather during the landing roll.

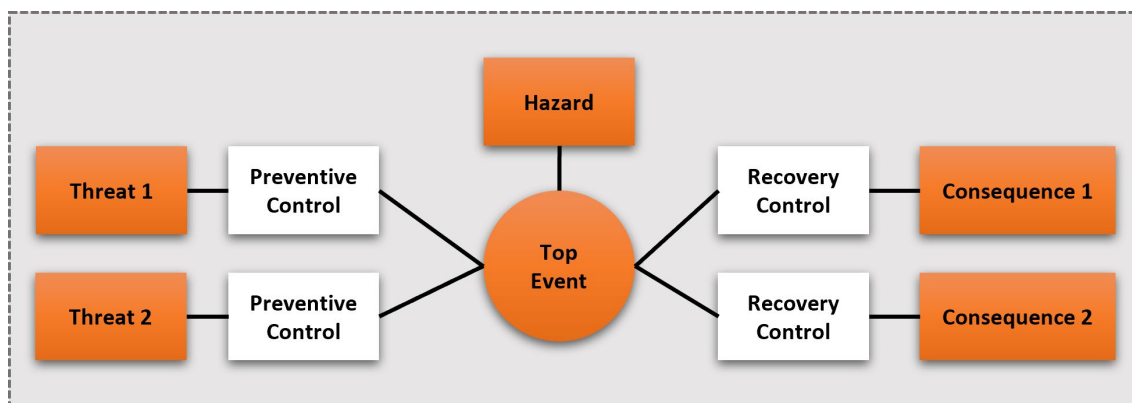
**Figure 6: Example bowtie structure**

The top event represents the loss of control of the hazard (undesired aircraft state), and damage or injury is represented by the consequence(s). A threat is a factor that 'itself should have the ability to cause the top event' (Figure 6). While aviation traditionally distinguishes between threat and error, the software program used threat as the descriptor for both.

When the risk assessment is constructed with multiple threats on the left side and consequences on the right side of the top event, a bowtie like structure appears. Between the threats and the top event are the preventive controls, to reduce the likelihood of the top event occurring. Between the top event and the consequences are the recovery controls, to reduce the likelihood and/or severity of the consequences.
