**ATSB SUPPLEMENTARY INVESTIGATION REPORT**

**Inspection of five vessels owned by the Department  
of Immigration and Multicultural  
and Indigenous Affairs**

**at Thursday Island**

**28 November to 2 December 2005**

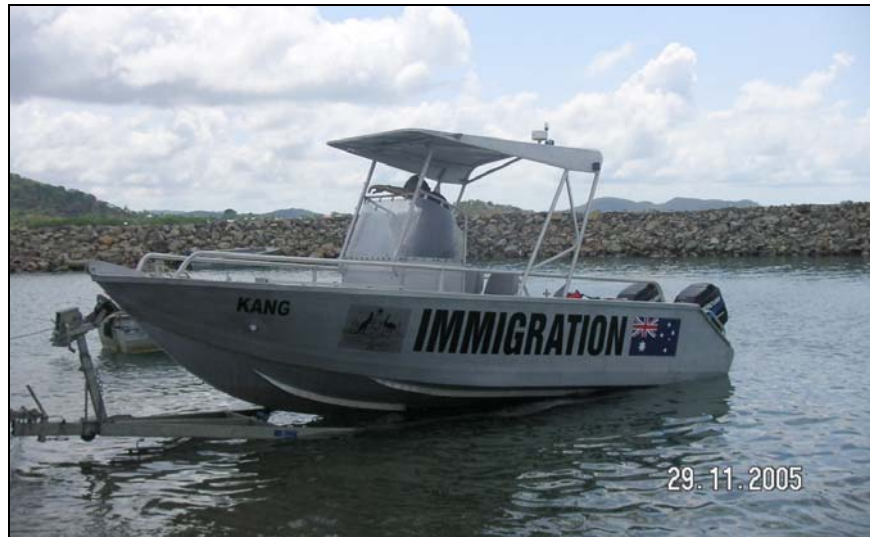
**Figure 2: Launching vessel**

- 2.1 We considered a sea trial to be appropriate in order to meet the more general requirements of our instructions to survey and test the subject vessels.
- 2.2 The relevant vessels available for sea trials were the vessels IMMI 004/005/006. (IMMI 002 could not be used for sea trials as it had no engines fitted and IMMI 001 was eliminated because of the likelihood of differences between her and the missing vessel as detailed above).
- 2.3 We selected IMMI 004 *Kang* for the purposes of conducting sea trials. The vessel appeared to be operational and typical of the remaining group of vessels.
- 2.4 *Kang* was launched by trailer and sea trials were conducted on the afternoon of 29/11/05.

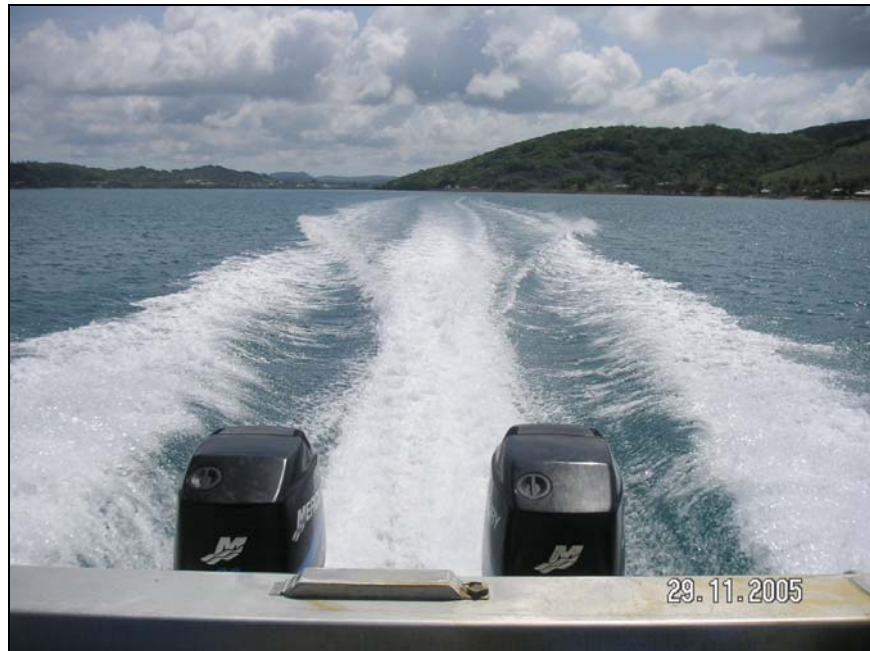
**Figure 3: View astern of vessel at full speed**

- 2.10 At 4200 rpm a speed of 24 knots was obtained and at 5200 rpm a speed of 35 knots was obtained (operating on both engines).

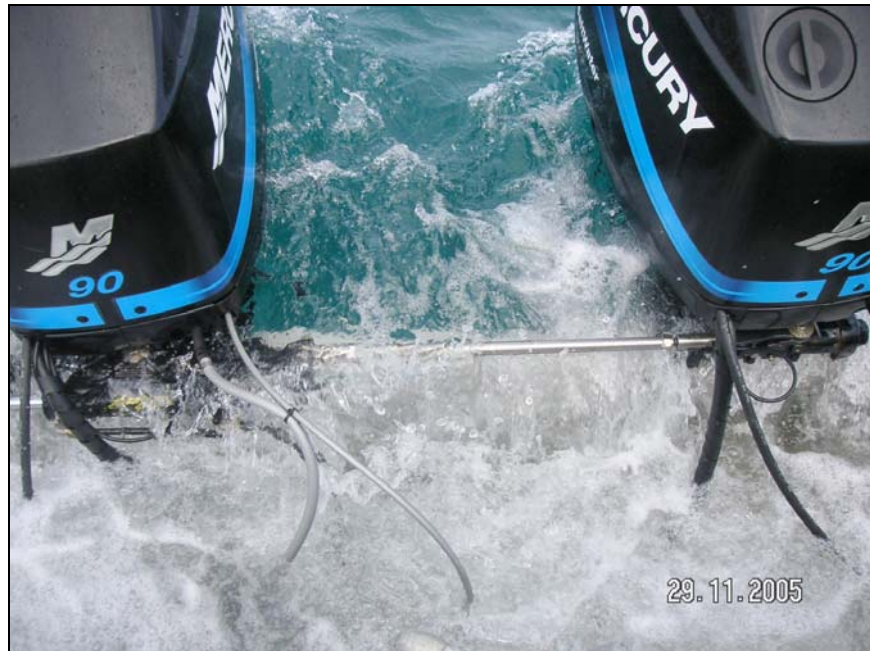
**Figure 4: Stern motor well flooding**

- 2.11 On one engine only a speed of 19 knots was obtained at 4300 rpm.
- 2.12 The vessel was found to perform and handle reasonably well when operating ahead and under powered turns under these conditions. The vessel did not ship any water other than a small amount of light spray.
- 2.13 A trial was conducted with the vessel operating astern at low to moderate power using both engines.
- 2.14 Under these circumstances the vessel took water over the motor transom into the motor well and the vessel exhibited alarming tendencies to bury her stern.
- 2.15 The astern trial was discontinued to avoid submerging the motors which would have been inevitable within a matter of seconds had it been continued.

- 2.16 Those on board were of the view that the vessel would in fact have buried its stern and flooded completely had the astern trial been continued.

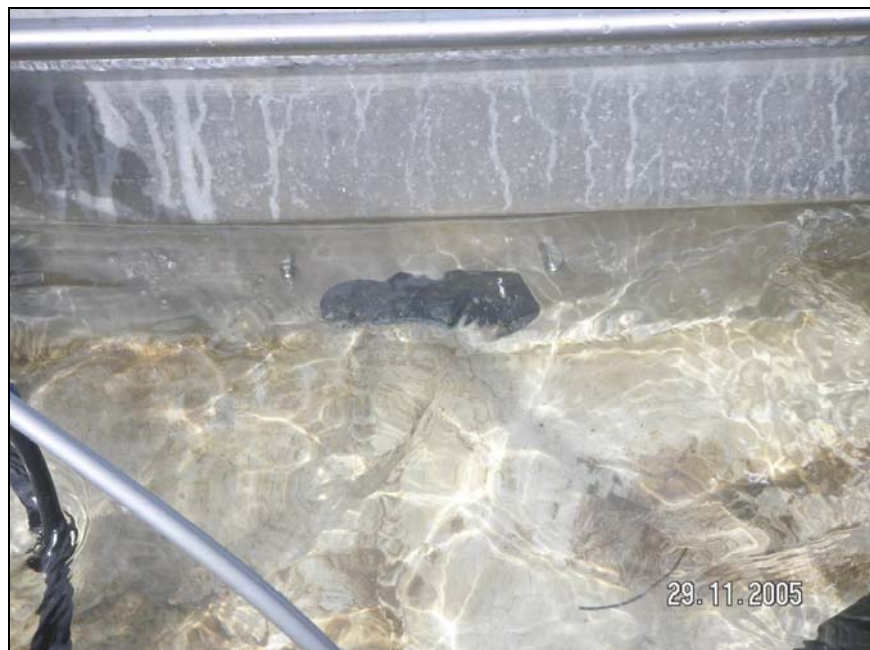
**Figure 5: Water in the motor well**

- 2.17 At the time of the astern trial there was a noticeable free surface effect from the water which came into the motor well (estimated at 325 litres) and which was detrimental to the vessel's stability under those conditions.

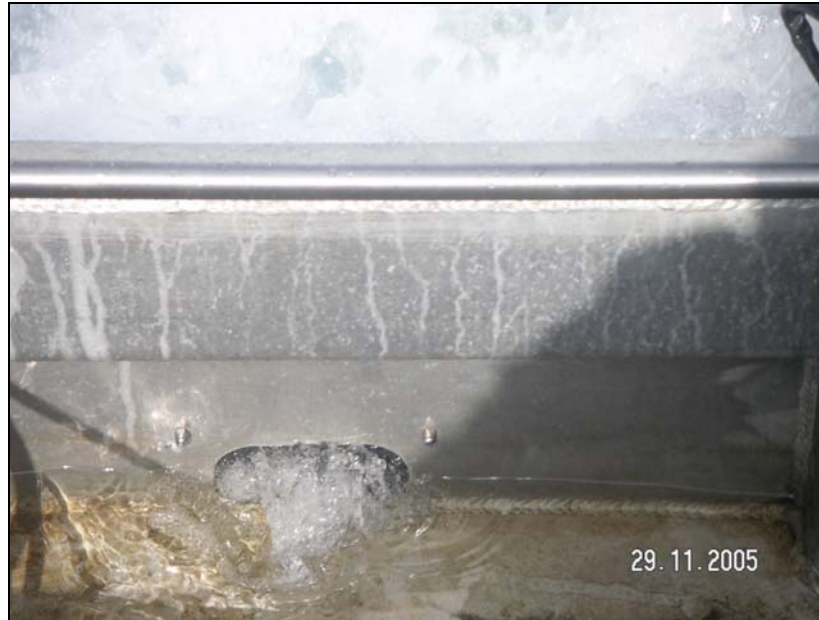
**Figure 6: Water draining from the motor well**

- 2.18 The water in the motor well took a considerable time to drain when the vessel was under way at operating speeds and at low speed the well appeared not to drain at all as the external water level was higher than the single transom freeing port provided.

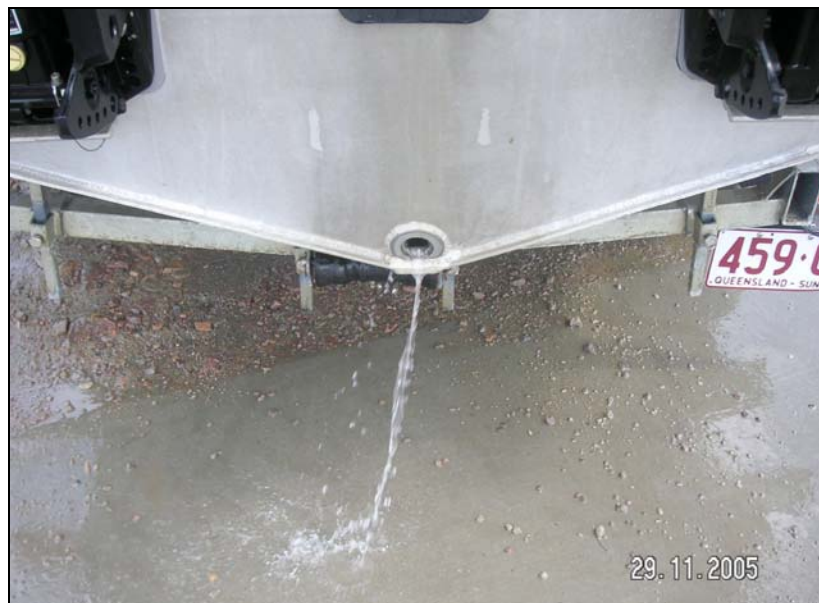
**Figure 7: Water draining from the void**

- 2.19 On return to the shore at the completion of the sea trial, the vessel was removed onto her road trailer.
- 2.20 During the course of the sea trial the vessel had been afloat for 74 minutes and under way for 54 minutes.
- 2.21 The main void bung was then opened with the vessel trimmed by the stern and a significant quantity of water, estimated at 20 to 40 litres, was drained from the void which had been empty before launching.

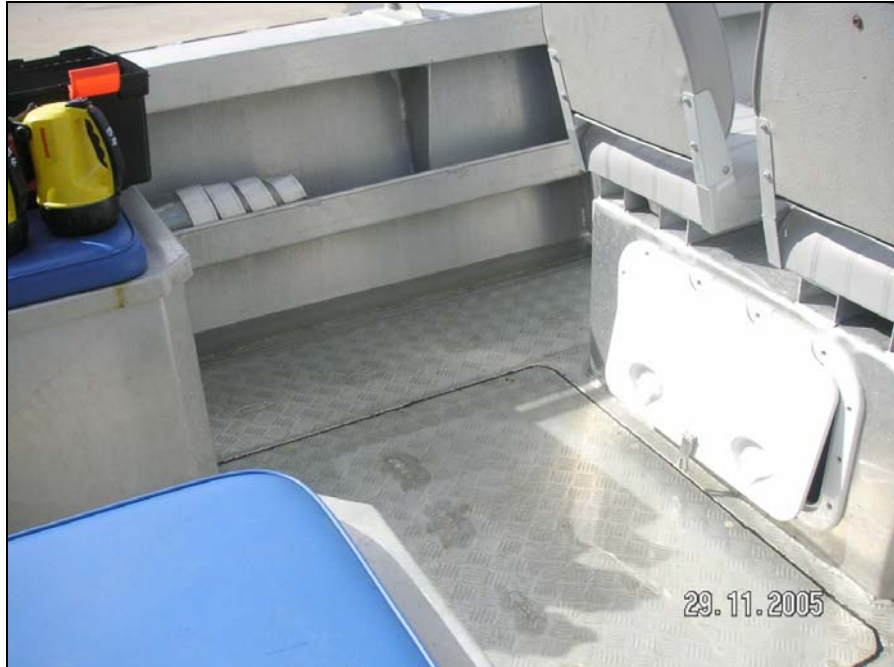
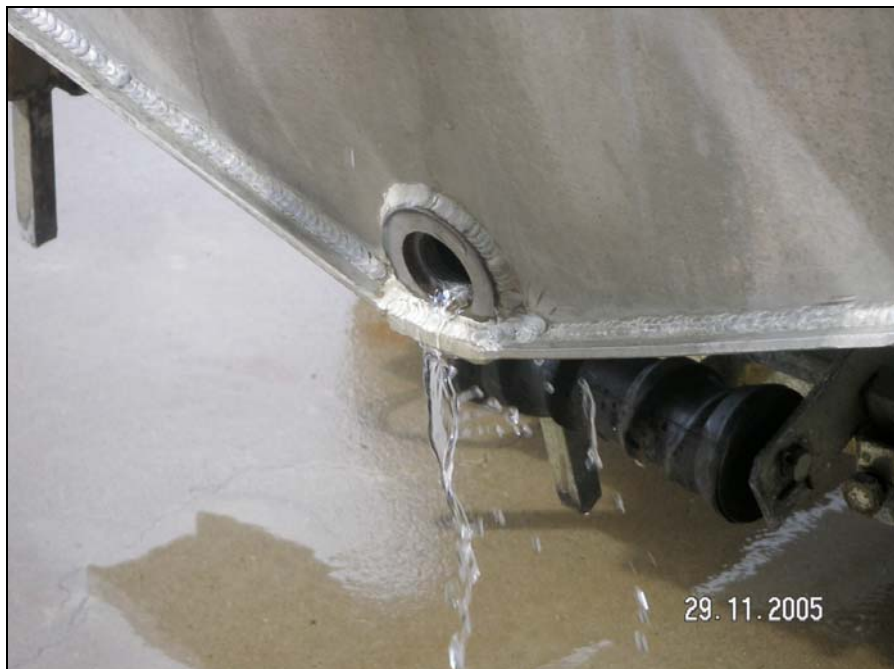
**Figure 8: Cockpit deck covered with water during the test**

- 2.22 The vessel was then subjected to a flooding test across the deck (refer to paragraphs 3.3 and 3.4) and water again found to ingress the hull void through the deck thus proving the lack of watertight integrity of the void space on this vessel.

**Figure 9: Water draining from the void after the test**

- 7.1 The vessels 002/004/005/006 were all found to have areas of poor quality welding.
- 7.2 The vessels 002/004/005/006 were all found to have significant leaks between the deck and the void space below and it was proven by practical test to each vessel that there was no watertight integrity to the void space thus rendering the void space ineffective as a means of reserve buoyancy and non compliance with AS 1799 – s 3.2.1 – ‘Weather decks shall be watertight’.

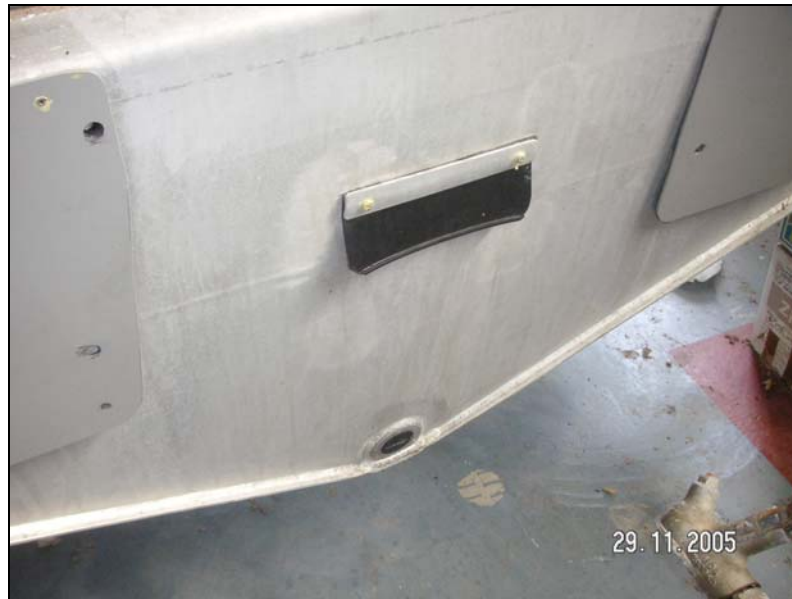
**Figure 12: Transom freeing port**

- 4.8 The transom freeing ports are in all cases rectangular openings with radiused corners.

- 4.9 The maximum dimensions of these openings vary between the vessels as follows:

Vessel Hull #	Vessel Name	Dimension
IMMI 001	<i>Kuzi</i>	112 mm x 55 mm
IMMI 002	<i>Zeuber Erkep</i>	155 mm x 53 mm
IMMI 004	<i>Kang</i>	112 mm x 55 mm
IMMI 005	<i>Magani Guthat</i>	112 mm x 55 mm
IMMI 006	<i>Ngagalayg</i>	112 mm x 65 mm

- 4.20 However, this freeing port is demonstrably inadequate in its ability to drain the motor well plus the volume of water which would flow into the well from the main deck via the scuppers if they were of an adequate and unrestricted area.

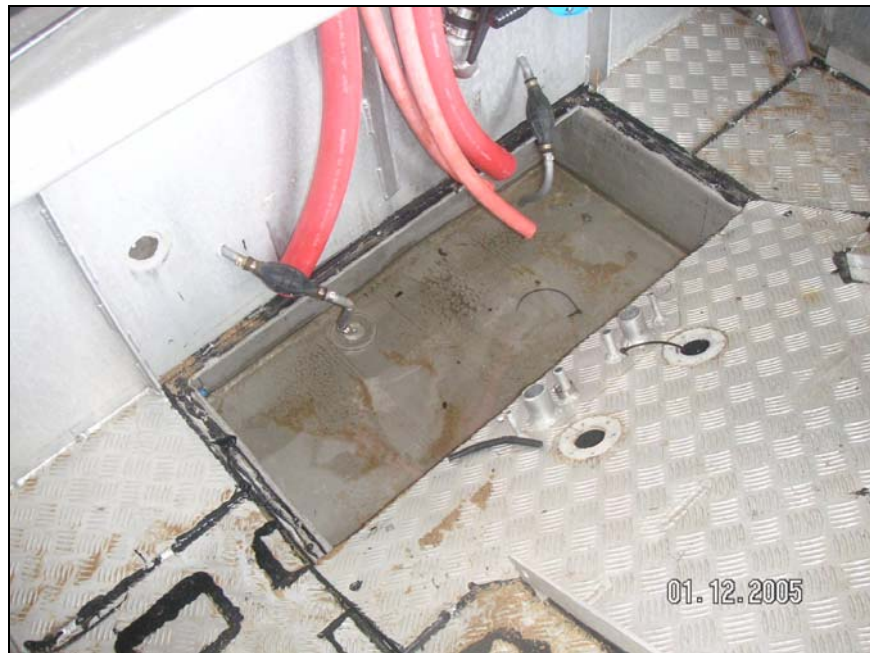
**Figure 13: Void space and fuel tank**

- 5.6 The tank occupied almost the entire tank void except for a small space at the aft end.

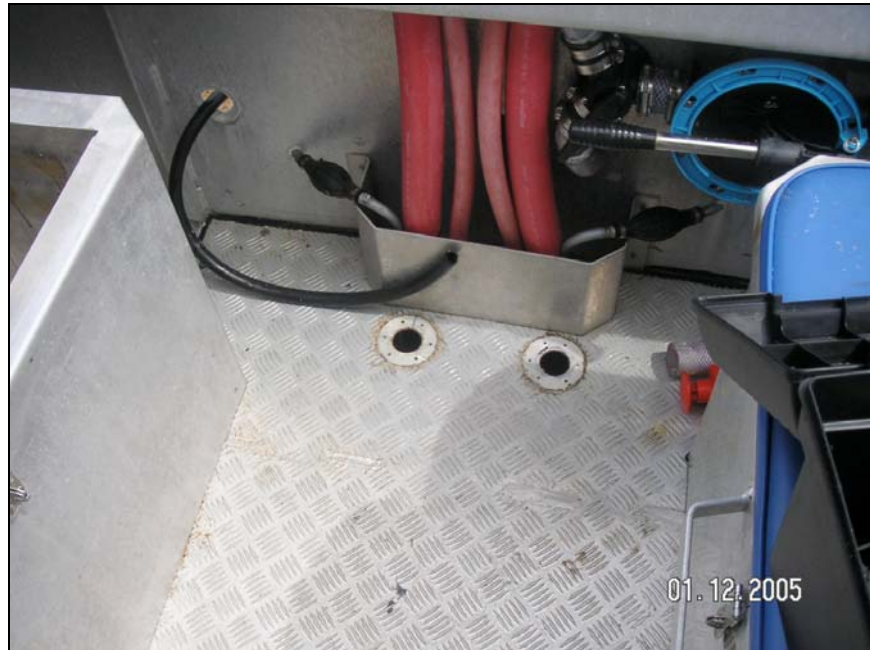
**Figure 14: Top of fuel tank with hoses leading from up-stands**

- 5.9 The filler, breather, and suction lines were attached to welded alloy up-stands at the aft end of each tank. The fuel gauge was flush mounted (directly onto the chequer plate tank top).

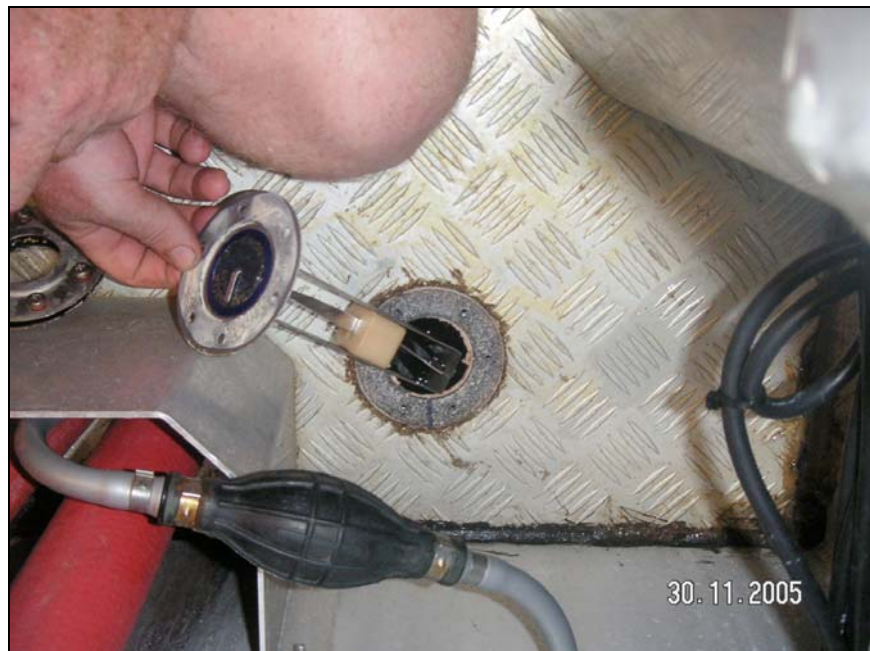
**Figure 15: Removal of a fuel gauge**

- 5.10 We removed fuel gauges from each vessel and, in every case, found them to be reading quantities significantly inconsistent with the actual level in the tank.

- 7.5 All vessels were found to have unreliable/inaccurate fuel gauges.
- 7.6 All vessels were found to have fuel void fume detectors disconnected.
- 7.7 All vessels were found to have unsealed penetrations to the fuel tank voids (i.e. fume detector cables).

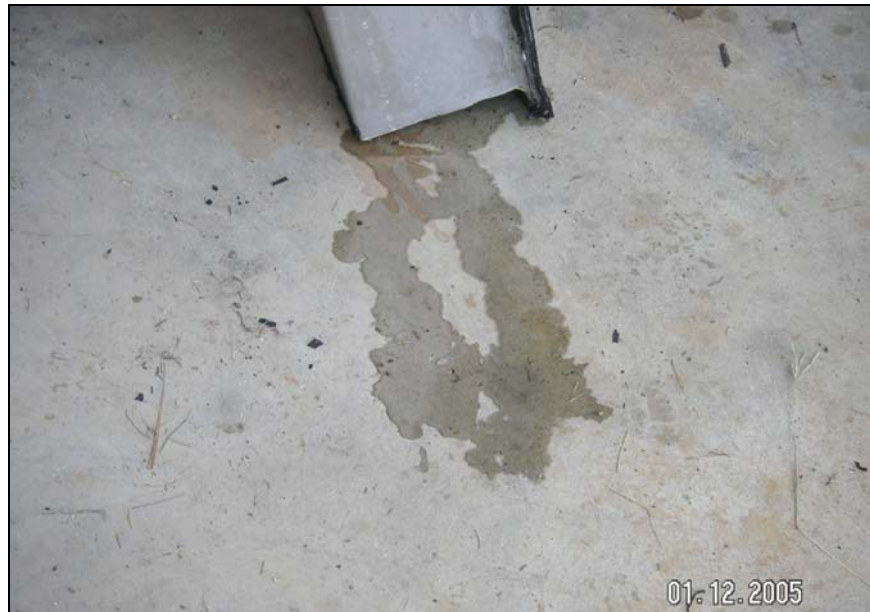
**Figure 16: Water leaking from the fuel tank during testing**

- 5.12 In order to further assess the fuel tank arrangements one tank was removed entirely from a vessel (IMMI 002 *Zeuber Erkep*). This activity was witnessed by representatives of ATSB and AMSA.
- 5.13 This tank had been previously filled with water and one section was observed to loose liquid overnight.
- 5.14 After removal, the tank was not formally pressure tested but was simply filled with water and was immediately found to leak.

- 5.15 The fuel tank was therefore not able to withstand the ordinary pressure of the liquid within it even under static conditions.
- 5.16 The fume detectors were also examined. In every vessel the alarm unit at the console had been disconnected from the wiring to the sensor.

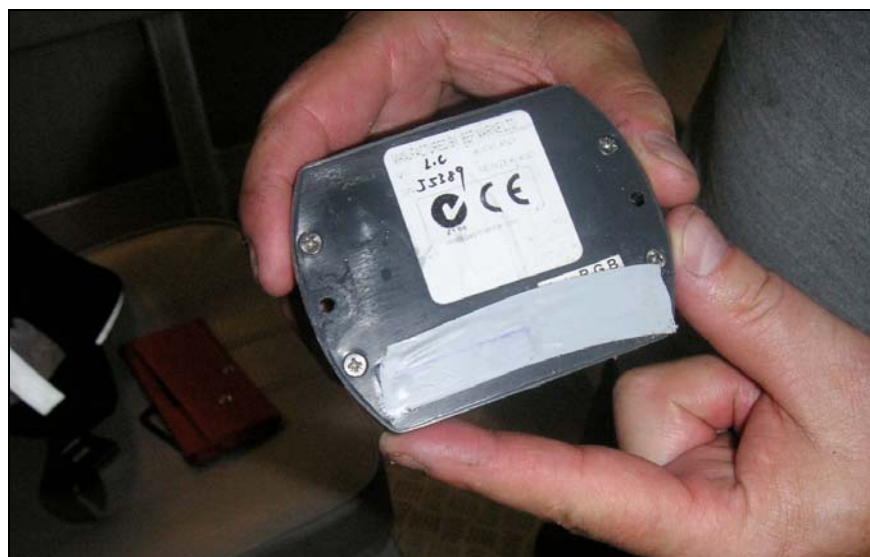
**Figure 17: Back face of fume detector**

- 5.17 In the vessel where the fuel tank was removed the sensor was found to be badly corroded from the presence of seawater in the void where it had been mounted and it would not, therefore, have operated even had it been connected.

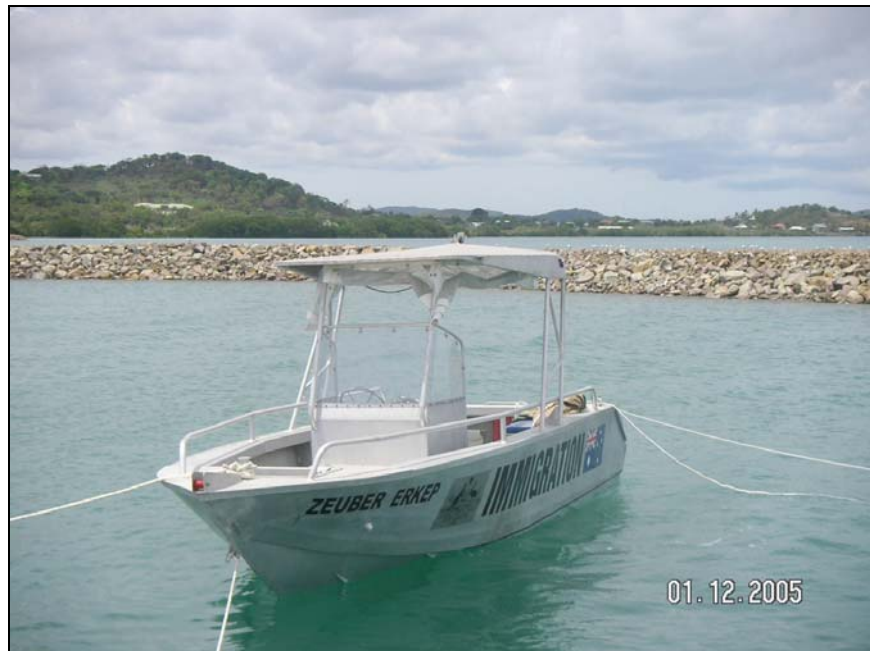
**Figure 18: Vessel secured and ready for testing**

- 6.1 We conducted a practical stability and swamp test of one vessel (IMMI 002 *Zeuber Erkep*) on 01/12/05.
- 6.2 This was attended and witnessed by representatives of ATSB, AMSA, and DIMIA.
- 6.3 The location chosen for this activity was a sheltered position adjacent to a breakwater and vessel ramp.
- 6.4 The subject vessel was secured bow into the ramp with its stern to seaward and an anchor on each quarter.
- 6.5 The vessel was secured aft by a bridle arrangement in such a manner that it was free to heel without impediment.

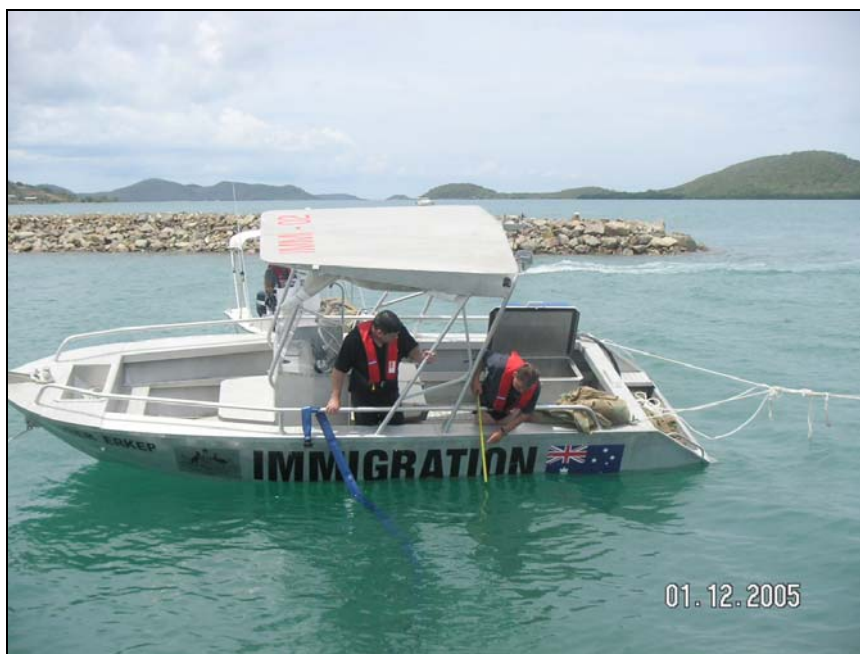
**Figure 19: Measuring the vessel's freeboard**

- 6.11 In order to simulate the weight of persons, sandbags weighing 120 kg were placed into the forward console locker on the centreline and a further sandbag with a weight of 40 kg was placed on the centreline at the helm station. 2 x 40 kg sandbags were placed in the port side locker aft close to the gunwale and 2 persons weighing a total of 210 kg then moved to the port side gunwale.
- 6.12 This arrangement provided (in addition to the weight of the motors) 160 kg (i.e. a little over the weight of two persons) on the centreline and 290 kg (a little under the weight of 4 persons) close to the gunwale.
- 6.13 In this condition, the lowest freeboard was measured at approximately 430 mm which was well in excess of the minimum requirement of 75 mm and the stability test was therefore discontinued without altering any further weight distribution.

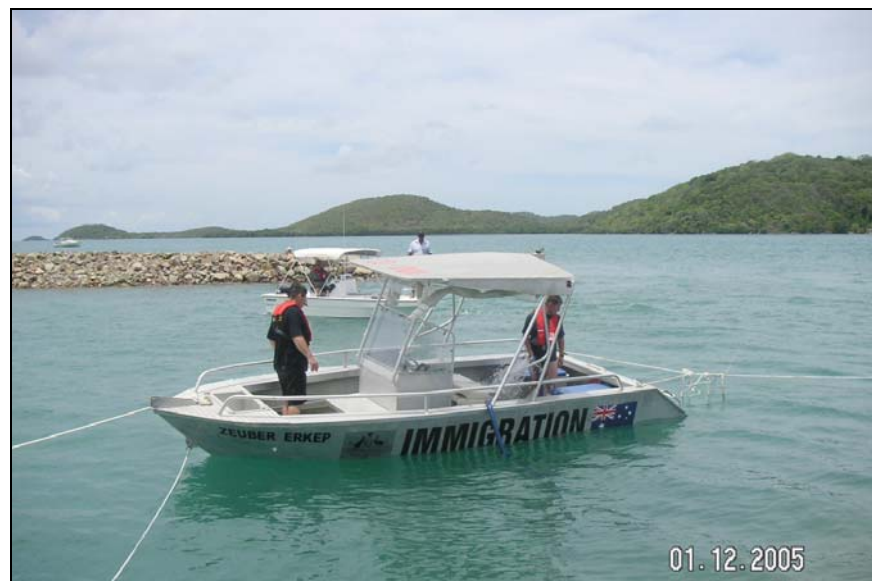
**Figure 20: The vessel showing signs of instability**

6.21 The vessel soon exhibited unstable characteristics and the two persons on board were observed to have difficulty maintaining the vessels stability by use of their body weight.

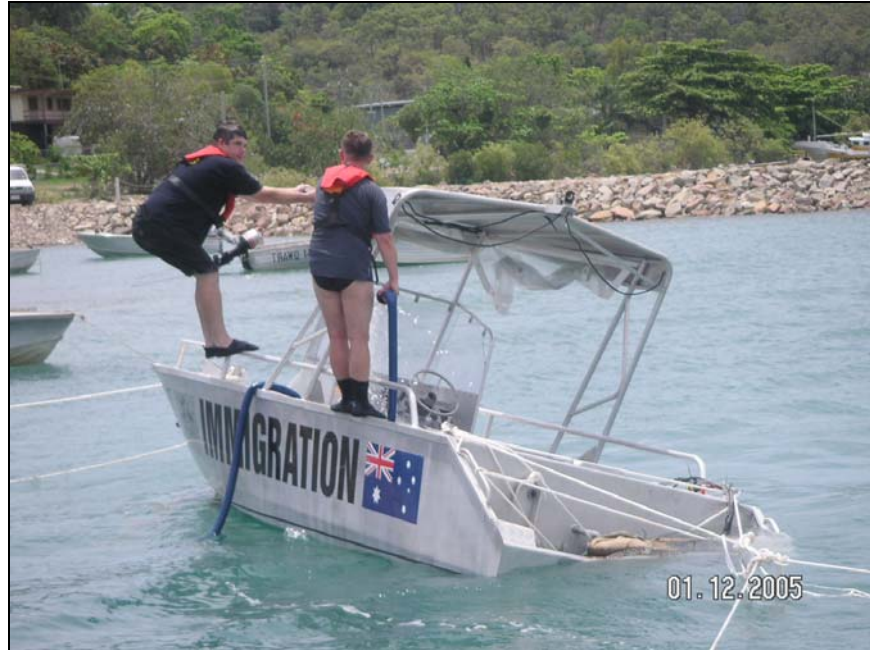
**Figure 21: Vessel listing to starboard**

- 6.22 At 1153, the vessel took a significant list to starboard and submerged the gunwale. The 2 persons moved to the port gunwale to try and keep the vessel from capsizing.

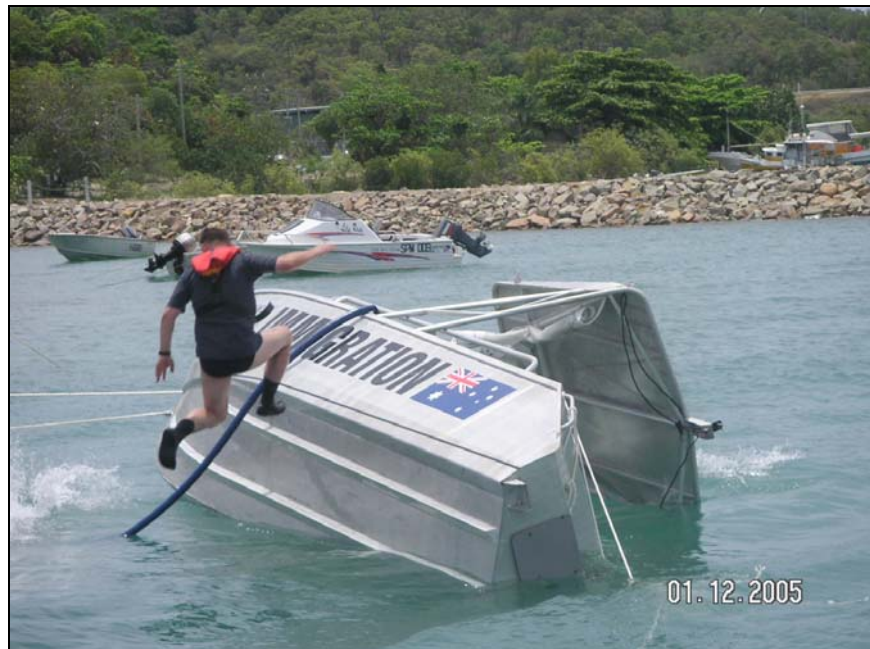
**Figure 22: Vessel capsizing**

- 6.23 At 1156, the vessel capsized to starboard and inverted.

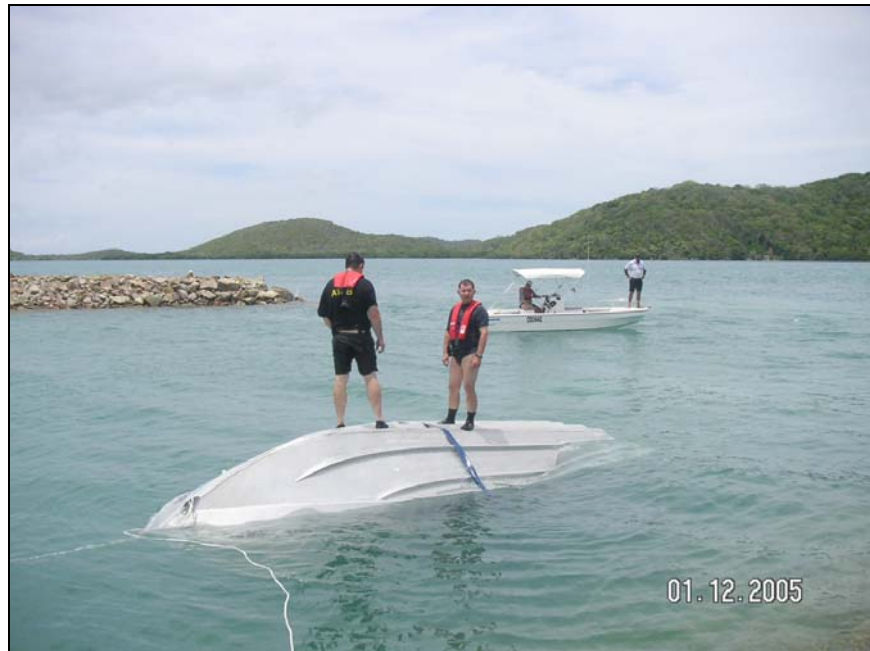
**Figure 23: Vessel floating inverted**

- 6.24 The vessel remained afloat inverted and was obviously supported for a time by entrapped air.

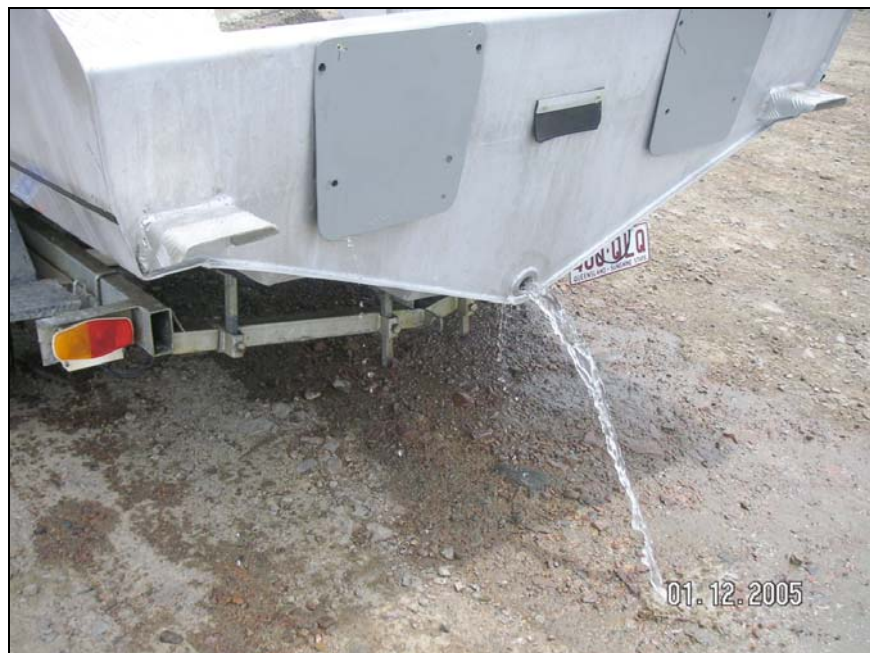
**Figure 24: Water draining from void**

- 6.25 The vessel was then righted and returned to its road trailer.
- 6.26 The transom bung was removed and a significant quantity of water (estimated 200 litres) was drained from the main void thereby proving again the lack of watertight integrity of this void.

- 7.9 One vessel IMMI 002, was proven non-compliant with the reserve buoyancy requirements of AS 1799 s 2.4. The other vessels are all believed to be similarly deficient.

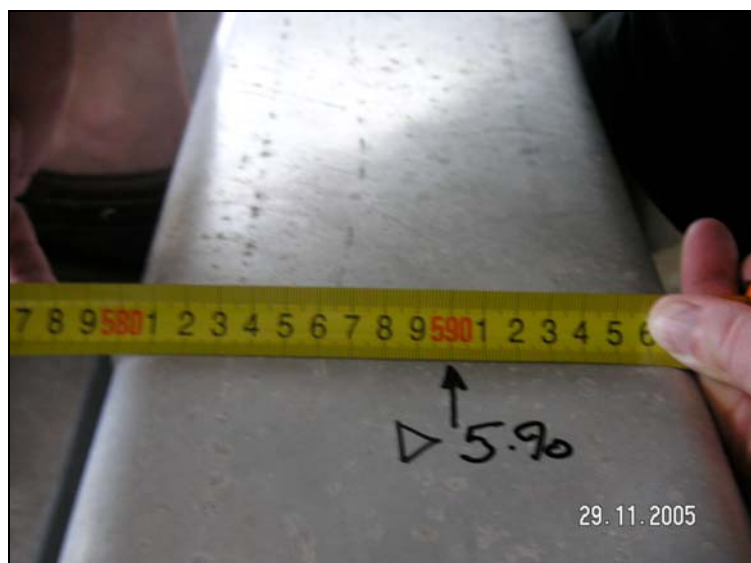
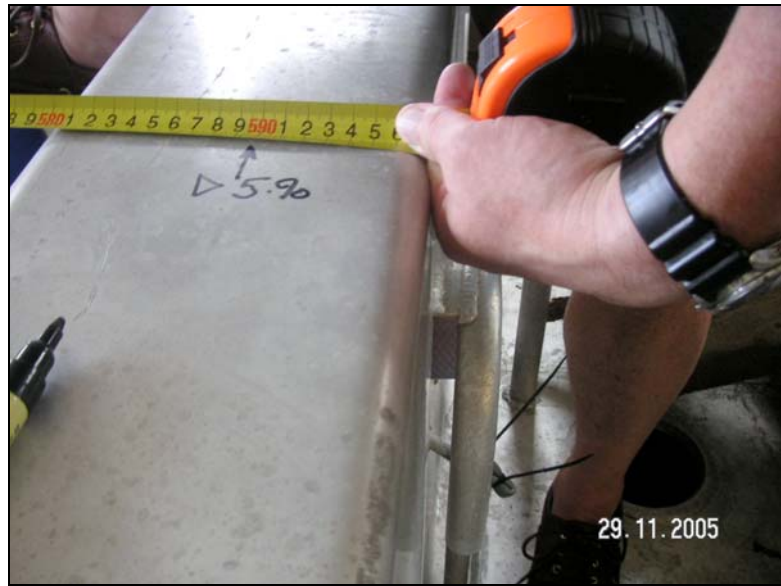
**Figure 26: Aft gunwale of vessel IMMI 002**

We note that the builder states in his documentation that the length of the vessel is 5.90m. We have measured 5.90m from the foremost part of the vessel and confirm that this is significantly short of the actual length:
