Coordination and communication breakdown during aerial firefighting operations

near Tenterfield, New South Wales, on 31 October 2023

ATSB Transport Safety Report

AO-2023-054

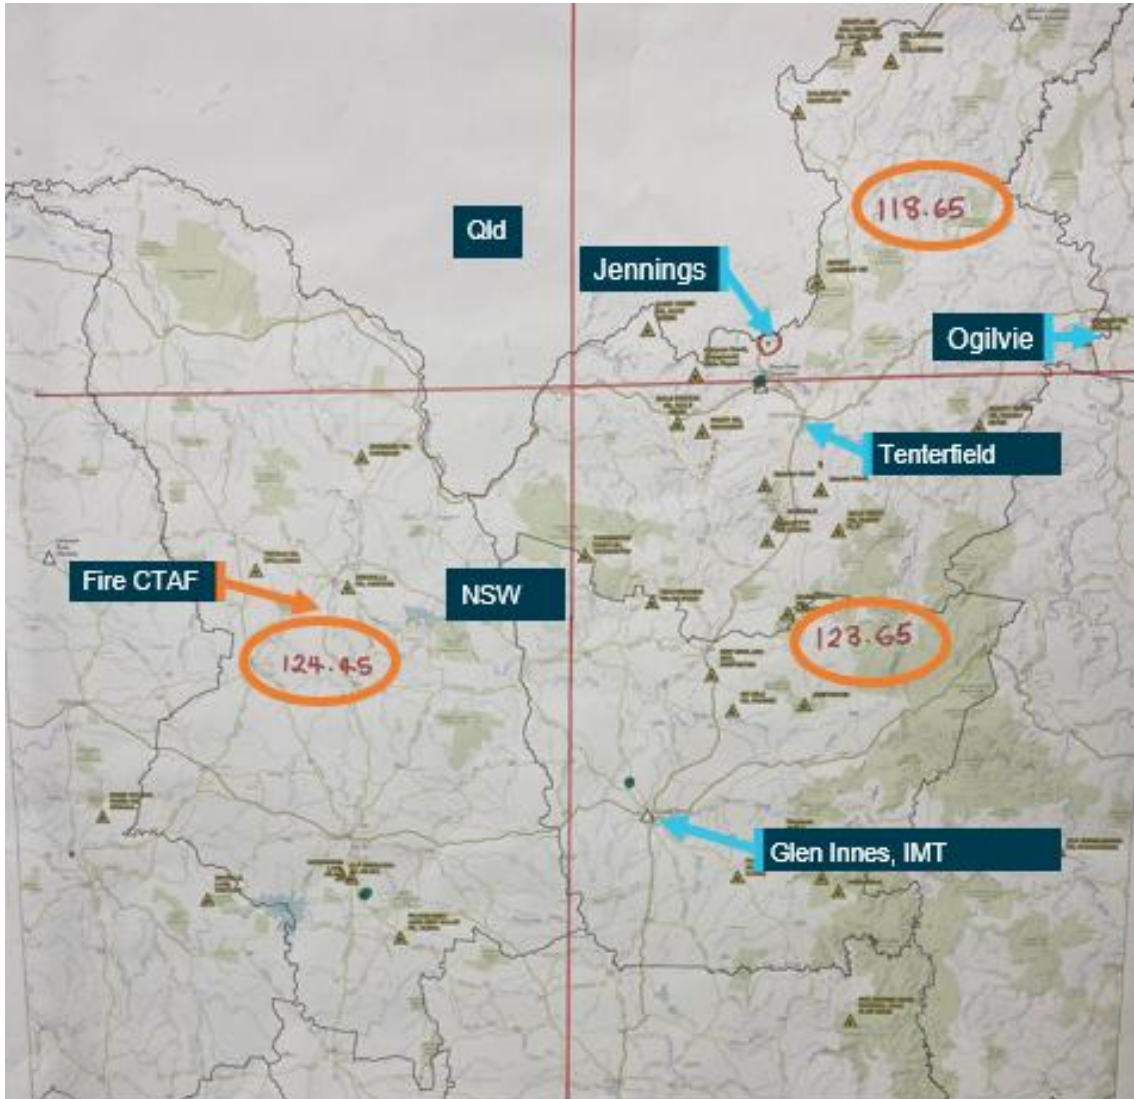
Figure 1: Map of NSW Fire-CTAFs in the Tenterfield area on 31 October 2023

As part of the daily morning briefing at the IMT, aerial crews deployed to the Tenterfield area were advised that there were 3 fire common traffic advisory frequencies (Fire-CTAFs)³ (see the section titled *Fire common traffic advisory frequencies*) and were provided the corresponding boundaries in use that day (Figure 1). These frequencies were allocated to help with communication in anticipation of the high number of aircraft expected to be operating in the area. The Fire-CTAFs in operation were the:

- northern area containing Jennings (118.65)
- southern area containing Tenterfield (123.65)
- western area (124.45).

Although the 3 Fire-CTAFs had been issued by the NSW RFS state air desk (SAD) (see the section titled *State air desk*) in Sydney the previous evening, the personnel manning the SAD on the morning of 31 October 2023 were only aware of the southern Tenterfield Fire-CTAF (123.65).

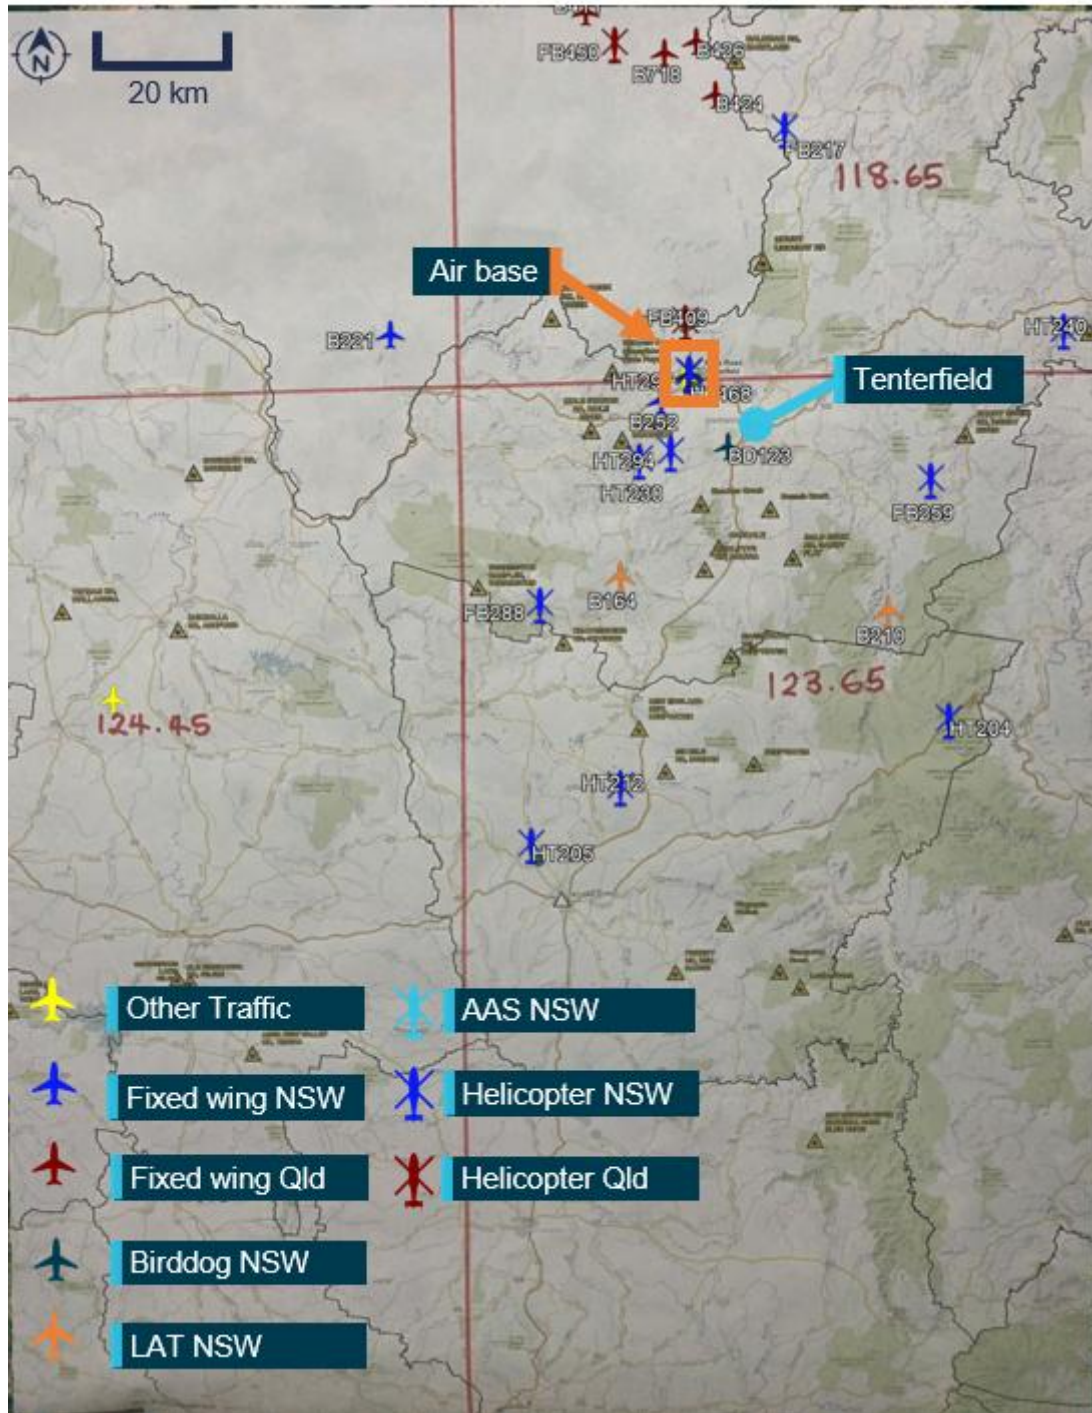
Figure 3: Aerial traffic in the Tenterfield area at 1500

Image shows aircraft active in the specified area between 1455 and 1505. A 10-minute duration was used noting some only transmit positional information at a rate of 2 minutes, and with low level work some transmissions may not be captured. 5 aircraft were identified as being on an airfield (FB254 (AAS), Cessna 182 (private), HT297, HT468 and FB717).

the LATs headed north towards Jennings, they remained on 123.65 instead of 118.65, which was being utilised by other aircraft in the Jennings area on the NSW side of the border (Figure 3).
