Collision with terrain involving Robinson R44 II, VH-TCF

about 46 km north-east of Tenterfield Airport, New South Wales, on 13 March 2026

ATSB Transport Safety Report
Aviation Occurrence Investigation
AO-2026-067
Preliminary – 30 April 2026

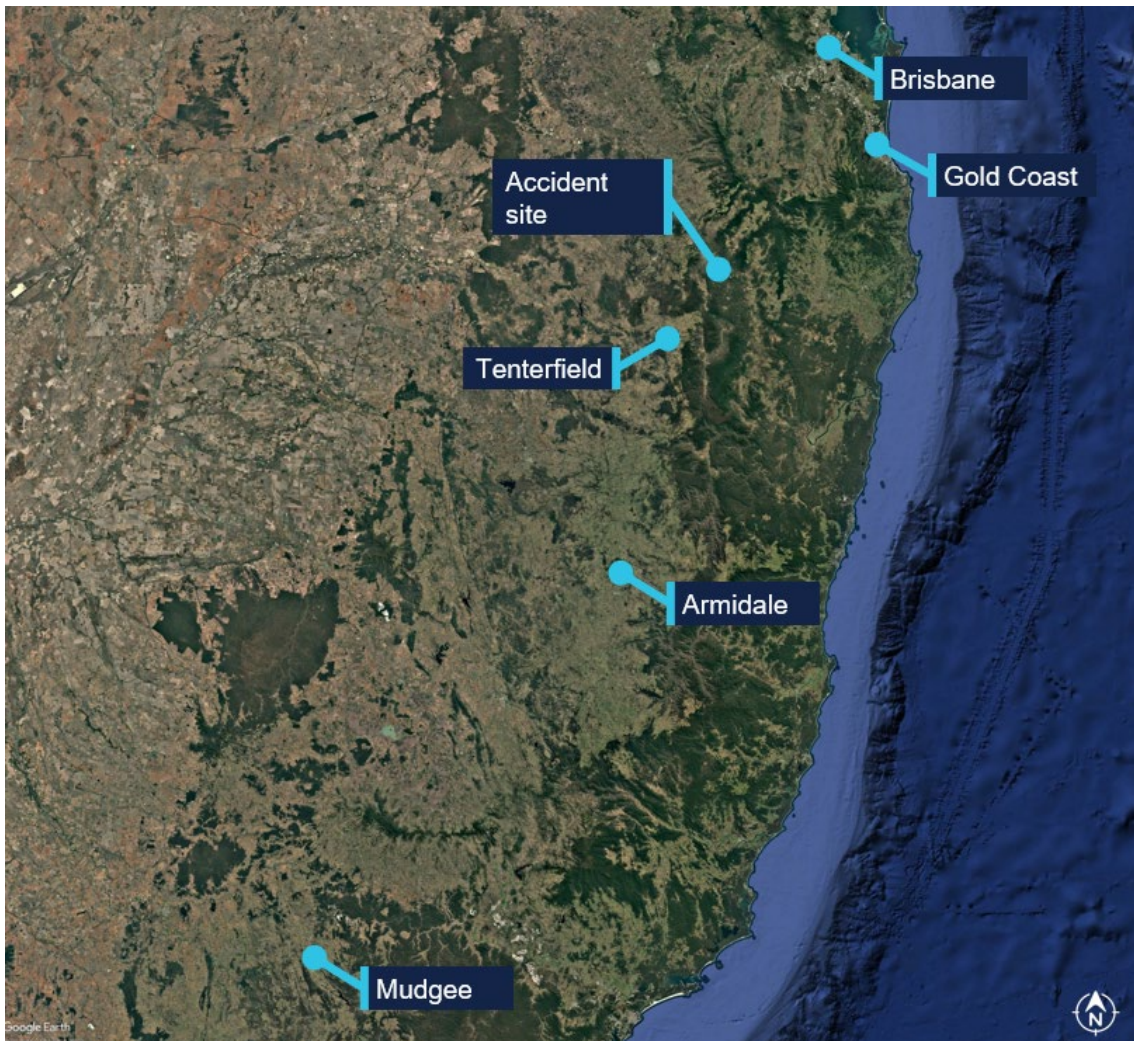
Figure 1: Map showing accident site and key locations

On 13 March 2026, the pilot of a Robinson R44 II helicopter, registered VH-TCF, planned to conduct a private flight from Gold Coast, Queensland, to Mudgee, New South Wales (NSW), with an intermediate stop at Armidale, NSW, to refuel (Figure 1).

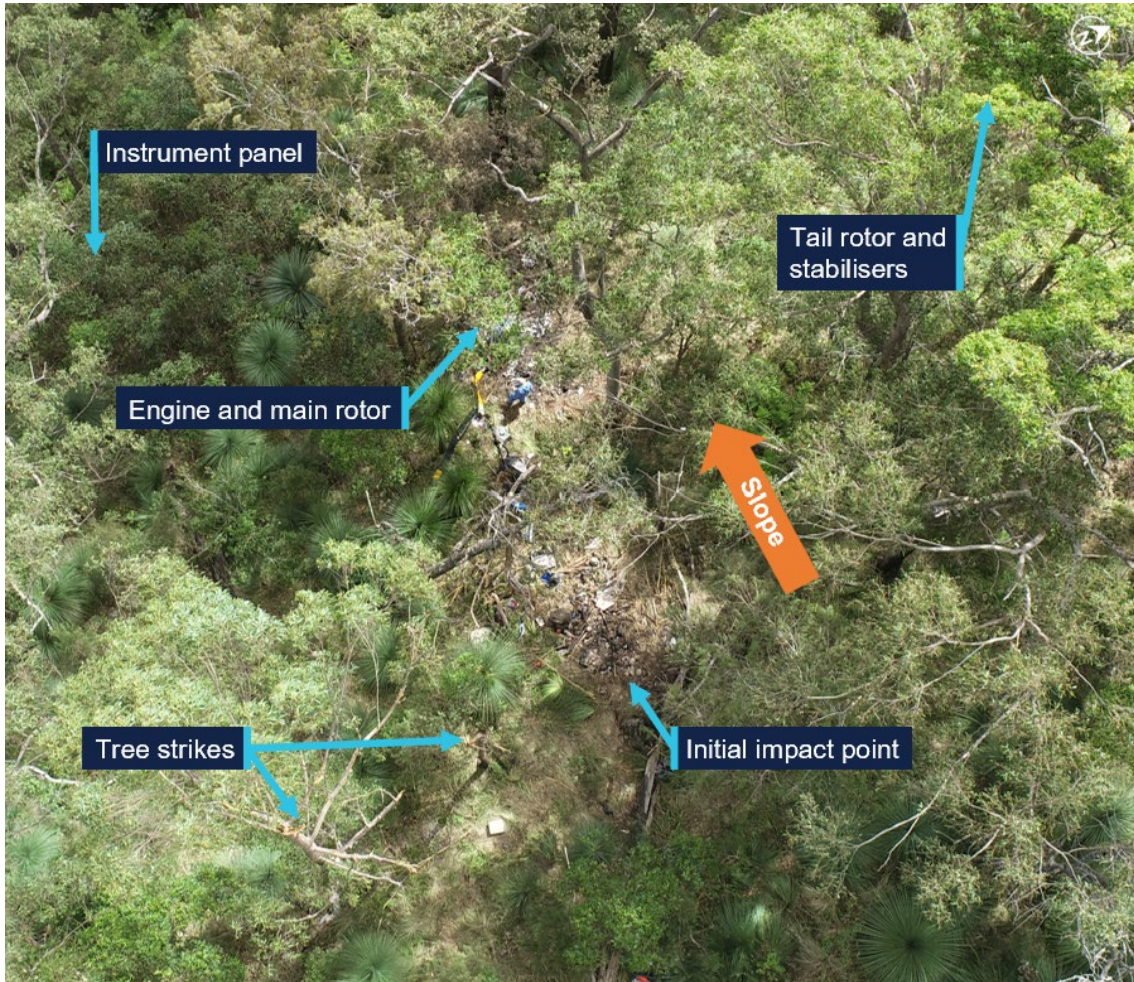
Figure 2: Accident site

The wreckage trail was approximately 12 m long in a westerly direction, across and down the slope as shown in Figure 2. It consisted of an initial impact point, followed by a trail of debris that led to the fuselage, engine and main rotors, much of which were consumed by a post-impact fire. The aft section of the tail cone assembly had separated from the fuselage and was located approximately 20 m from the fuselage across the slope.

Significant damage was evident on 2 trees located near the initial impact point, indicating the helicopter had collided with trees in a near vertical descent. A bag found in the tree canopy, and various other parts from the helicopter, were located around 20 m up the slope from the initial impact site.

The instrument panel and other debris were found further down the slope away from the fuselage location. A fuel jerry can, which had been filled at the helicopter's departure location, was found onsite. The contents were tested for presence of water, which returned a negative result.

The accident site was located about 46 km north-east of Tenterfield Airport in a densely vegetated area to the west of Cataract National Park. It was situated on the southern side of a steep slope, at an elevation of about 870 m (2,850 ft).

The ATSB also obtained weather data from 2 Weather Underground⁹ stations close to the accident site (inset Figure 2):

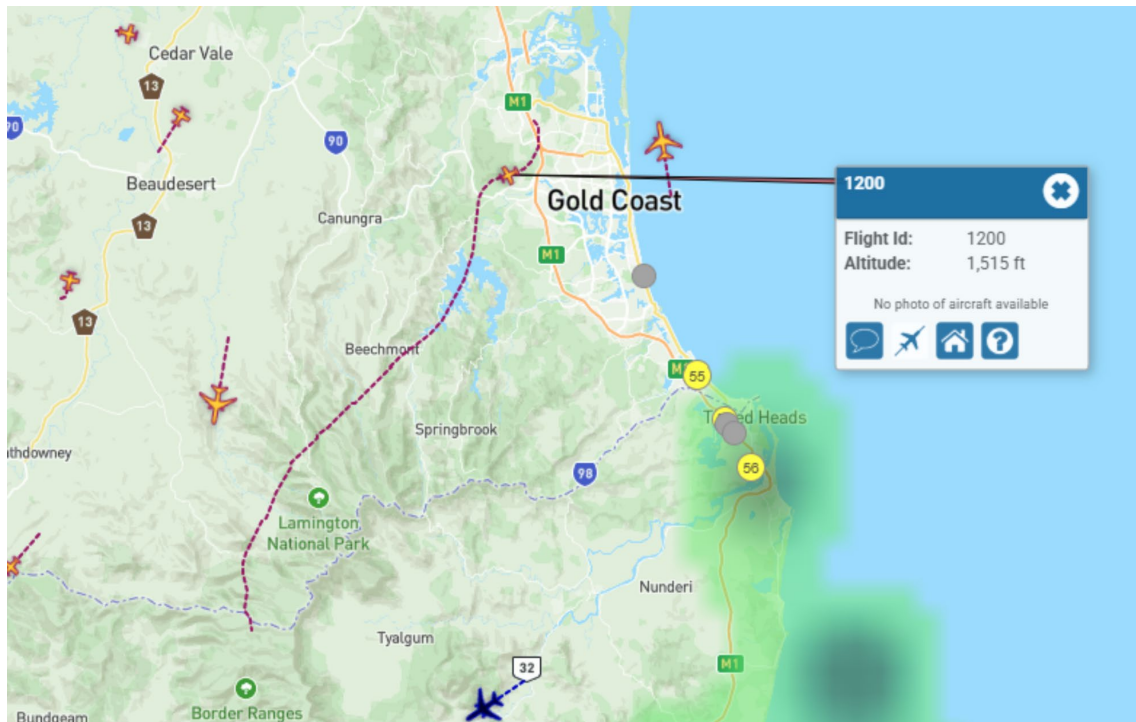
Figure 3: Aircraft track from departure to the NSW border

VH-TCF was identified on WebTrak³ around Gold Coast Airport. It showed that the helicopter tracked roughly south-west before crossing the NSW border at 0854. This service then stopped recording the helicopter's position (Figure 3).

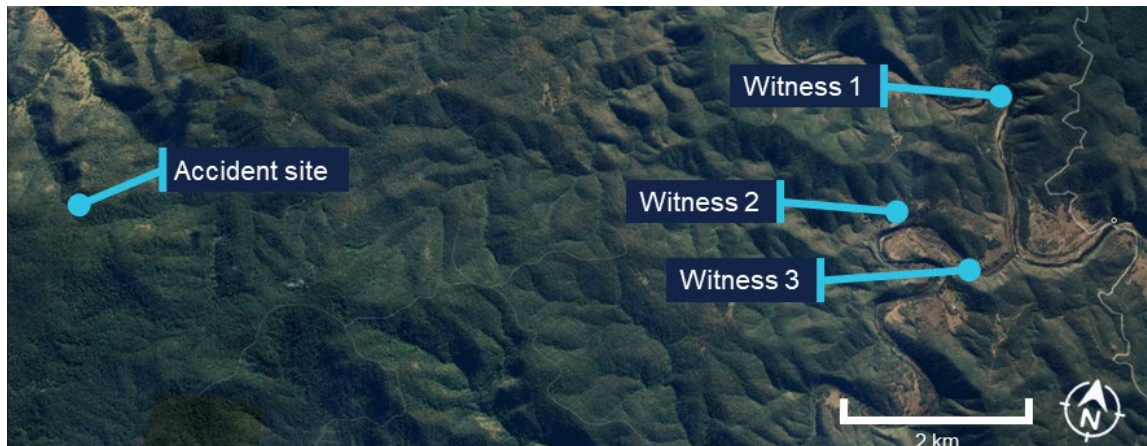
Figure 6: Witness locations

Several witnesses located near the accident site (Figure 6) stated that they observed a helicopter flying very low, 'before lunchtime' on the day of the accident. All witnesses reported that it was unusual to see a helicopter in the area, but this one was particularly unusual due to its low altitude.

All witnesses reported very low cloud and drizzle on the morning of the accident. One witness stated that the helicopter seemed to be stuck below cloud and remarked to their partner that it 'looks like it's trying to find a way out'. Another witness recalled waving at the helicopter and stated that it passed them twice before heading west.
