# Near collision involving Cessna 172S, VH-KOJ, and Cirrus SR22, VH-XC5

About 21 km south-south-east of Melbourne Airport, Victoria, on 22 January 2026

Aviation Occurrence Investigation (Short)

AO-2026-007

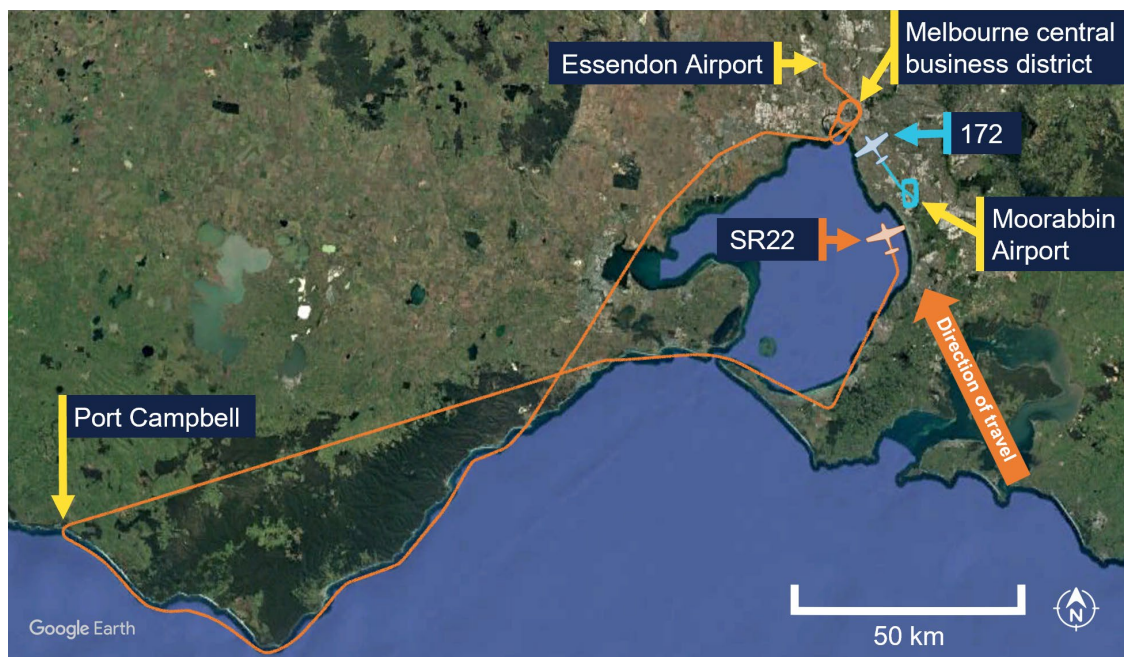
**Figure 1: Aircraft historical tracks and positions at 2142:19**

At 2142:19 local time,<sup>2</sup> the student on board the 172, who was the pilot flying, contacted Essendon Tower air traffic control (ATC) and requested approval to conduct one right-hand orbit of the Melbourne central business district (CBD) (see *Airspace information*). This request was approved by ATC who issued a clearance for one right-hand orbit at 2,100 ft.

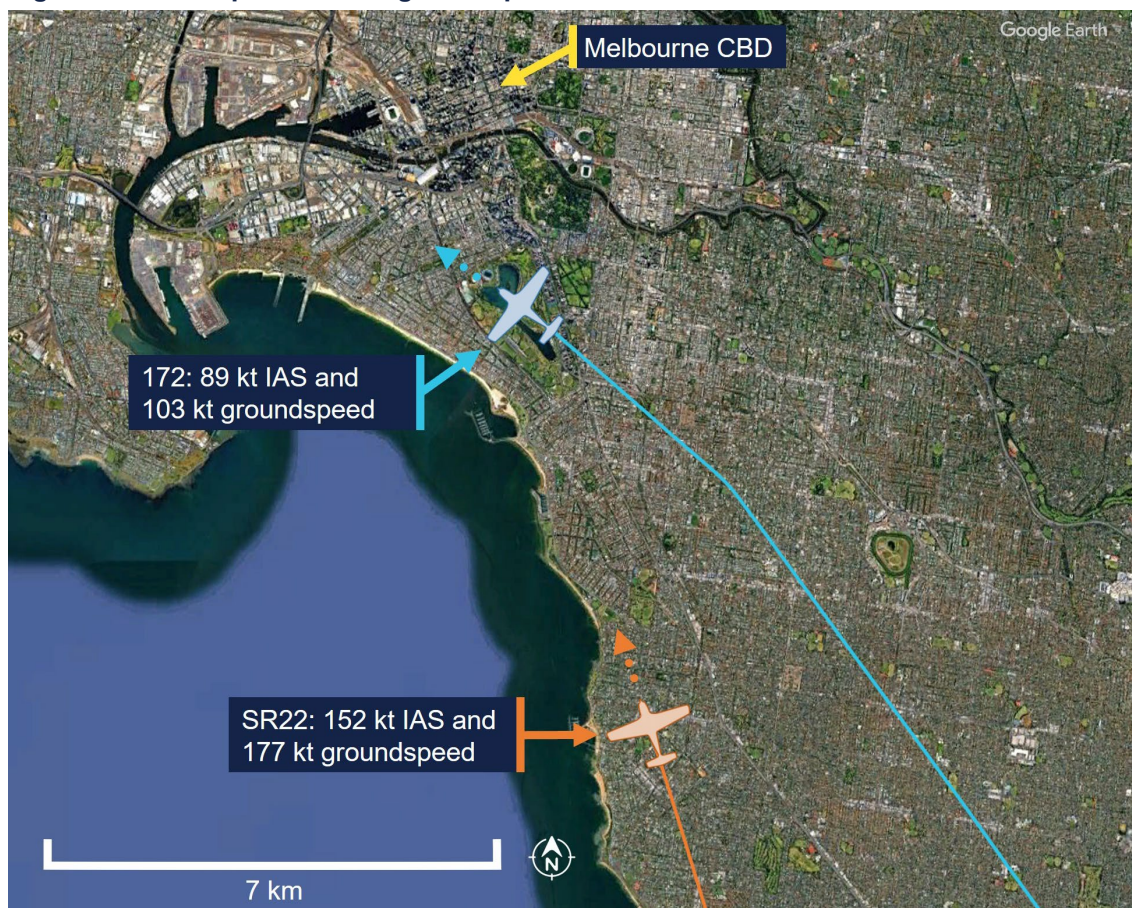
**Figure 2: Aircraft position and groundspeed at 2145:02**

At 2145:02, the pilot of the SR22 advised ATC they had sighted the 172 on their traffic advisory system (TAS) (see *Garmin traffic advisory system*) and that they would follow the 172 and slow down. The SR22 pilot also had visual contact with the 172 and recalled that they could see the aircraft quite easily. Aviation routine weather report data for Essendon Airport from the Bureau of Meteorology issued at 2130 local time indicated the visibility was greater than 10 km with no cloud detected. At this time, the SR22 had an indicated airspeed (IAS)<sup>4</sup> of 152 kt and a groundspeed<sup>5</sup> of 177 kt, whereas the 172 had an IAS of 89 kt and a groundspeed of 103 kt. The distance between the 2 aircraft was 7 km (Figure 2). At that time, the SR22 and 172 were subjected to a tailwind component of 17 kt and 14 kt respectively. A short time later, the IAS of the SR22 began to decrease, although it remained faster than the 172 throughout the orbit.

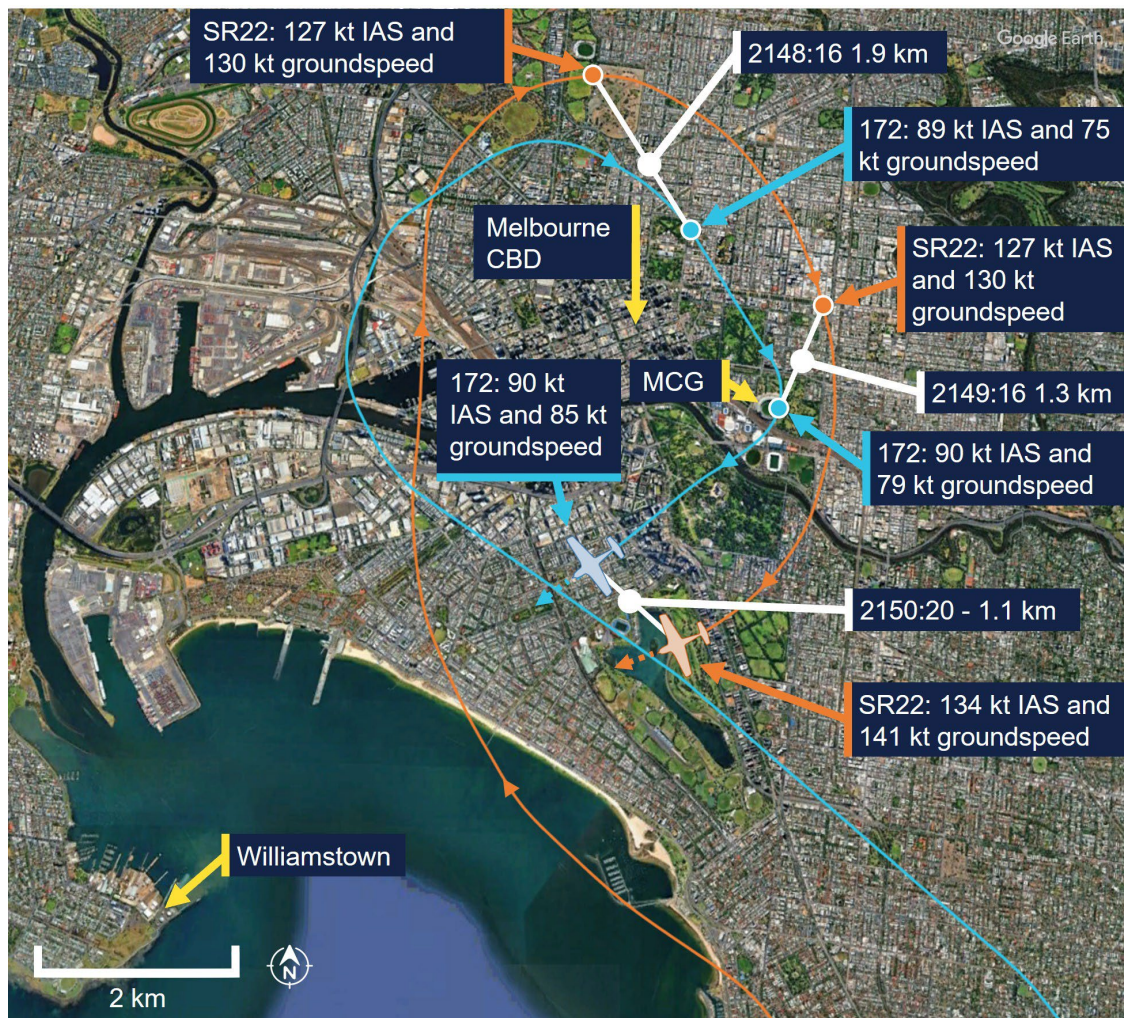
**Figure 3: Flight paths and lateral separation around the Melbourne CBD**

At 2148:16, ATC cleared the SR22 to proceed to Essendon Airport on completion of their orbits. At that time, the groundspeed of the SR22 was 55 kt faster than the 172 and the distance between the 2 aircraft had reduced to 1.9 km (Figure 3). The pilot of the SR22 recalled the 172 appeared to slow down to the east of the CBD. At that time, the 172 was experiencing a headwind component of 14 kt, while the SR22 was still experiencing a tailwind. In response, the SR22 pilot widened their orbit in an attempt to maintain separation.

At 2149:16, the 172 overflew the MCG and turned onto a westerly heading towards Williamstown. At this time the distance between the 2 aircraft had reduced to 1.3 km. After the 172 overflew the MCG, the instructor and student observed a traffic advisory (TA) on their TAS. This alerted the pilots to traffic positioned behind the 172 on the left

The pilot of the SR22 received an ATC clearance to orbit the CBD and follow the 172, which they understood. They advised ATC they would slow down to remain behind the 172, which they had on the TAS and visually acquired. However, although the indicated airspeed (IAS) of the SR22 reduced from 152 kt to 121 kt (momentarily) after obtaining the clearance to conduct the orbits, it remained significantly faster than the 172. During that time, the IAS of the 172 remained between 85–97 kt. While the SR22 had a higher normal operating airspeed than the 172, it was able to match the speed of the 172 during the orbit with flaps retracted. As the orbit progressed, both aircraft encountered a headwind and the SR22 pilot became aware that the 172 appeared to slow down relative to their own aircraft. In response, they elected to widen their orbit, however the separation between the 2 aircraft further reduced due to the higher groundspeed of the SR22.

The pilot of the SR22 then recalled hearing ATC issue a clearance to the 172 to track from overhead the Melbourne Cricket Ground (MCG) to Williamstown, which facilitated a southerly exit from the orbit. As the 172 overflew the MCG and turned towards Williamstown, the student and instructor on board the 172 received a traffic alert on their TAS. At that time the distance between the 2 aircraft had reduced to 1.3 km. The instructor determined that the traffic was the SR22, also conducting Melbourne CBD orbits, and assessed that no conflict existed. Given the traffic information for the SR22 provided by ATC, and the instructor's previous experience with TAS, it was likely reasonable for the instructor to believe the SR22 was following ATC instructions and would remain behind the 172.

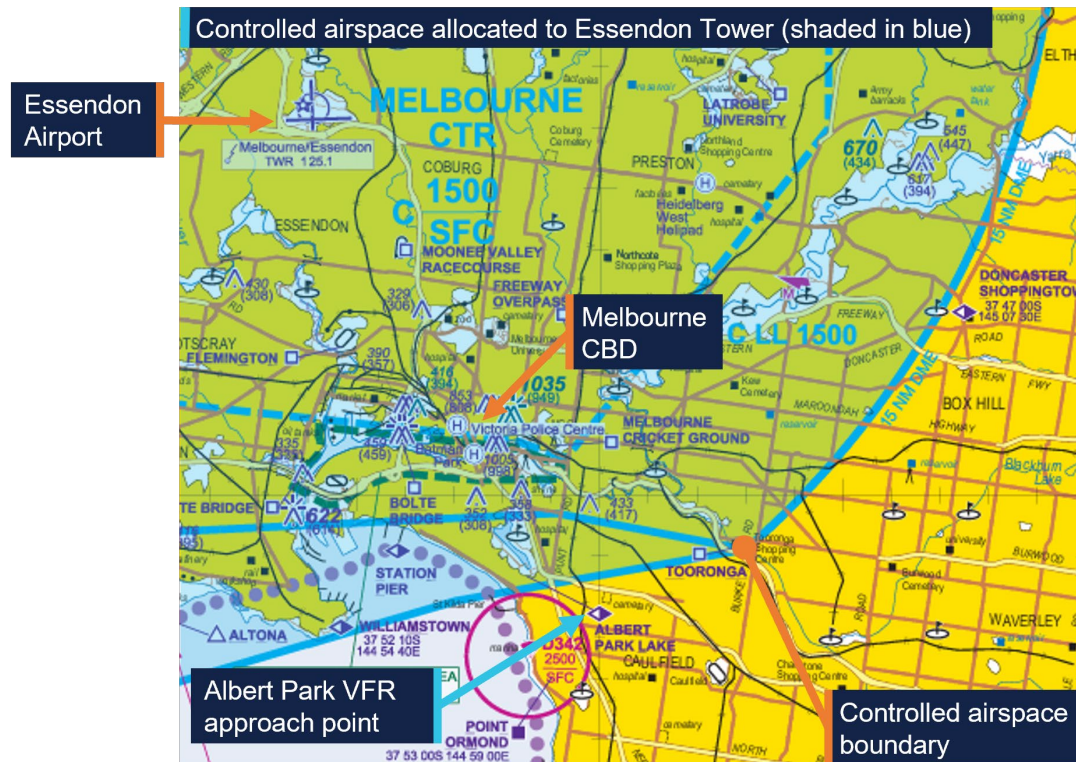
Figure 5: Melbourne visual terminal chart

All aircraft wishing to operate in this airspace were required to contact Essendon Tower (during the hours of operation) at the appropriate VFR approach point depicted on the Airservices Australia visual terminal chart (Figure 5).
