Technical assistance to the NSW Police – Recovery of data from an avionics system VANS RV-12

Lismore Airport, NSW | 24 March 2013

ATSB Transport Safety Report
Aviation External Investigation

AE-2013-069

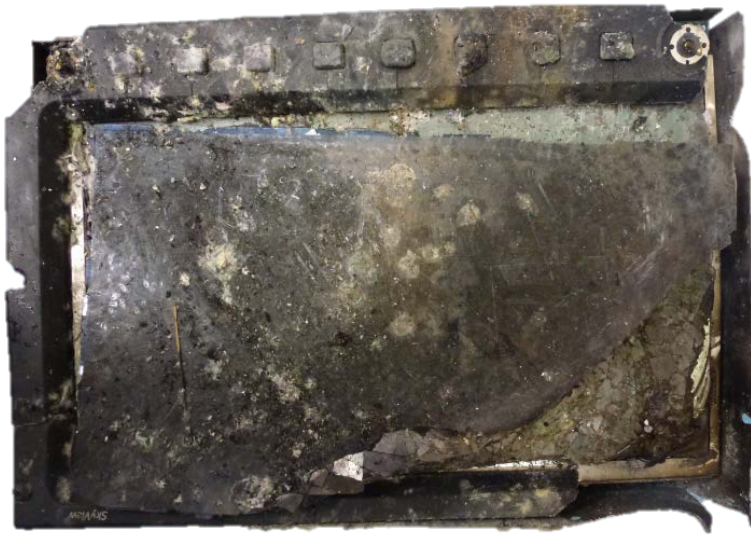
Figure 1: Dynon Avionics display unit – as received

The display unit (Figure 1) had been substantially damaged by fire and exhibited mechanical damage to the exterior case and screen. In preparation for subsequent handling, the device was decontaminated with a methylated spirits solution applied to the exterior of the device, and left to dry.

The NSW police service was responsible for investigating the accident on behalf of the state Coroner. On 10 April 2013, investigating officers contacted the ATSB and requested assistance with the recovery of data from the aircraft's *Dynon Avionics Skyview* system. The display unit (Figure 1) and control module (Figure 2) were subsequently sent to the ATSB for examination.

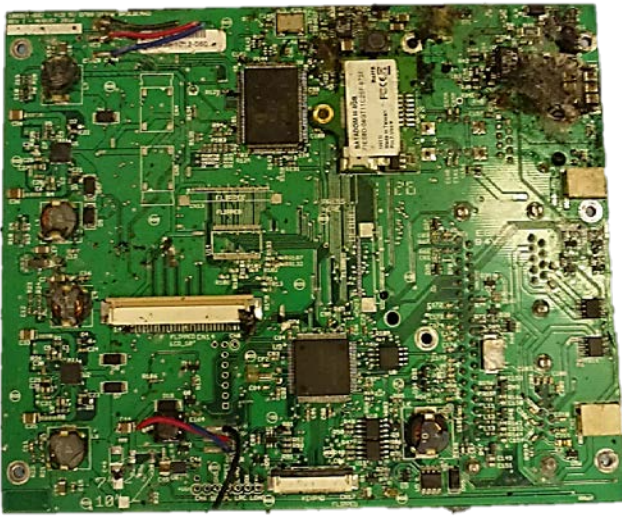
Figure 3: Recovered circuit board

Due to the extent of mechanical damage to the device, it was disassembled and the internal components were inspected. The device contained a circuit board (Figure 3) which had minimal fire damage; however, some mechanical damage to components was evident.

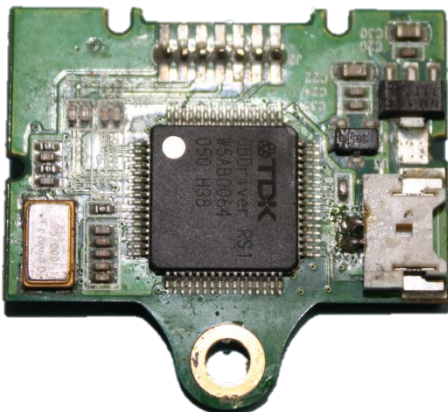
Figure 4: Recovered *InnoDisk* SATADOM

The ATSB contacted the manufacturer of the display unit, Dynon Avionics for information on recovering stored data. The manufacturer advised that flight data was recorded on a 4GB *InnoDisk* Serial ATA Disk on module (SATADOM) which was soldered onto the circuit board (Figure 4). The SATADOM was subsequently de-soldered and removed from the circuit board in preparation for download.

Download of the SATADOM was conducted via a conventional SATA computer interface, utilising a Tableau forensic download device to inhibit any writing to the non-volatile memory. Power requirements for the module were provided per the device manufacturer's datasheet.

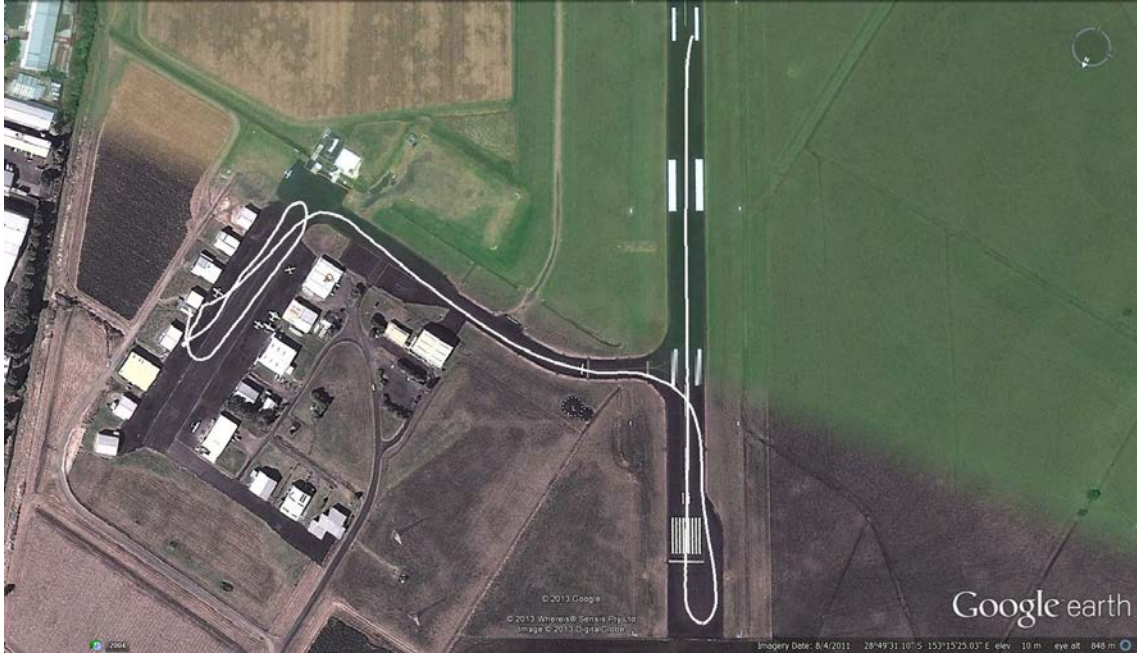
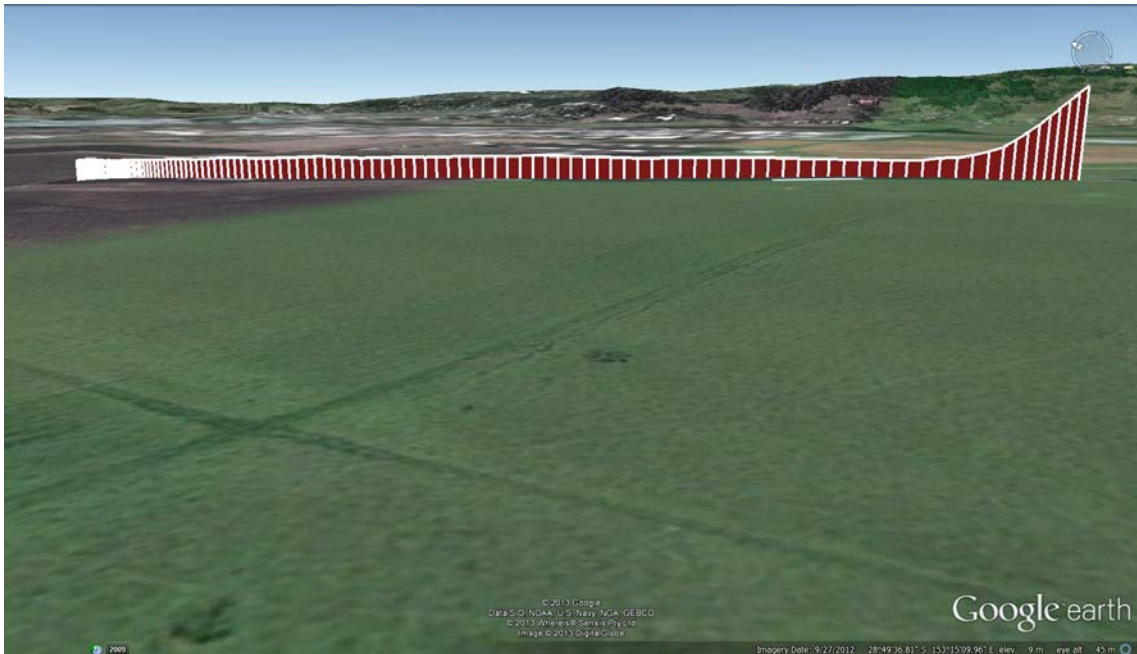
Figure 5: Recovered GPS track

A ground track was produced in *Google Earth* which combined the positional information of the two data sets (Figures 5 and 6). To provide an indication of the aircraft dynamics during the accident flight, plots of pitch, roll, heading, indicated airspeed and altitude were generated from the accident data set (Figures 7 – 11). Stall sensor and elevator trim position data were also plotted for reference (Figures 12 and 13).

Due to the recording logic of the device, the accident flight was separated between two sets of logging files. The first file set contained recorded data from the hangar area at Lismore Airport, to the point where the aircraft lined up on the runway. The second file set (containing the accident event) began at 0950:21UTC¹ on 23 March 2013 and commenced with the aircraft lined up on the runway and continued until the end of recorded data at 0950:46 UTC.

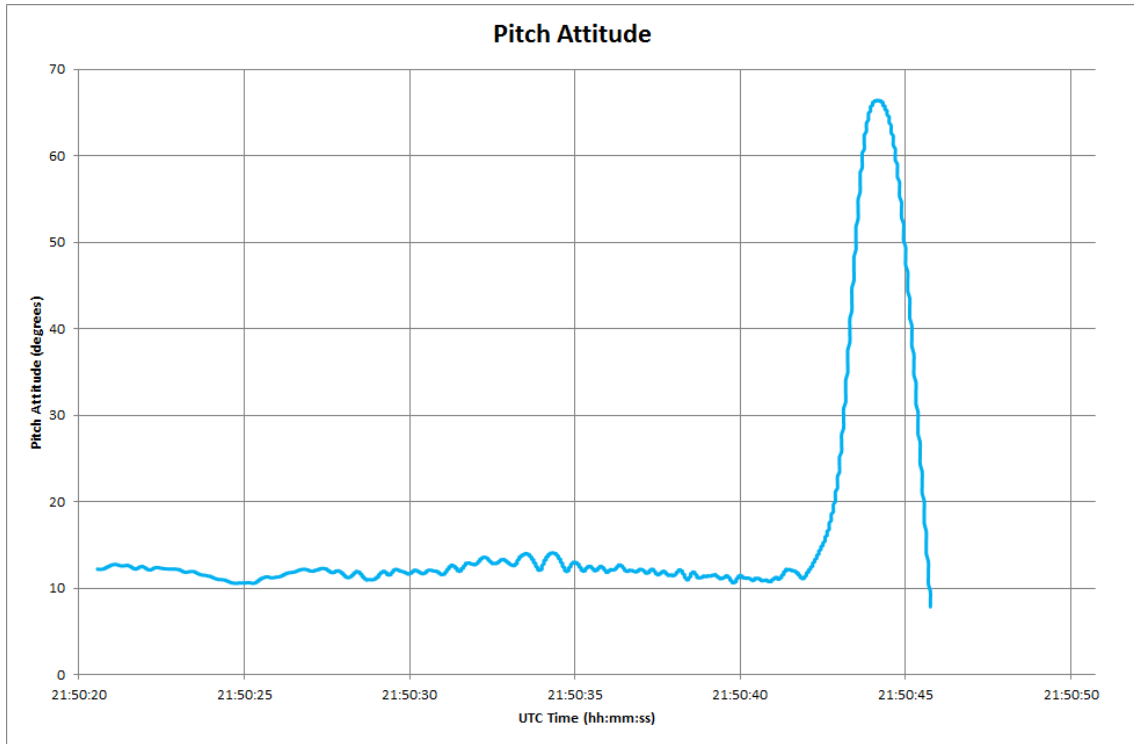
Figure 7: Recorded pitch attitude

- The pitch attitude appeared to be offset by around 12 degrees.
- The roll appeared to have had a small contribution from changes in the aircraft heading.
- The elevator trim position appeared to have been mapped from -1 to 1; this range represents the travel of the motor arm attached to the pitch trim servo. Further information is required to convert this value into elevator trim position
