Derailment of empty passenger train 71SG

Near Teepookana, Tasmania | 9 December 2014

ATSB Transport Safety Report
Rail Occurrence Investigation
RO-2014-023
Final – 8 April 2015

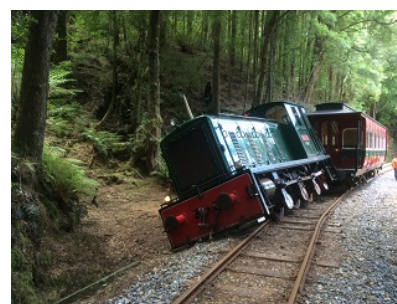
Incident site

At about 1215, a radio message was received from the train crew advising that the locomotive had derailed all wheels. The trailing empty passenger carriage remained on track. The crew sustained minor injuries (bruising and stiffness).

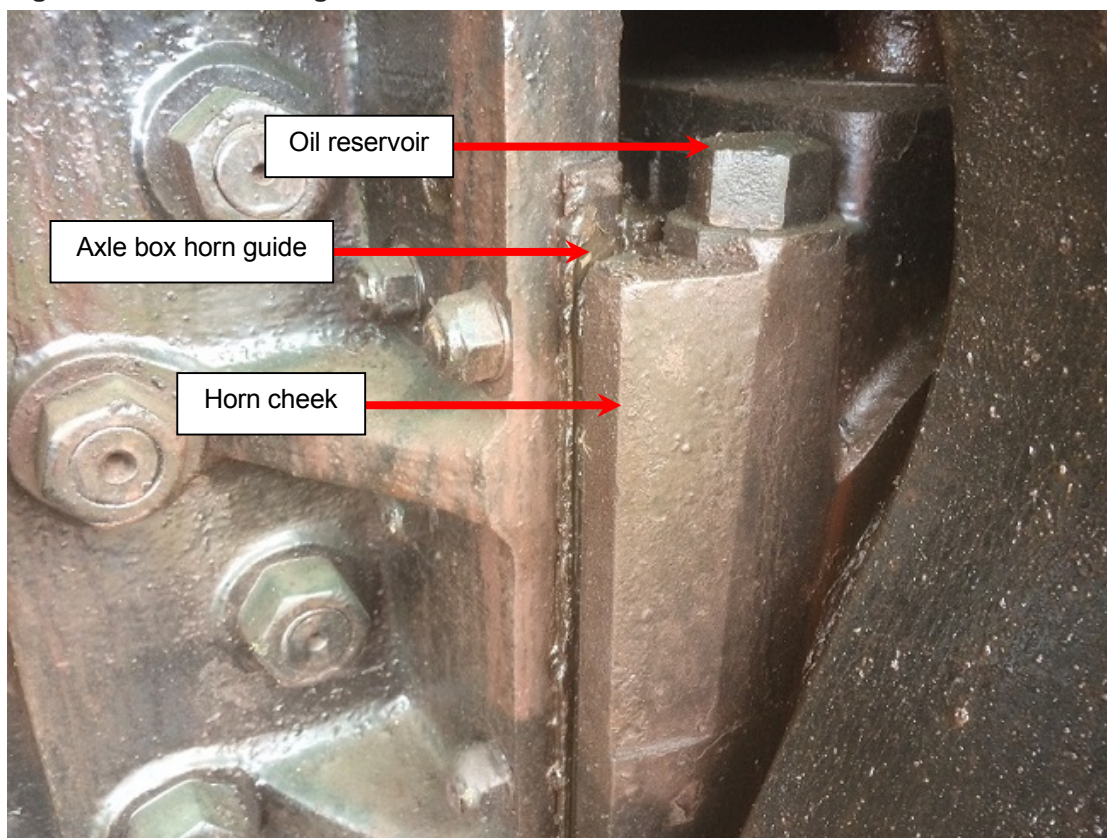
Figure 1: Axle box horn guide

West Coast Wilderness Railway (the operator) investigated the occurrence; the findings of which indicated the track condition and geometry was not a contributing factor. Mechanical examination of the locomotive found that the front right hand axle box horn guide had jammed due to a lack of lubrication (Figure 1). The jammed horn guide had restricted axle articulation while the locomotive was negotiating a slight left-hand curve, causing the leading wheel on the right side to climb the rail head and derail to the right.

A pre-departure inspection (A-exam) was conducted on the locomotive before operation, but the lack of adequate horn guide lubrication was not noted. The investigation found that the A-exam did not specify a requirement to check the axle box horn guide oil reservoir to ensure lubrication was being applied.

- Review locomotive AB examination recording sheet; making changes where needed and ensuring maintainers are advised of any changes made.
- Review the daily locomotive A-exam to include the need for ensuring the oil reservoir above the axle box horn guide is clear, horn cheeks are showing signs of lubrication and checked for visual signs of binding, and ensure that locomotive crews are advised of the change.
- Investigate the possibility of improving the lubrication delivery method.
- Revisit and amend the risk register for rolling stock inspections.
- Undertake a review of the rolling stock maintenance procedures manual.
