Helicopter winching accident involving Bell Helicopter Co. 412EP, VH-VAS

19 km south-south-east of Mansfield, Victoria | 31 August 2013

ATSB Transport Safety Report
Aviation Occurrence Investigation
AO-2013-136
Final – 7 April 2015

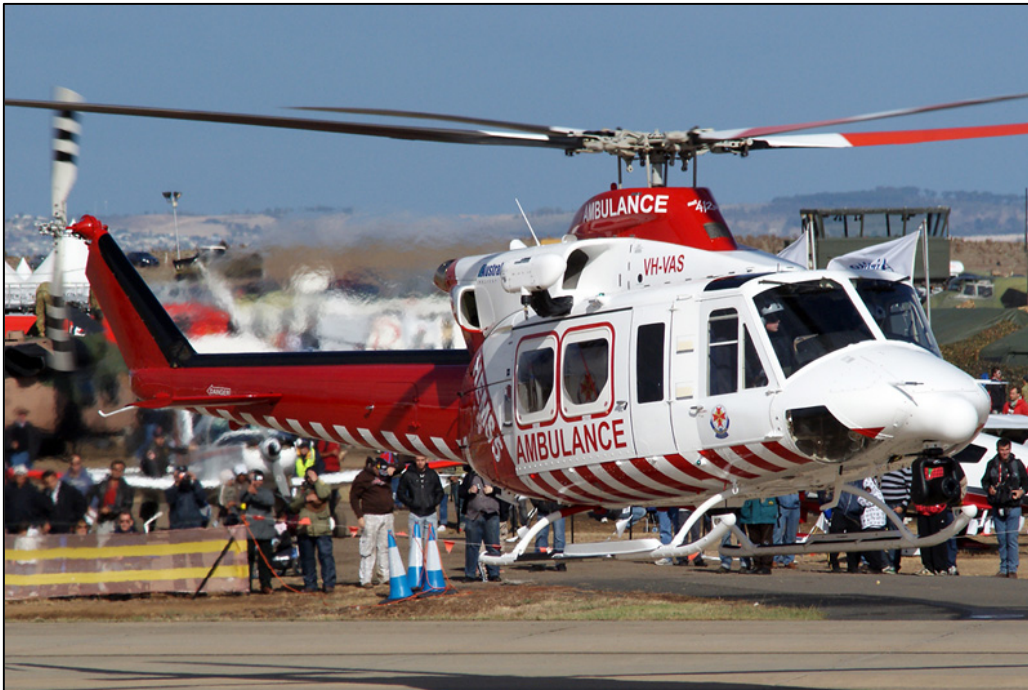
Figure 1: VH-VAS

At about 1050 Eastern Standard Time¹ on 31 August 2013, the crew of a Bell Helicopter Co. 412EP helicopter, registered VH-VAS and operating as 'HEMS 5' (Figure 1), were tasked to recover a patient who was reported to have fallen and broken their ankle in the hills around Macs Cove, near Mansfield, Victoria (Figure 2). The helicopter was contracted by Air Ambulance Victoria to provide helicopter emergency medical service (HEMS) operations. The crew consisted of a pilot, an air crewman (ACM) and an ambulance rescue crewman (ARC). The crew were informed that the patient weighed between 130 and 140 kg and that, due to the difficult terrain and the size of the patient, a winch extraction would likely be required. The helicopter departed from its base at Essendon Airport, Victoria, for the scene at 1105.

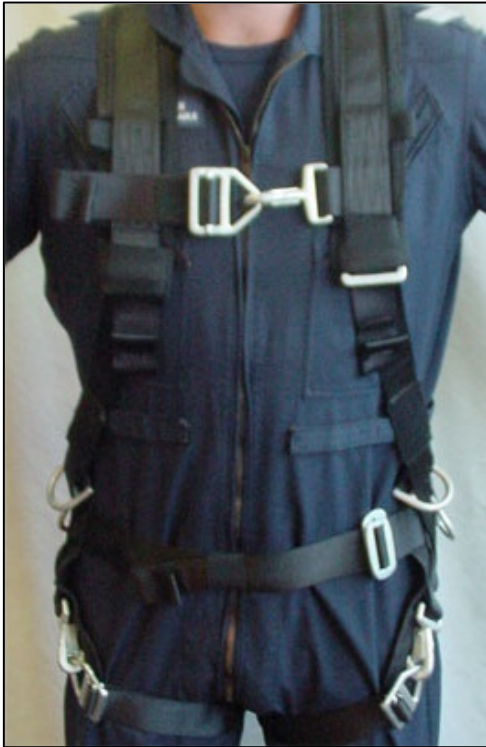
Figure 4: Rescue harness

The rescue harness is a full-body harness worn by the helicopter ACM, the ARC and, in some situations, the person being retrieved (Figure 4). The harness is designed to provide a secure, comfortable lift for the occupant and is available in various sizes. At the time of the accident, spare harnesses were not carried on board the helicopter as standard retrieval equipment for patients. Although the ARC's harness could have been used for a patient during a single-person lift, the ARC's harness would not have fitted the patient on this occasion.

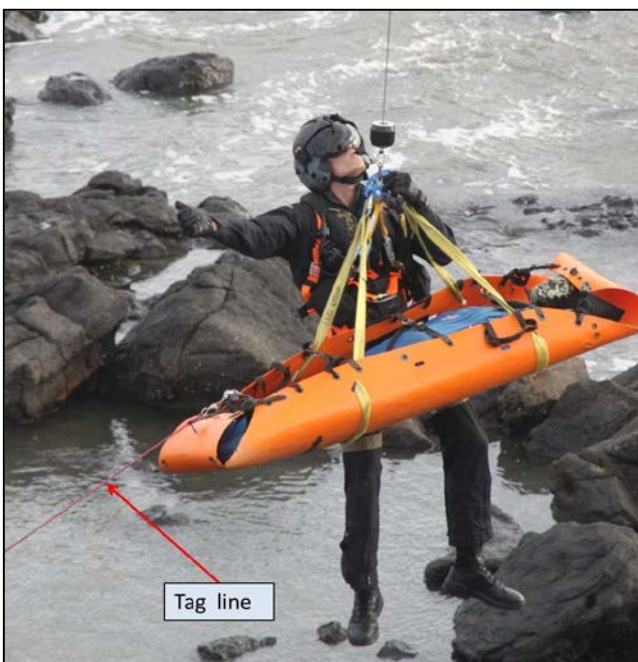
Figure 5: Stretcher double-lift using a tag line

The stretcher allows a patient to be carried securely while flat on their back (Figure 5). In order to counteract the tendency of stretchers to spin under a helicopter’s rotor wash, a trained person on the ground uses a stabilising rope (tag line) attached to the stretcher. Stretcher use in confined areas is limited by the size of the stretcher and the possibility of it, and the tag line, fouling on obstacles such as trees.

When a survivor is injured or unconscious and conditions permit, a stretcher lift should be carried out... To optimise patient care the preferred method of recovering the stretcher is with a double lift using a tag line...

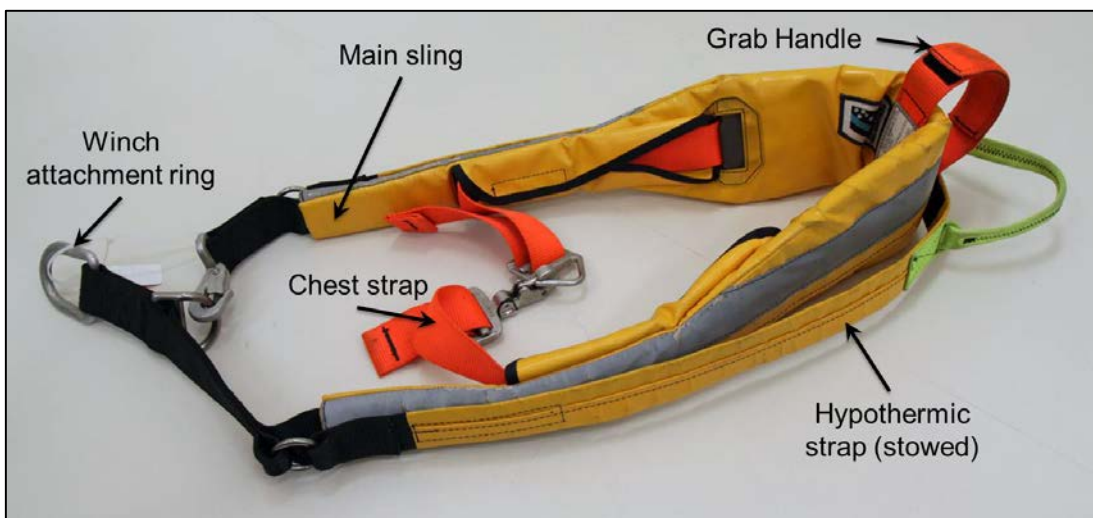
Figure 6: Rescue strop

The operator's operations manual specified that, in a single-lift application, the rescue strop was typically only to be used to rescue trained or pre-briefed personnel who were physically able to keep themselves in the strop (see the section titled *Guidance for rescue equipment selection*). Single-lift of untrained personnel using the strop was to be avoided unless there was no practical alternative. The preferred method for lifting untrained people with a rescue strop is the double-lift method, which involves an ARC accompanying the patient on the winch wire up to the helicopter.

All of the strop's components appeared to be in good condition with no evidence of component failure. There was no significant fraying of any of the webbing or stitching and no significant wear on the attachment hardware or the main sling cover.

During the trial it was found that pulling the rescue strop grab handle (Figure 6), as would be done by the ACM to assist a person into the helicopter, altered the position of the strop around the subject's shoulder blades. This increased the risk of slipping out of the strop.

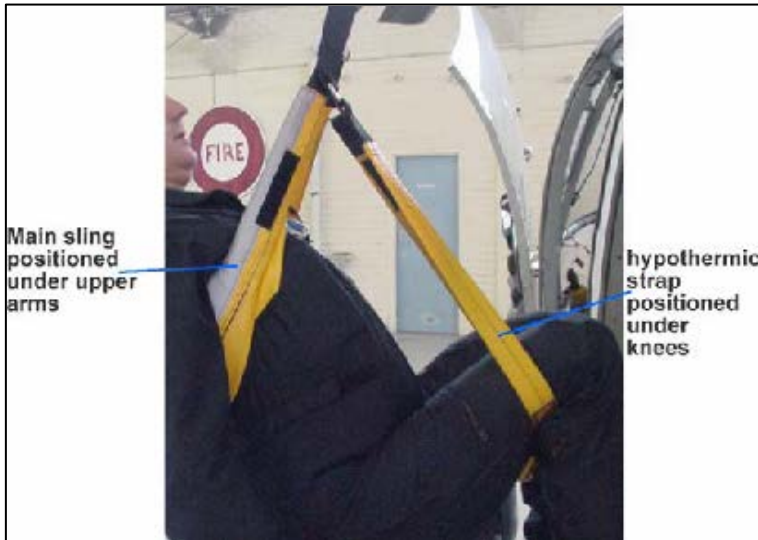
Figure 7: Rescue strop with hypothermic strap deployed

The rescue strop with hypothermic strap is fitted by slipping the hypothermic strap under the person's knees and passing the strop around the person's chest. If required, the strop can be unlatched at the D-ring directly under the winch attachment ring to assist with passing the strop around the person's chest (Figure 6).
