Derailment of freight train 7AD1 at Edith River near Katherine, Northern Territory

27 December 2011

Abstract

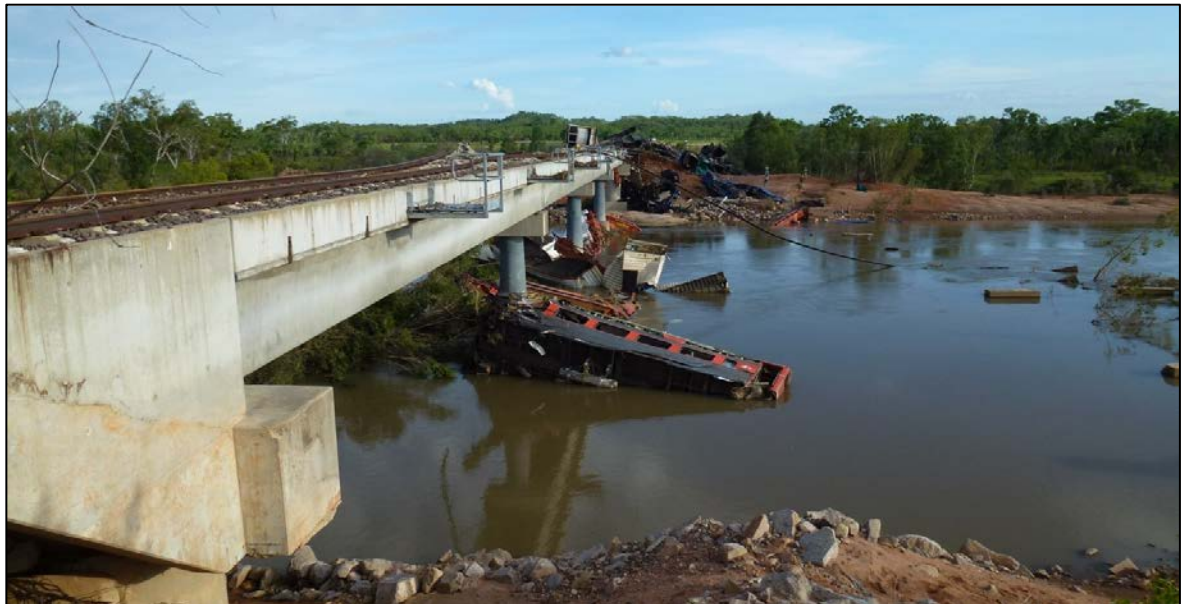
Figure 1: Derailment site, looking south towards Katherine, crew van in foreground.

As a result of the derailment, the co-driver suffered minor injuries. The train driver was unhurt. There was significant damage to the bridge and rolling-stock and a number of wagons, including the crew van which was unoccupied at the time, derailed into the river (Figure 1, 29 December 2011).

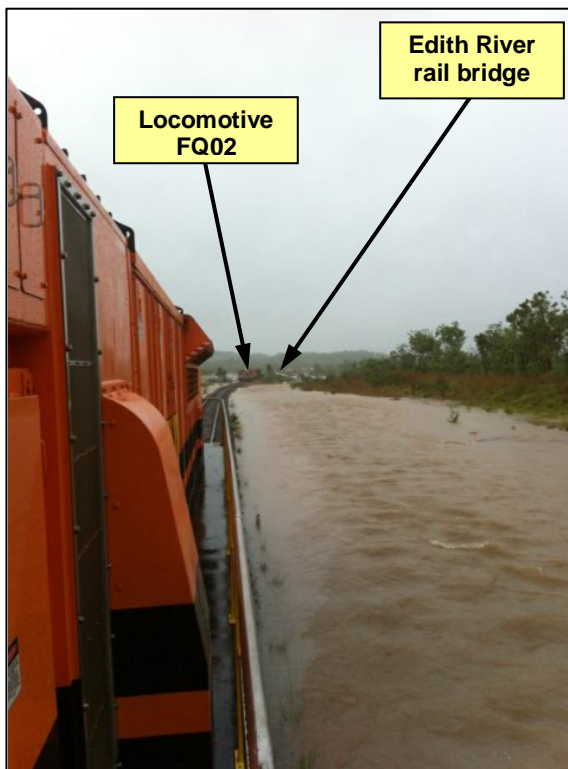
Figure 5: View from lead locomotive GWA001, looking south towards Edith River, about one hour after the derailment.

The train continued towards the bridge, shuddering as it collided with the water and then lurching heavily as it advanced onto the bridge structure. Both drivers were thrown violently about in their seats and feared for their safety. The lead locomotive GWA001 continued across the bridge coming to a stand about 800 m beyond the first point of impact with the water on the southern side of the bridge. The lead locomotive was upright but surrounded by floodwaters, about 1 m

deep on either side of the track (Figure 5). The crew knew that the train had derailed.
