# Runway excursion involving Piper PA-28, VH-SFK

Bankstown Airport, New South Wales, 4 September 2012

**ATSB Transport Safety Report**  
Aviation Occurrence Investigation  
AO-2012-113  
Final

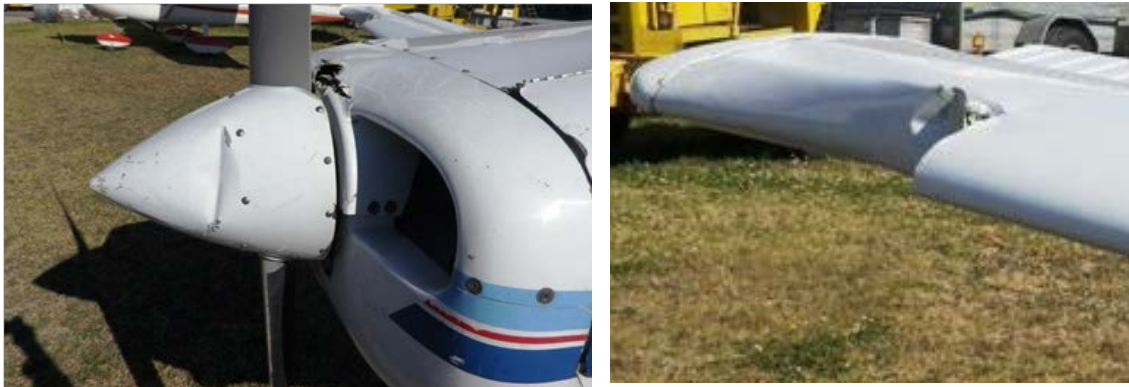
**Figure 1: Aircraft damage**

After landing, when the pilot applied full power for take-off, SFK veered suddenly to the left onto the grass. The pilot reduced the throttle setting to the idle position and applied the brakes, however the aircraft collided with the airport perimeter fence. The pilot shut down the aircraft and exited. The aircraft sustained substantial damage (Figure 1) and the pilot sustained minor injuries.

The aircraft operator visually inspected the aircraft and noted there was no evidence of an aircraft unserviceability. The operator also inspected the runway, which appeared to show that the left brake had been applied during the landing.
