Collision with terrain involving a Robinson R22, VH-YPS

28 km E of Fitzroy Crossing Aerodrome, Western Australia, 22 March 2014

ATSB Transport Safety Report
Aviation Occurrence Investigation
AO-2014-055
Final – 26 May 2014

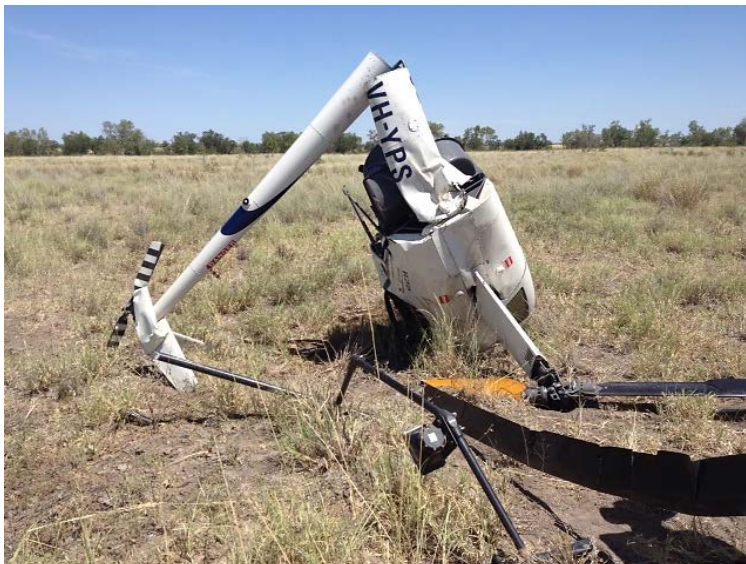
Figure 1: Damage to VH-YPS

The pilot reported that the impact dislodged the top of the front dash board and struck his helmet. He was uninjured and the helicopter sustained substantial damage (Figure 1).

The pilot reported that following this incident, the property manager has advised pilots that jerry cans are not to be carried in the helicopters during mustering operations.

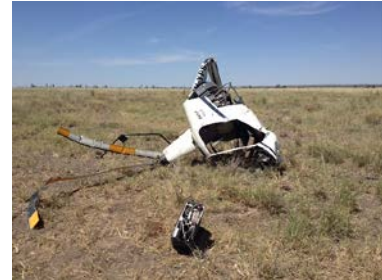
Damage to VH-YPS
