Ground strike and loss of control involving R22, VH-HAY

near Fitzroy Crossing Aerodrome, Western Australia, 18 May 2014

ATSB Transport Safety Report
Aviation Occurrence Investigation
AO-2014-091
Final— 15 October 2014

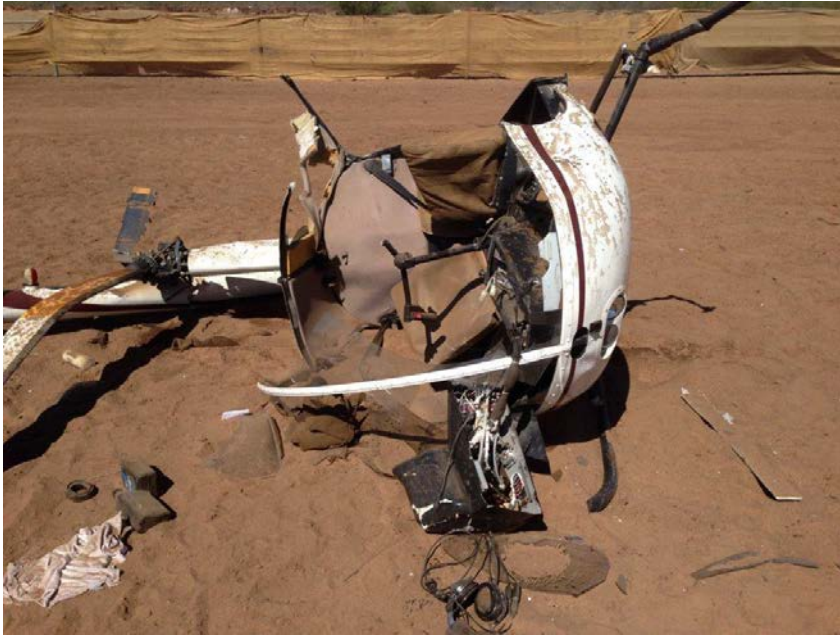
Figure 1: VH-HAY damage

To arrest the yaw, the pilot immediately closed the throttle, resulting in a rapid rate of descent. In an attempt to lessen the rate of descent, the pilot raised the collective. The helicopter struck the ground heavily, and then rolled onto the right side. The pilot sustained serious injuries and the helicopter was substantially damaged (Figure 1).
