Near collision involving Cessna 404, VH-VEC and Piper PA-28, VH-UNW

near Mangalore Aerodrome, Victoria, 10 January 2014.

ATSB Transport Safety Report

AO-2014-006

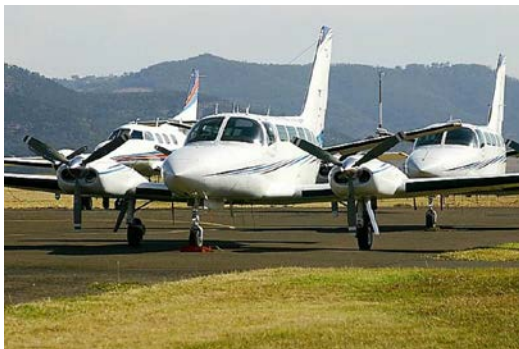
Figure 1: VH-VEC (in foreground)

On 10 January, 2014 the pilot of a Cessna 404 aircraft registered VH-VEC (Figure 1), (VEC) planned to conduct a number of aerial survey flights throughout Victoria. On the evening of 9 January, the pilot received a copy of the survey tasks for the following day from his company. These tasks included a relatively short survey flight of about thirty minutes in the Mangalore Aerodrome area. The pilot received specific latitude and longitude coordinates, and a defined radius of 10 NM for the flight.

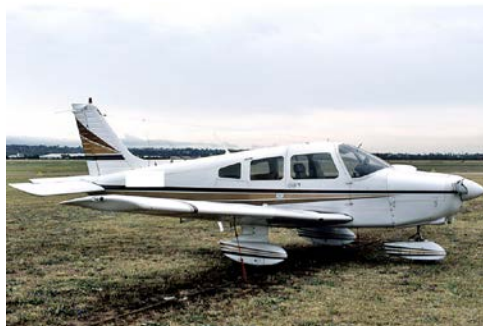
Figure 2: A PA28 aircraft (Piper Warrior)

The first of the flying school aircraft to depart was a PA28 aircraft, (Figure 2), registered VH-IPO (IPO). The pilot of VEC and the pilot of IPO had a brief exchange on the radio. The pilot of VEC then advised his aircraft's position, level and intentions which put him 8 NM north at 2,000 ft, turning back toward the field. He did not receive a reply to this transmission.
