# Fuel starvation event involving a Cessna 210, VH-BKD

3 km east of Broome Airport, Western Australia, 3 May 2015.

**ATSB Transport Safety Report**  
Aviation Occurrence Investigation  
AO-2015-042  
Final – 7 October 2015

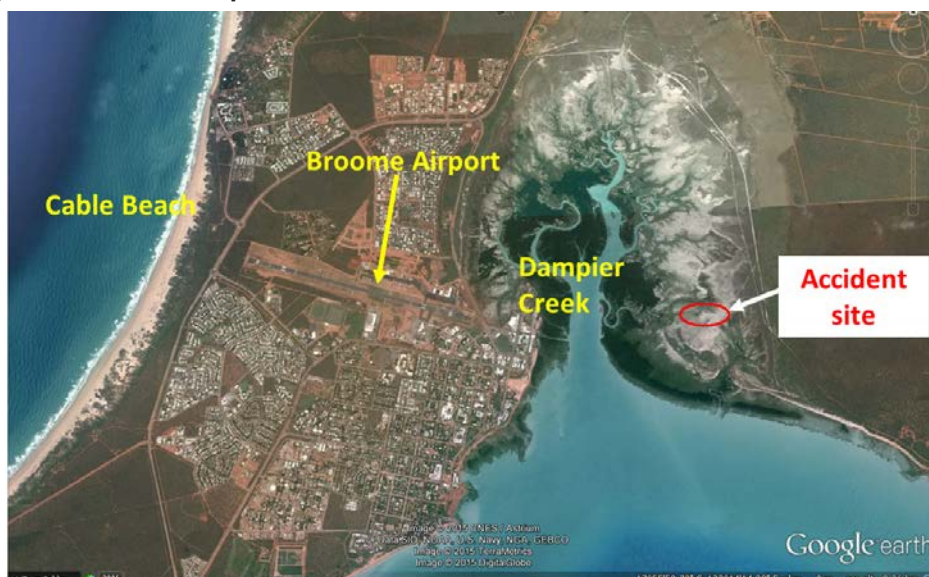
**Figure 1: Broome Airport and accident site**

At about 15 NM from Broome, the pilot observed the start of a thick layer of fog below the aircraft. Arriving overhead Broome Airport at about 0622 Western Standard Time (WST), with the right fuel tank selected, the pilot initially surveyed the area from about 1,000 ft above ground level. However, as there were no breaks in the fog, the pilot descended the aircraft to about 650 ft. The pilot kept the aircraft in visual conditions while circling the airport and Cable Beach areas (Figure 1) occasionally flying at a lower level to take a closer look for possible breaks. With the right fuel tank still selected, the pilot's search continued for about forty-five minutes.

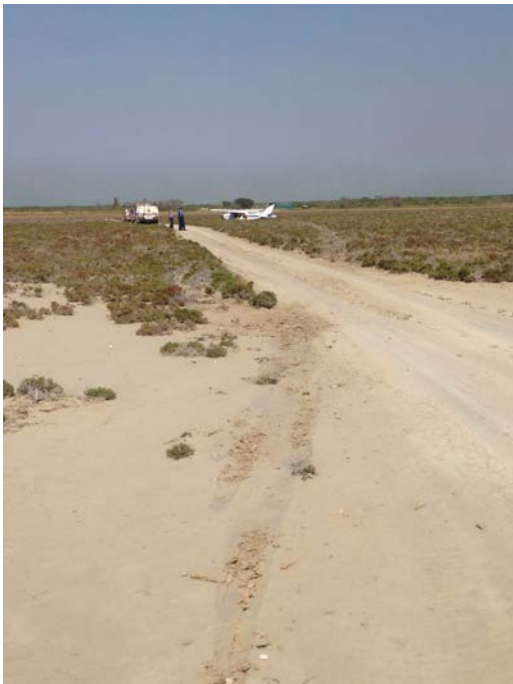
**Figure 2: Initial contact point**

With the aircraft only at about 500 ft and descending into the thick layer of fog, the pilot levelled the aircraft's wings and prepared for a forced landing. Electing to leave the undercarriage retracted, the pilot descended through the fog and noted the outline of a dirt track. The pilot attempted to land on the track, but the aircraft collided with the sandy terrain just prior to reaching it. The aircraft momentum allowed it to skid across the track, coming to rest in the mangroves a few metres on the other side (Figure 2 and 3). The accident site was located within the mangrove area of the Dampier Creek.

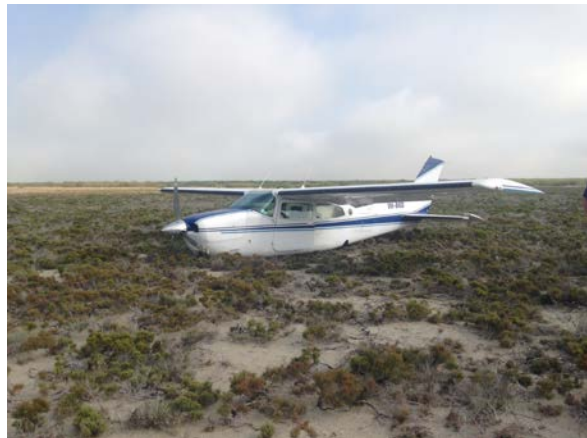
**Figure 3: VH-BKD in the mangroves**

The pilot was not injured; however, the aircraft propeller and engine sustained substantial damage.
