Wheels-up landing involving a Cessna 210, VH-SKQ

Broome Airport, Western Australia, 9 July 2014

ATSB Transport Safety Report
Aviation Occurrence Investigation
AO-2014-123
Final – 3 December 2014

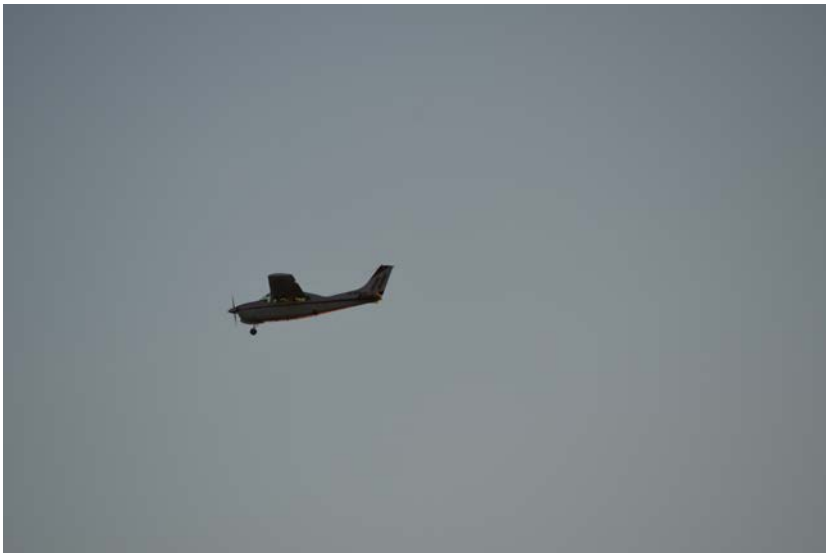
Figure 1: Aircraft on base leg

A witness observed the aircraft on the base leg, with the nose landing gear extended and the main landing gear retracted (Figure 1).

An engineering inspection found that a faulty nose gear up lock switch resulted in the nose gear extending during flight. This resulted in the main landing gear failing to extend.
