Collision with terrain involving a Robinson R22, VH-APP

54 km NNW of Kalbarri, Western Australia, 11 February 2015

ATSB Transport Safety Report
Aviation Occurrence Investigation
AO-2015-017
Final – 27 August 2015

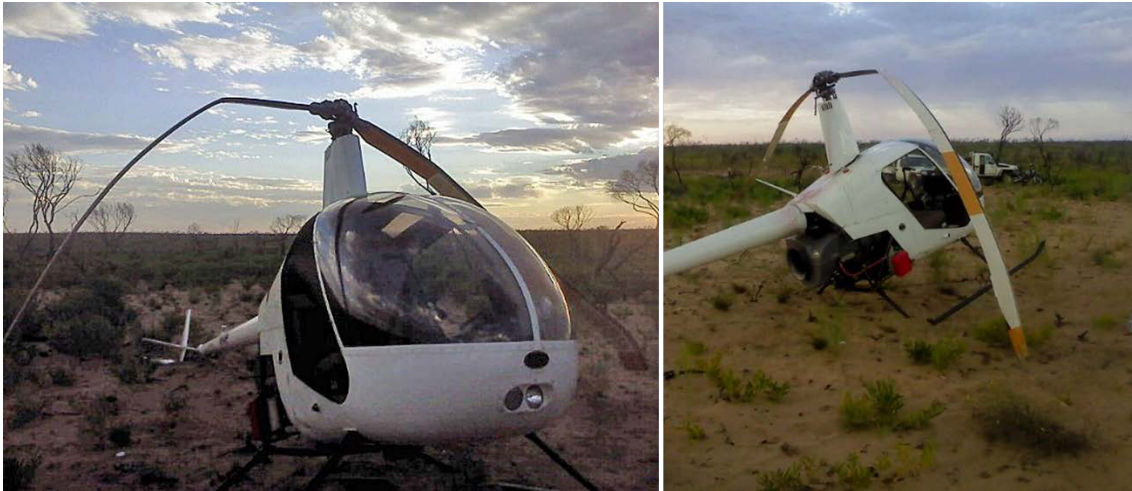
Figure 1: Helicopter damage

The pilot was unable to recall the exact length of time, but sometime in excess of about 2 minutes later, just as the pilot and passenger had concluded their conversation, the pilot heard the helicopter engine RPM increase and almost simultaneously, noticed that the helicopter was lifting clear of the ground. The helicopter climbed to a height of about 3 to 4 m above the ground and yawed through about 80 degrees to the left. The helicopter travelled backwards for a distance of about 8 m, remaining laterally level, and sank back to the ground with a significantly nose-high attitude. The tail of the helicopter struck the ground first, followed by the rear end of the skids. The tail rotor blades separated from the helicopter as the tail struck the ground and the rear part of the left skid broke away during the impact. The helicopter settled upright but during the accident sequence, the main rotor blades struck the ground and stopped abruptly. When the pilot was satisfied that it was safe to approach the helicopter, he moved forward and shut the engine down. Although the helicopter remained upright, it was substantially damaged (Figure 1). The pilot and passenger were both uninjured.

The pilot believed that despite the application of control frictions, the vibration of the helicopter over the following couple of minutes (as he was engaged in conversation with the passenger) was enough to allow the collective to vibrate up with a commensurate application of engine power. He also commented that he was surprised at how quickly the accident happened. From the moment he heard the engine RPM begin to increase to the collision with terrain, was only a few seconds.

Leaving any vehicle unattended with the engine running carries considerable risk. Even where appropriate approvals are in place, pilots are encouraged to exercise extreme caution when considering the circumstances, and not allow perceived time pressures or other external factors to affect their judgement.
