Passenger injury at Gosnells Railway Station

Perth, Western Australia, on 26 October 2019

Rail Occurrence Investigation

RO-2019-019

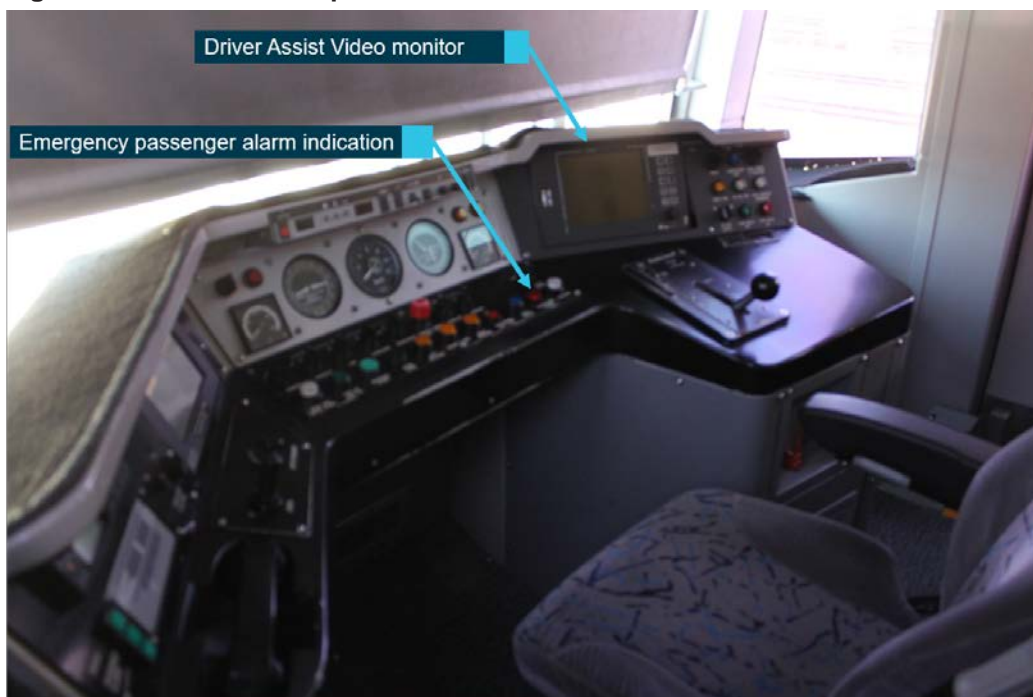
Figure 1: View of driver's panel

Around the same time, the driver of 5077CP⁴ was preparing to depart the train from the platform. The driver viewed the Driver Assist Video (DAV) monitor located on the driver's console (Figure 1) to check passengers had completed boarding/alighting the train. The DAV displayed vision from a CCTV camera⁵ of the platform and along the side of the train from front to back. The angle of the camera was sufficient to provide drivers a view along the side of the whole train.

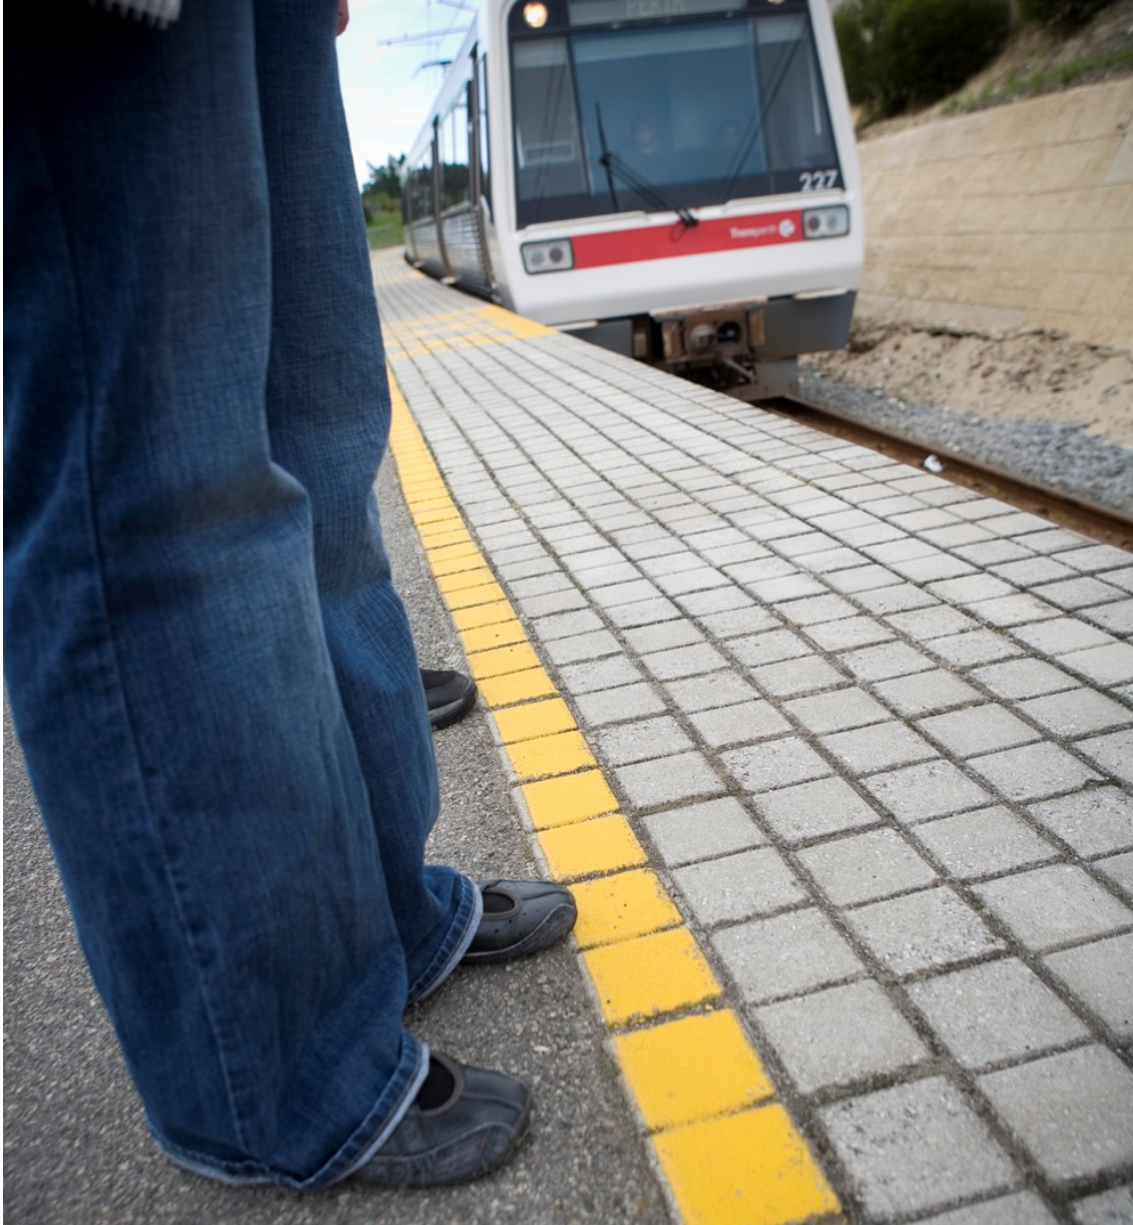
Figure 2: Typical platform showing painted safety line.

There were still numerous passengers across the width of the platform walking toward the station exit adjacent to the last (fourth) railcar. As the doors were closing, the child crossed the painted safety line (Figure 2) and continued to approach the edge of the platform before turning and looking back toward his family group. He stumbled against the side of the third railcar adjacent to its rear door and accidentally stepped off the edge of the platform coping, falling between the railcar and platform to the track formation below. Nearby persons on the platform and the child's family members responded almost immediately raising an alarm to passengers on-board the train or reaching down between the platform and railcar trying to retrieve the child.⁶
