Collision with terrain involving Cessna U206G, VH-JVR

124 km west of Norseman, Western Australia, on 3 March 2022

ATSB Transport Safety Report

AO-2022-011

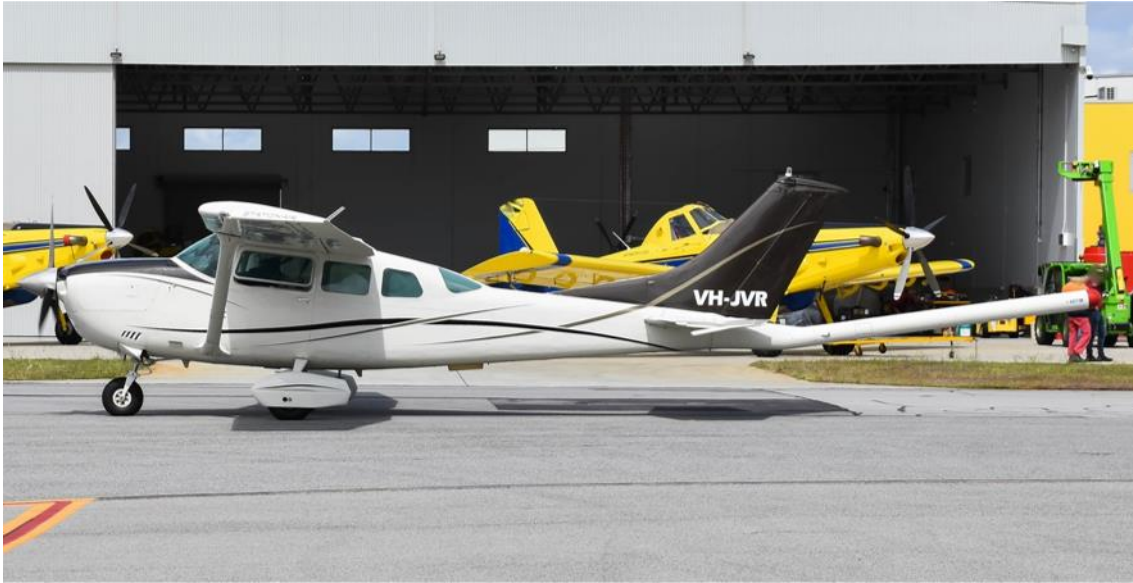
Figure 2: VH-JVR

VH-JVR was a Cessna U206G Stationair, which was a single-engine, fixed landing gear aeroplane powered by a Continental IO-520-F piston engine (Figure 2). It was manufactured in 1978 with serial number U20604795 and was first registered in Australia in 1998. Its last periodic inspection was in March 2022 and it had accrued almost 8,000 hours total time in service.

VH-JVR had been modified to conduct geophysical survey flights. A magnetometer boom was installed at the rear of the aircraft and associated survey equipment was in the rear cabin. The survey equipment had its own separate power supply. The aircraft also had a GPS tracking device.

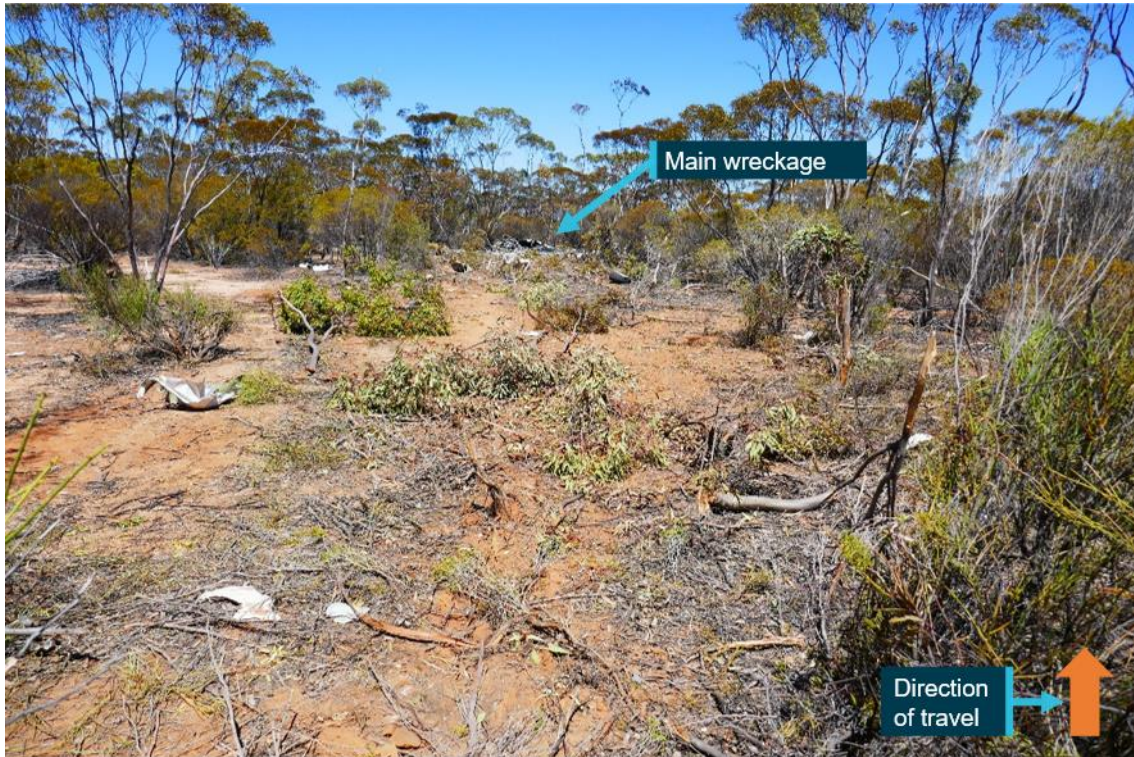
Figure 3: Wreckage trail looking south towards the main wreckage

Damage at the point of impact indicated that the aircraft initially struck trees in an upright but relatively steep nose-down attitude. The impact caused the left wingtip and aileron to separate from the aircraft. The aircraft then impacted the ground on its left side and continued through the bush in a southerly direction, coming to rest about 45 m from the initial point of impact (Figure 3).

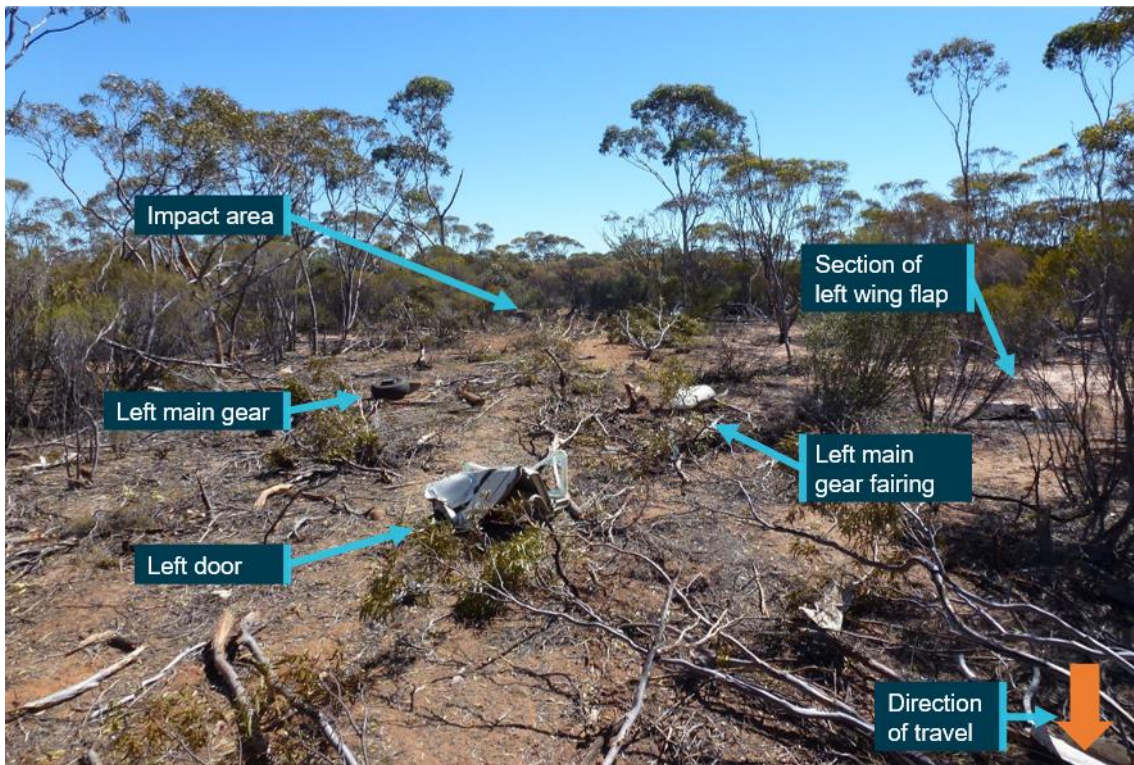
Figure 4: Wreckage trail looking north towards the impact area

The aircraft felled a number of trees and several parts had separated from the main body, including the nose gear assembly, left main gear, left door, windscreen and sections of the lower engine cowlings and lower engine components (Figure 4). There was no indication of fire in the wreckage trail, either in the bushland or aircraft components. However, the remainder of the aircraft was almost entirely destroyed by a post-impact fire. The propeller had separated from the engine and was located towards the rear of the wreckage and the engine had been detached from its mounts. The right wing was relatively intact as was the magnetometer boom, albeit damaged by fire (Figure 5).

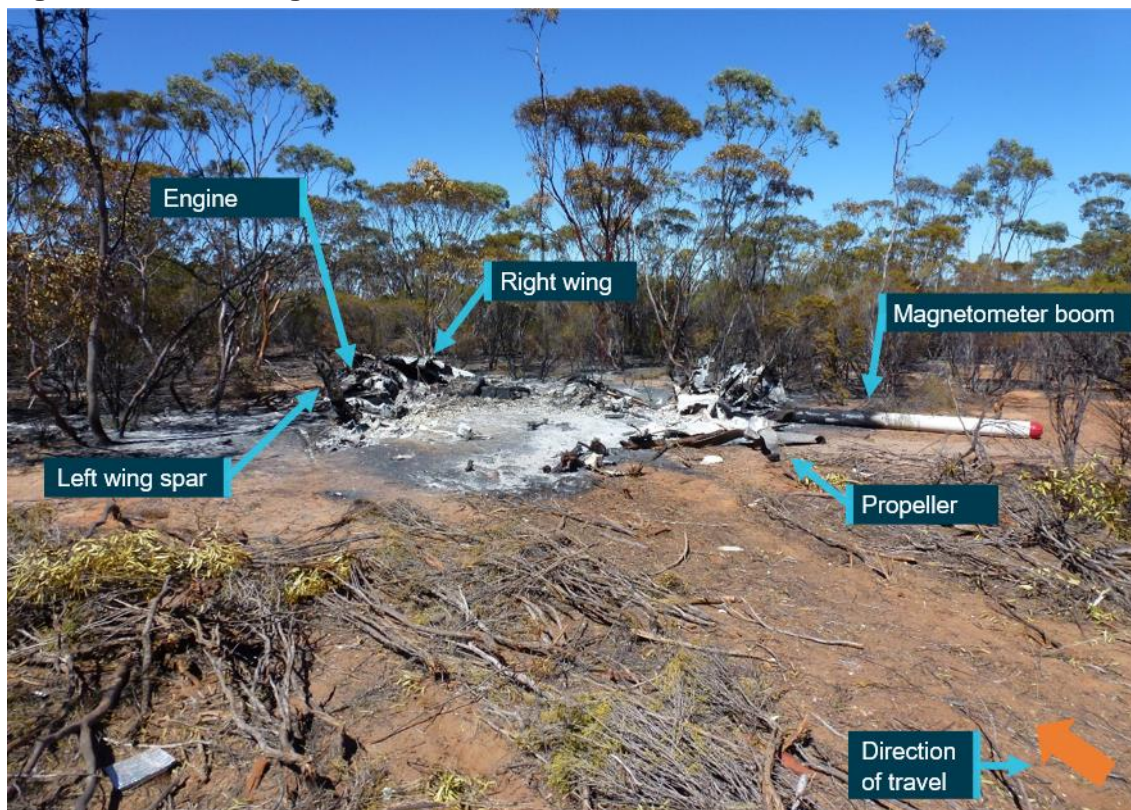
Figure 5: Main wreckage
