APPENDIX A: FLIGHT DATA RECORDER TECHNICAL ANALYSIS REPORT

Flight Data Recorder Readout and Analysis
SA227-DC VH-TFU
Lockhart River, Qld
7 May 2005

ATSB TECHNICAL ANALYSIS REPORT 21/06

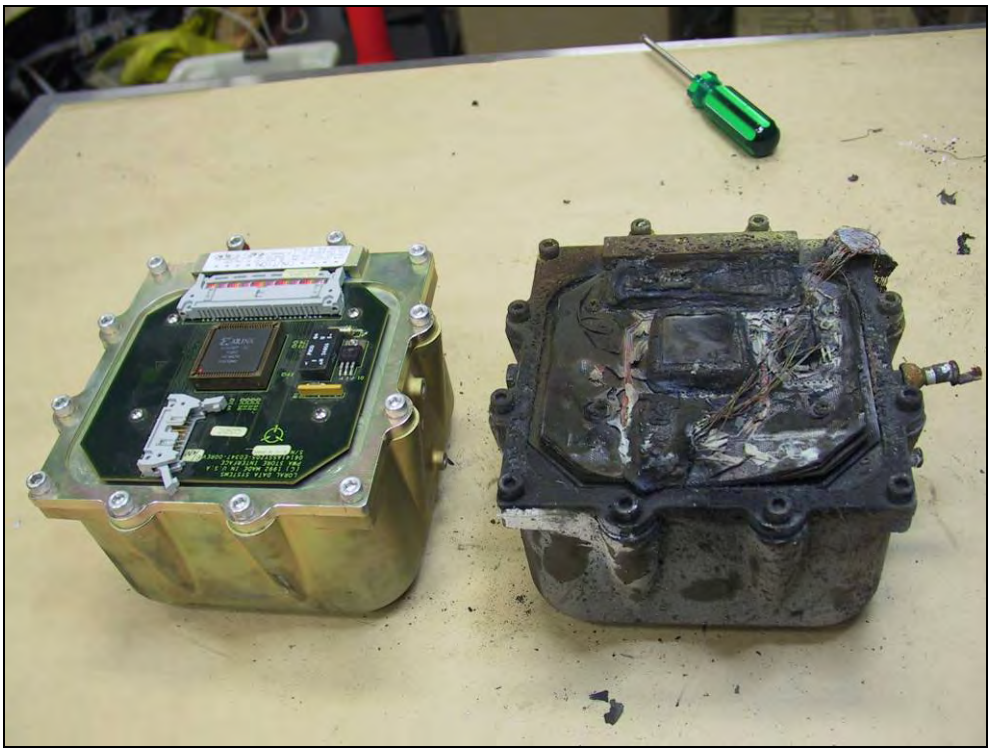
Figure A-7: Crash-protected memory module with a comparison unit

When the FDR was recovered the data plate was missing and the serial number could not be confirmed. Examination of the FDR at the ATSB confirmed that the reported model and part number were correct.

7. A new connector was crimped onto the memory board cable at the ATSB FDR laboratory in accordance with Loral Data Systems documentation[6].
8. On 11 May, an ATSB flight recorder specialist hand-carried the memory board to an authorised repair agency of the FDR manufacturer in Melbourne.

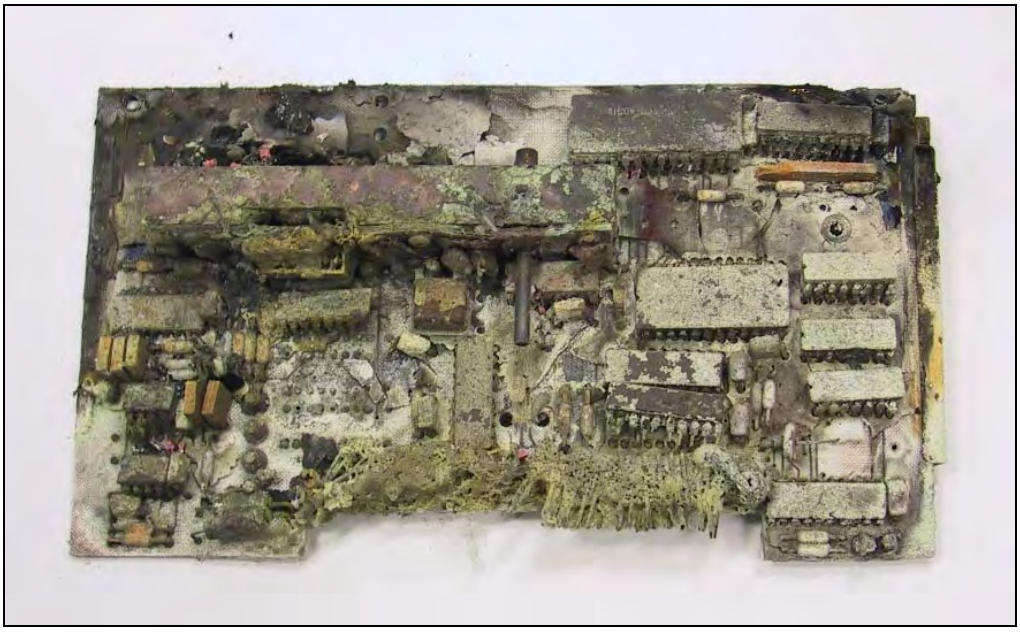
Figure A-16: Pneumatic printed circuit board from VH-TFU

The recorded IAS data was initially processed using the manufacturer's standard polynomial conversion equation. Examination of the results showed that the IAS values were unreasonable i.e. cruise speeds did not agree with the cruise speeds documented in the operator's trip records. The damage to the pneumatic PCB from VH-TFU precluded any direct testing/calibration.

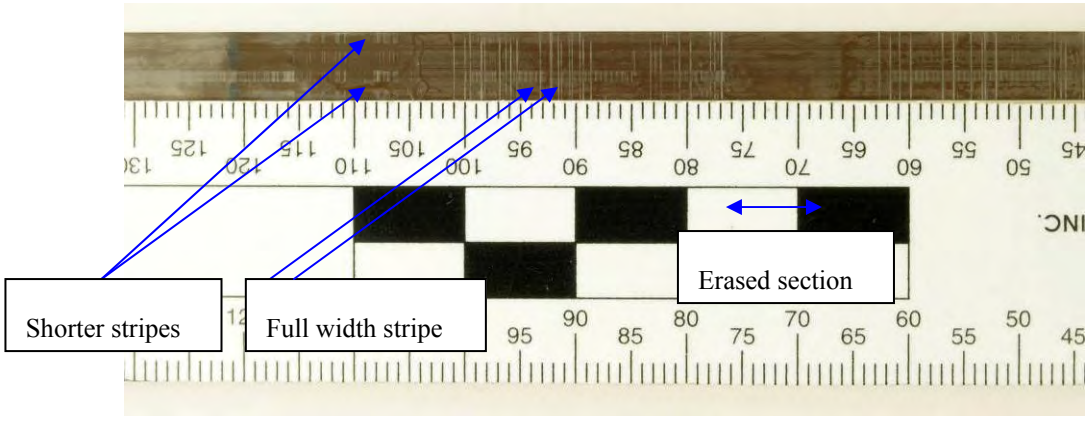
Figure B-9: Recovered tape with Magnasee applied

Figure B-9 shows the signals recorded on a section of the tape recovered from the CVR fitted to VH-TFU that were made visible by Magnasee. The interference signal 'spikes' are indicated by the light grey transverse stripes visible on the tape. Sources of the spikes are characterised by the stripes visible across the width of the 0.25 in (6.4 mm) tape. Present are single full-width stripes and shorter stripes that are broken into four segments across the tape. Only the erase head is able to impress a signal across the full width of the tape. The four segments represent the four tracks produced by the four pole pieces of the recording head. The second track from the tape edge where the scale is located, see Figure B-9, has more signals visible than the other tracks. This track contains signals originating from the CAM. Replay of the CAM showed that signals relating to propeller noise associated with the operation of the aircraft were present on this portion of tape.

From about 62 mm to 77 mm, there are no stripes visible. This corresponds with the physical area of tape that existed between the erase head and the record head (about 15.5 mm) at the time of stoppage. The absence of stripes indicates the erase head was functioning. The magnified image of the section of tape following the erased portion, see Figure B-10, and preceding the erased portion, Figure B-11, clearly shows the visible stripes.

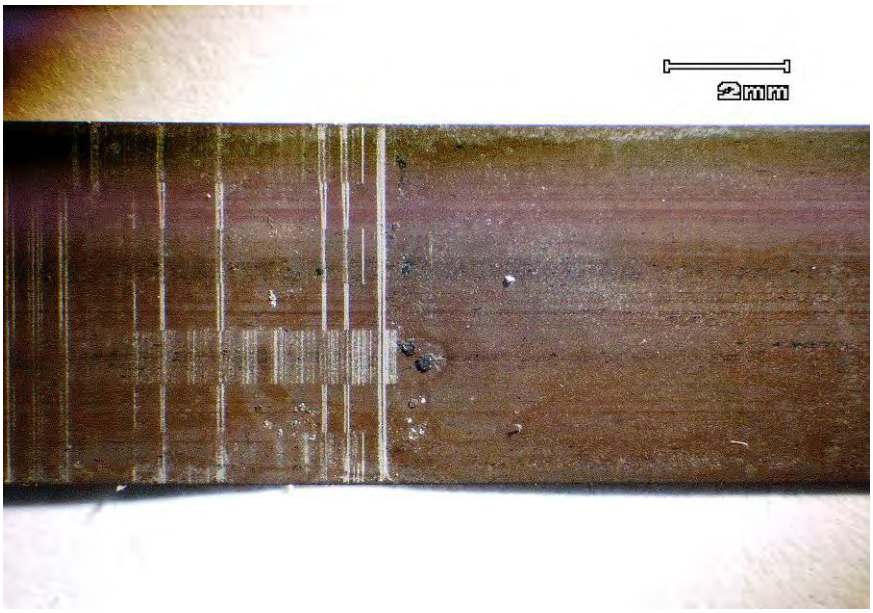
Figure B-10: The newest information recorded on the CVR tape, showing stripes indicating 'spikes' that are present for individual tracks and full width of the tape. Also illustrated is part of the erased section of tape.

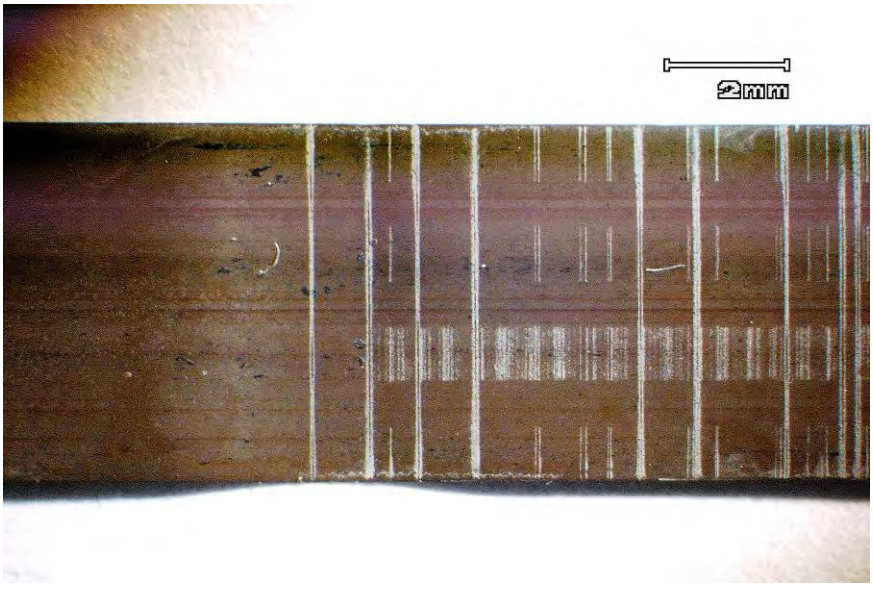
Figure B-11: Recovered tape with Magnasee applied, magnified to oldest information recorded.

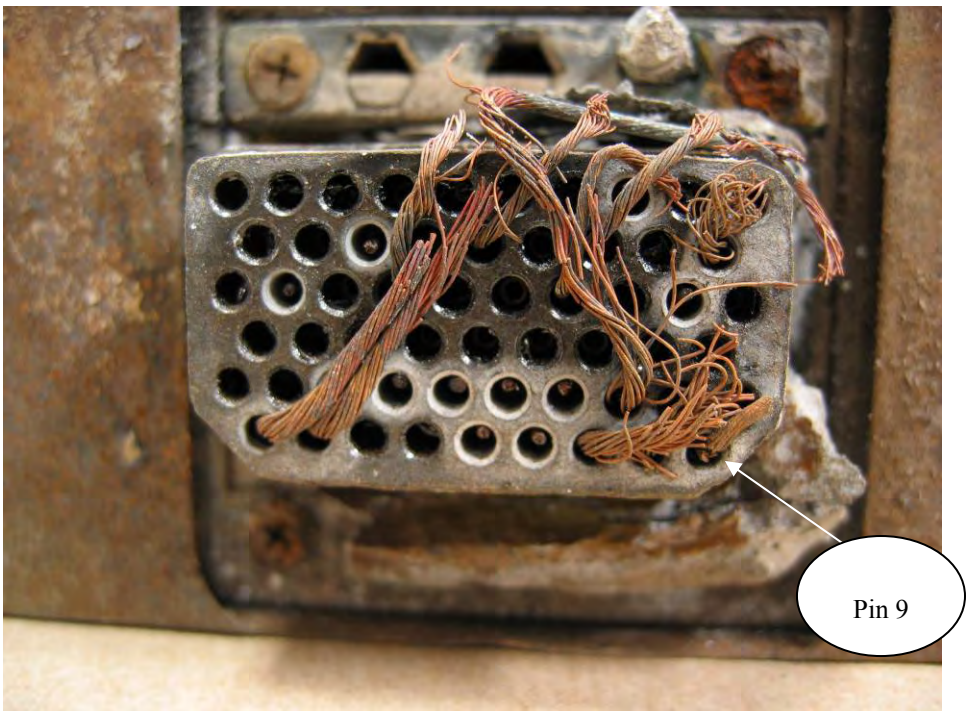
Figure B-16: Photograph of VH-TFU CVR unit aircraft interface connector

The aircraft interface connector fitted to the CVR unit was examined. A photograph of the rear of the connector is included as Figure B-16. The photograph shows the rear of the connector, part number DPXB-57-33S-0001, fitted to the rack that holds the CVR in the aircraft. This connector mates with plug (P1), p/n DPXB-57-34P-0101, at the rear of the CVR. The remnants of wiring and pins, still fitted to the connector, conform to the interwiring shown in L-3 Communications Aviation Recorders Component Maintenance Manual (CMM), p/n 165E101-00, page 125, interwiring diagram regarding CVR units model A100, A100A.

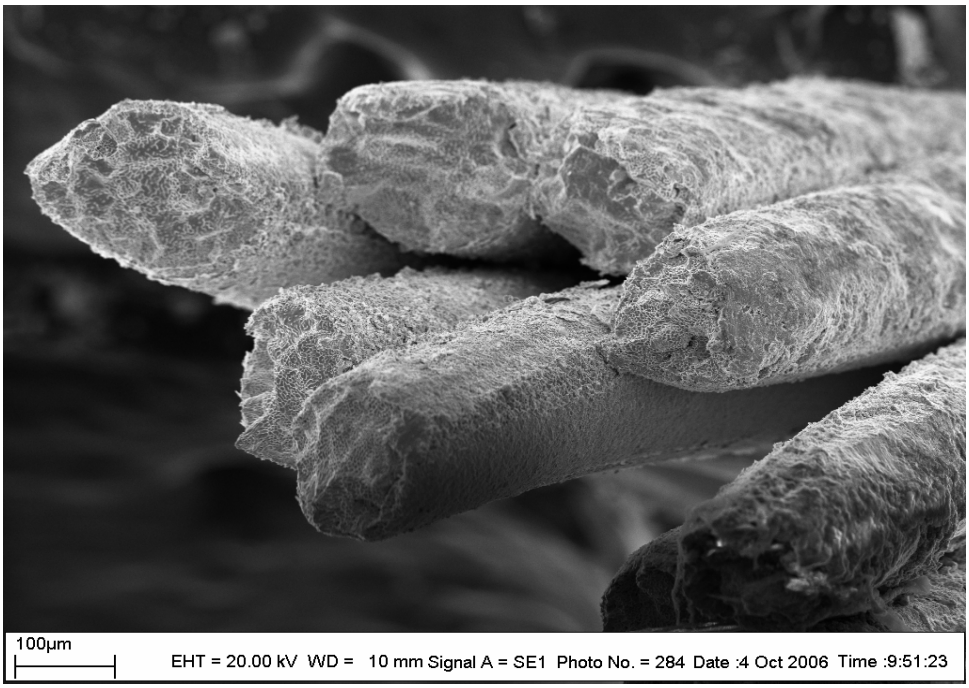
Figure B-17: Photograph of aircraft interface connector wire strand ductile unpowered fracture

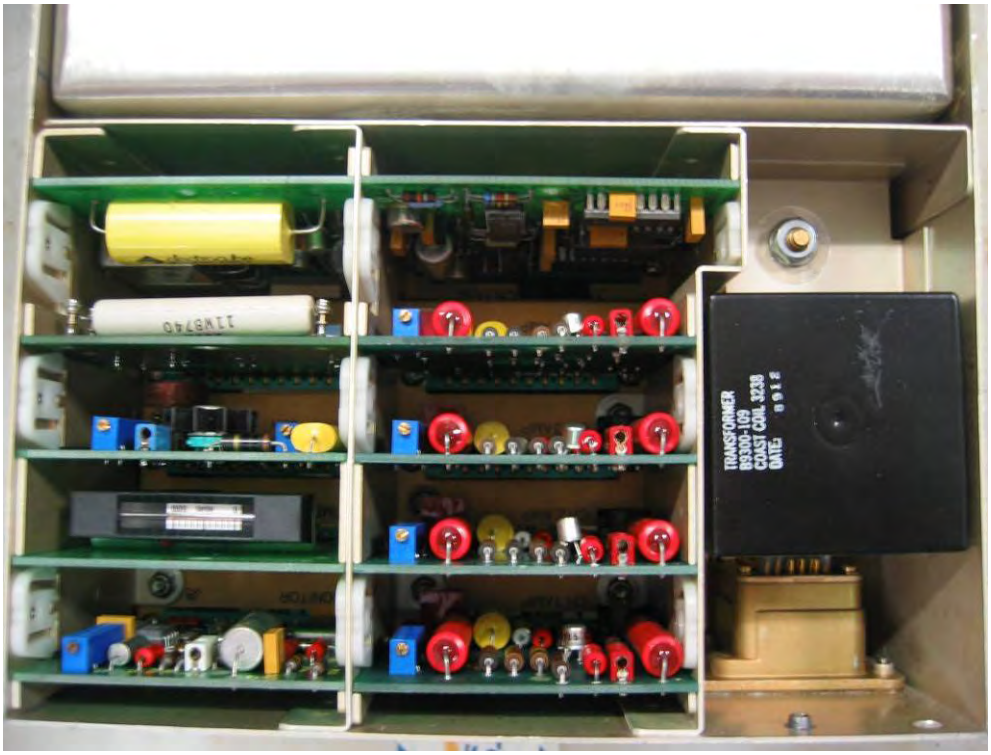
Figures 19 through 27 show the extent the CVR unit was affected by heat and fire. The integrity of the printed circuit assemblies and the CVR unit interwiring could not be determined due to the damage.

Figure B-21: VH-TFU CVR printed circuit card assembly wiring

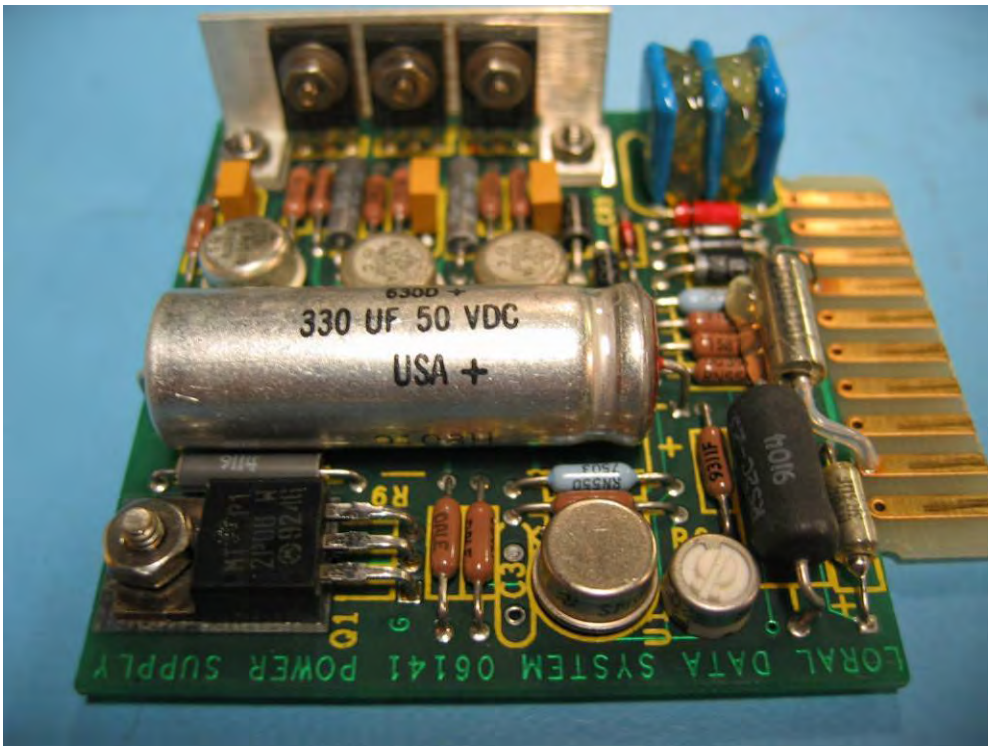
However, since the Bias Generator circuit provides the record bias signal to each of the four Record Amplifier circuit cards as well as the erase head, it is the most likely cause of the anomaly that was observed.

Figure B-25: VH-TFU bias oscillator assembly

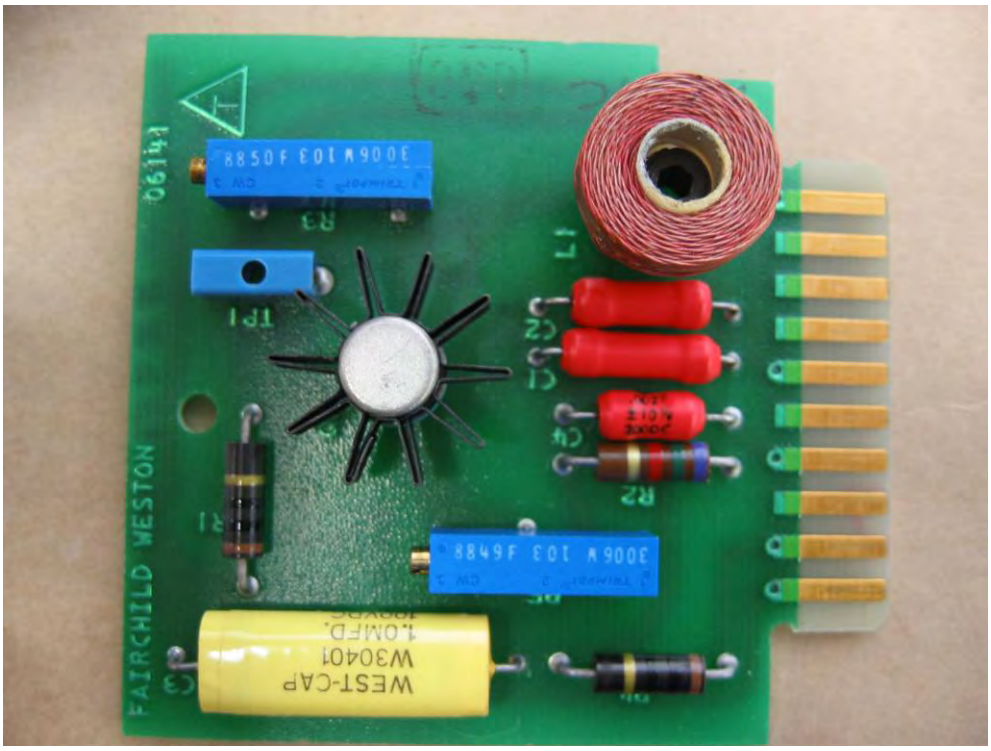
Figure B-27: VH-TFU CVR inverter assembly
