ATSB TRANSPORT SAFETY REPORT

Aviation Occurrence Investigation – AO-2008-046

Airframe event
Orange aerodrome, NSW
6 July 2008
SAAB SF340B VH-ZLC

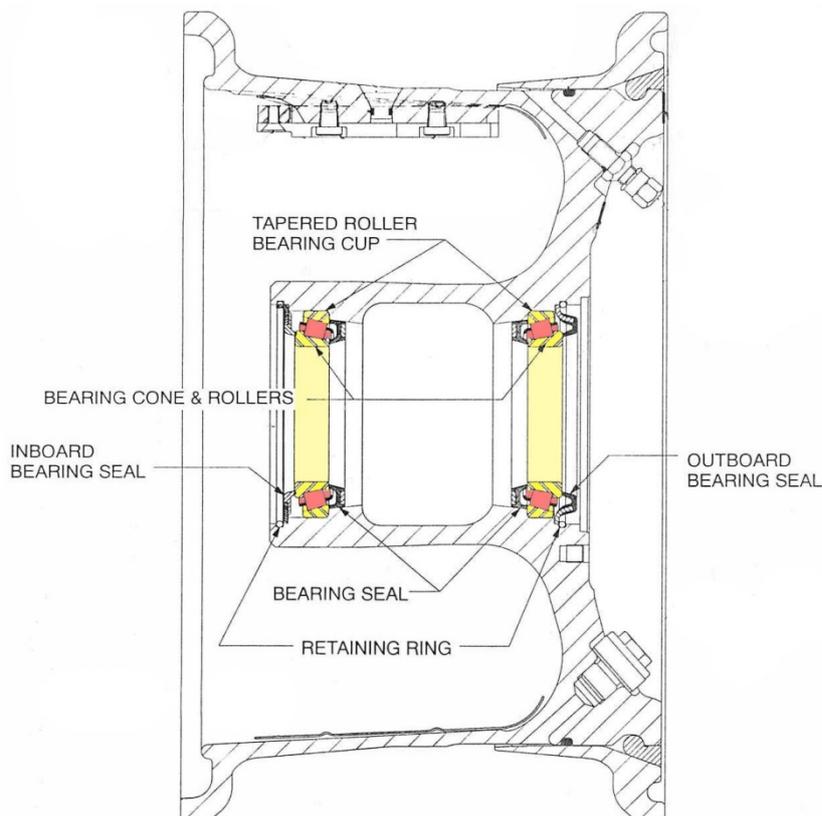
Figure 5: Wheel cross section with inner and outer bearings highlighted

The wheel assembly included an inboard and outboard tapered roller bearing, installed as illustrated in Figure 5. The bearings consisted of a cup (outer race), cone (inner race), cage, and rolling elements (Figure 6).
