ATSB TRANSPORT SAFETY INVESTIGATION REPORT

Aviation Occurrence Investigation – 200600001

Collision with terrain - Willowbank, Qld

VH-UYB

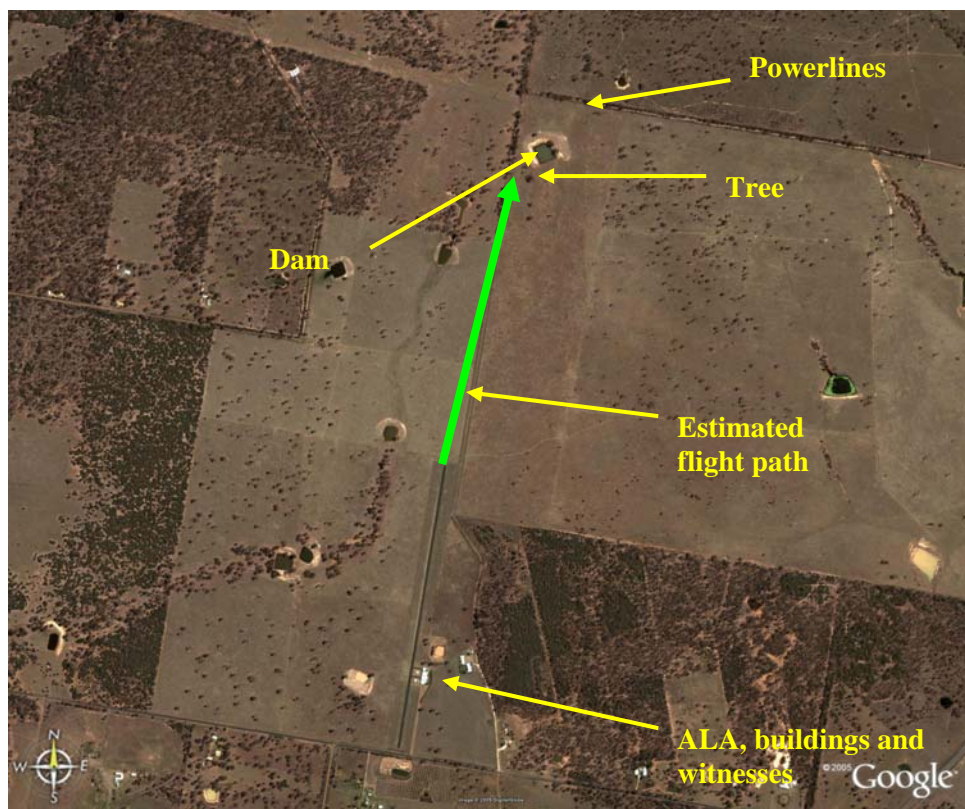
Figure 1: Willowbank ALA⁸

The facilities at the ALA included two hangars and an administration building to the east of the runway (Figure 1). Two aircraft parking areas were located between the hangars and the runway. A windsock was located directly across from the hangars, on the western side of the runway.

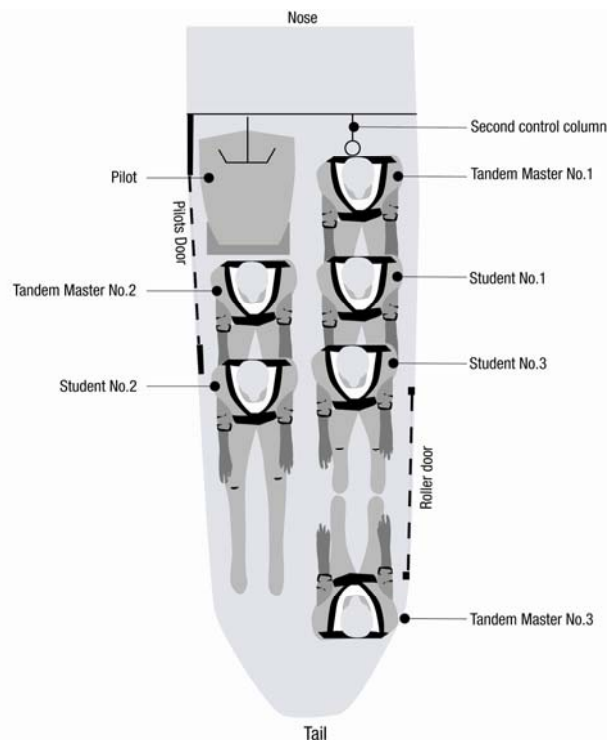
Figure 2: Seating configuration of the aircraft

The two survivors (labelled Tandem Master No. 3 and Student No. 1 in Figure 2) sustained injuries including: aviation gasoline (Avgas) chemical burns, fractures, lacerations and bruising. Table 1 summarises the injuries to the aircraft's occupants.

The damage to the cockpit area was severe, but the cabin area remained relatively intact. Of the aircraft's seven occupants, only two successfully exited the aircraft. The owner/operator (Tandem Master No.3, see Figure 2) advised the investigation that he exited the aircraft after it submerged in the dam water. Tandem Student No. 1 had no recollection of exiting the aircraft.

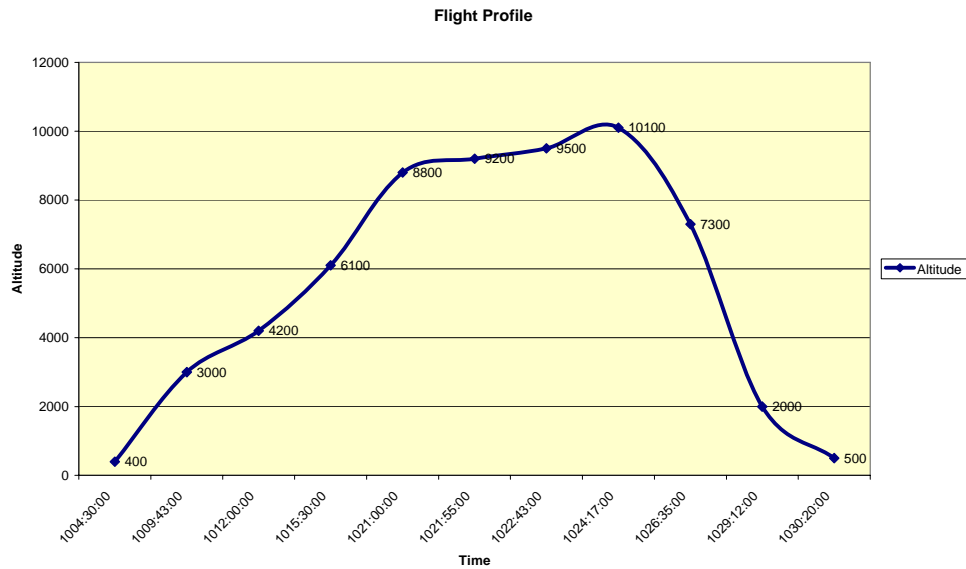
Figure A-1: Flight profile for the first flight

Radar information for the first flight was sourced from Airservices Australia and the nearby Royal Australian Air Force (RAAF) Base Amberley.⁶⁸ The recorded information indicated that the aircraft departed the Aircraft Landing Area (ALA) at Willowbank for the first flight at 1004:30. The aircraft climbed to Flight Level 110⁶⁹ for the parachutists' exit before descending back towards the ALA (Figure A-1). A tabulated representation of the radar data is at Table A-1.
