ATSB TRANSPORT SAFETY INVESTIGATION REPORT

Aviation Occurrence Report – 200603140

Fuel Starvation
2.4 km north-west Bathurst Island Aerodrome, NT
1 June 2006
VH-JDJ
Beech Aircraft Corp A36

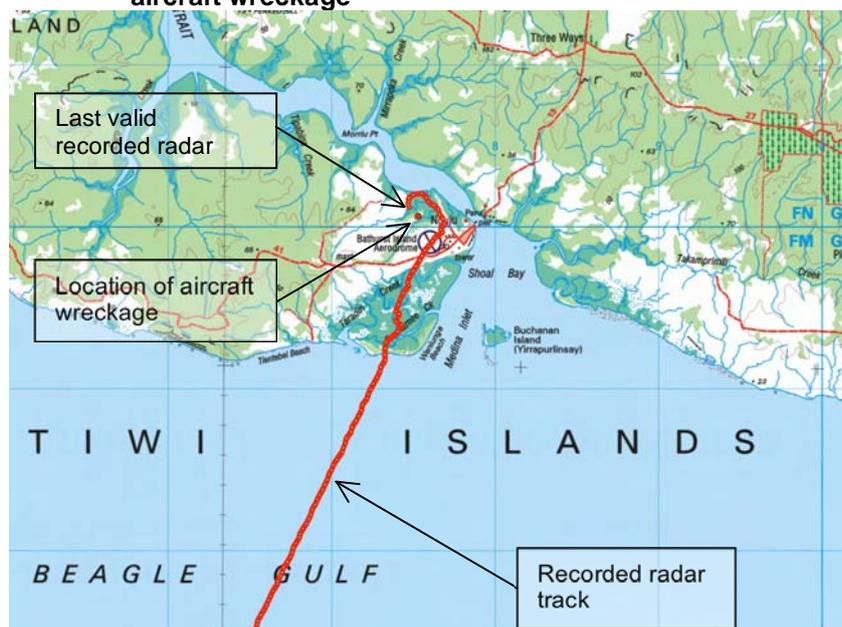
Figure 1: Bathurst Island aerodrome, recorded radar track and location of aircraft wreckage

Figure 1 depicts the aircraft's recorded radar position during the final stages of the flight.
