**ATSB TRANSPORT SAFETY INVESTIGATION REPORT**

Aviation Occurrence Report – 200500004

**Collision with terrain  
Wynella Station, Qld  
6 January 2005  
VH-BQN  
Air Tractor AT-802A**

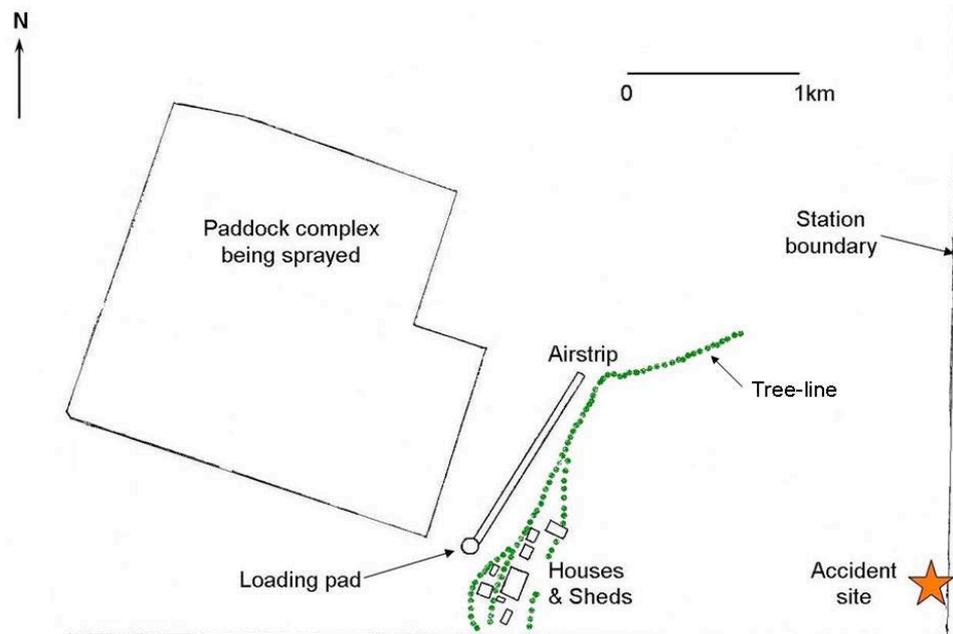
**Figure 1: Wynella Station – south-east corner**

The aircraft wreckage was located in a level paddock 2.7 km east of the Wynella airstrip and 3.6 km east-south-east of the eastern boundary of the paddock being sprayed (figure 1).
