Crew member seriously burned by steam on board *MSC Sonia*

At about 0945¹ on 10 April 2007, *MSC Sonia's* boatswain and ordinary seaman were on the top platform of the ship's funnel casing, painting the starboard main engine exhaust pipe, when steam unexpectedly exhausted from the nearby boiler safety valve vent pipe. The ordinary seaman was seriously burned by the steam.

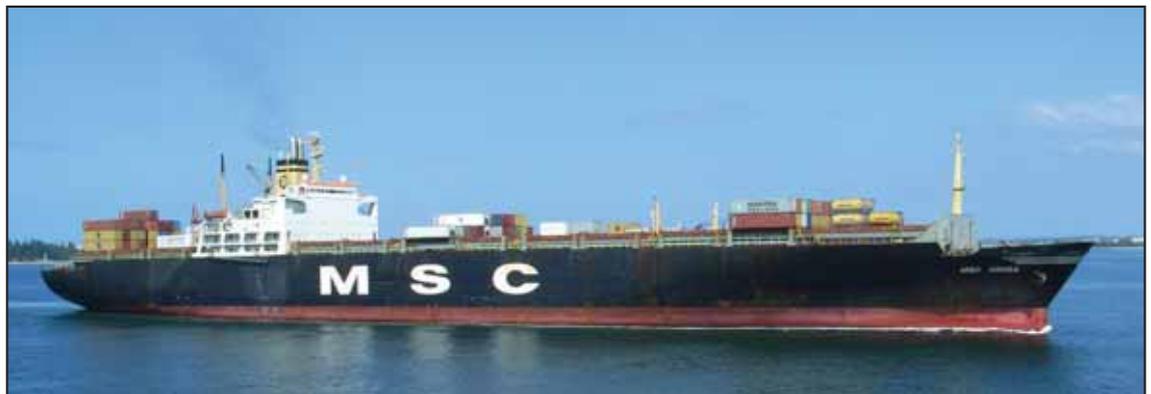
MSC Sonia (Figure 1) is a 2450 TEU² cellular container ship that operates on a liner service between Asia and the Australian east coast ports of Melbourne, Sydney and Brisbane.

Figure 1: *MSC Sonia*

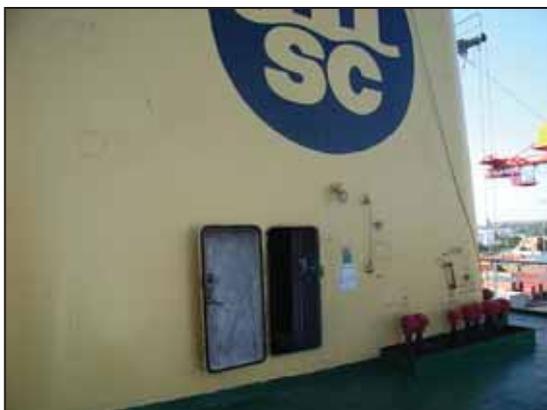
He then returned to the funnel casing top platform with the chief mate. The two men explained to the ordinary seaman that he would have to climb down the funnel casing ladder because there was no other way of getting him down. With their assistance, the ordinary seaman climbed down the ladder and walked out of the funnel casing, onto the bridge deck (Figure 5). He then lay on the deck while the chief mate used a nearby hose to shower him with water to cool his burns.

Figure 5: Funnel casing and bridge deck
