Fatality aboard *Golden Bell*, Dampier WA

16 May 2005

Fatality following fall in engine room

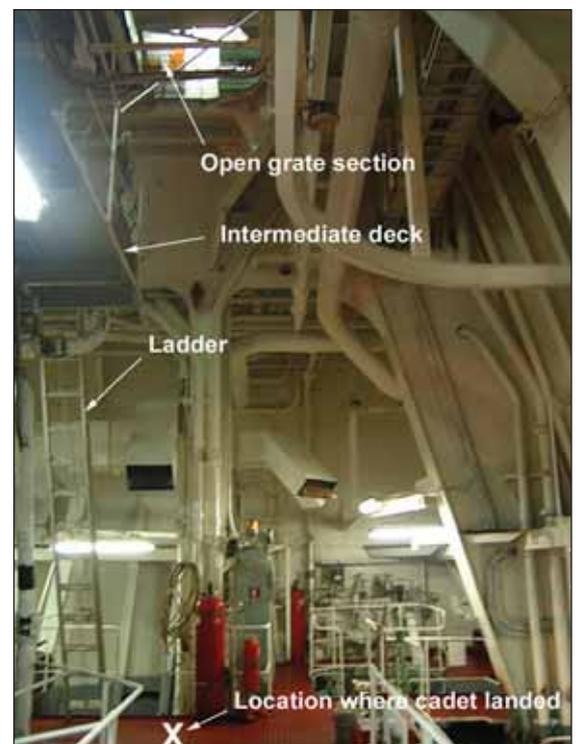
FIGURE 4:
Engine room layout

At about 0900, in order to gain access to the steam valve, the oiler removed a section of deck grating from the third deck, forward and to port of the main engine (figure 3). He placed a danger sign near the open section of grating as a warning to crew using the area. The oiler then passed a long aluminium extension ladder through the hole to the third engineer standing on the intermediate deck below. The ladder was to be used to stand on while repairing the valve, with its feet on the bottom deck plates.
