Independent investigation into the collision  
between the Liberian flag bulk cargo vessel

# Silver Bin

# Chinderah Star

Report No 156

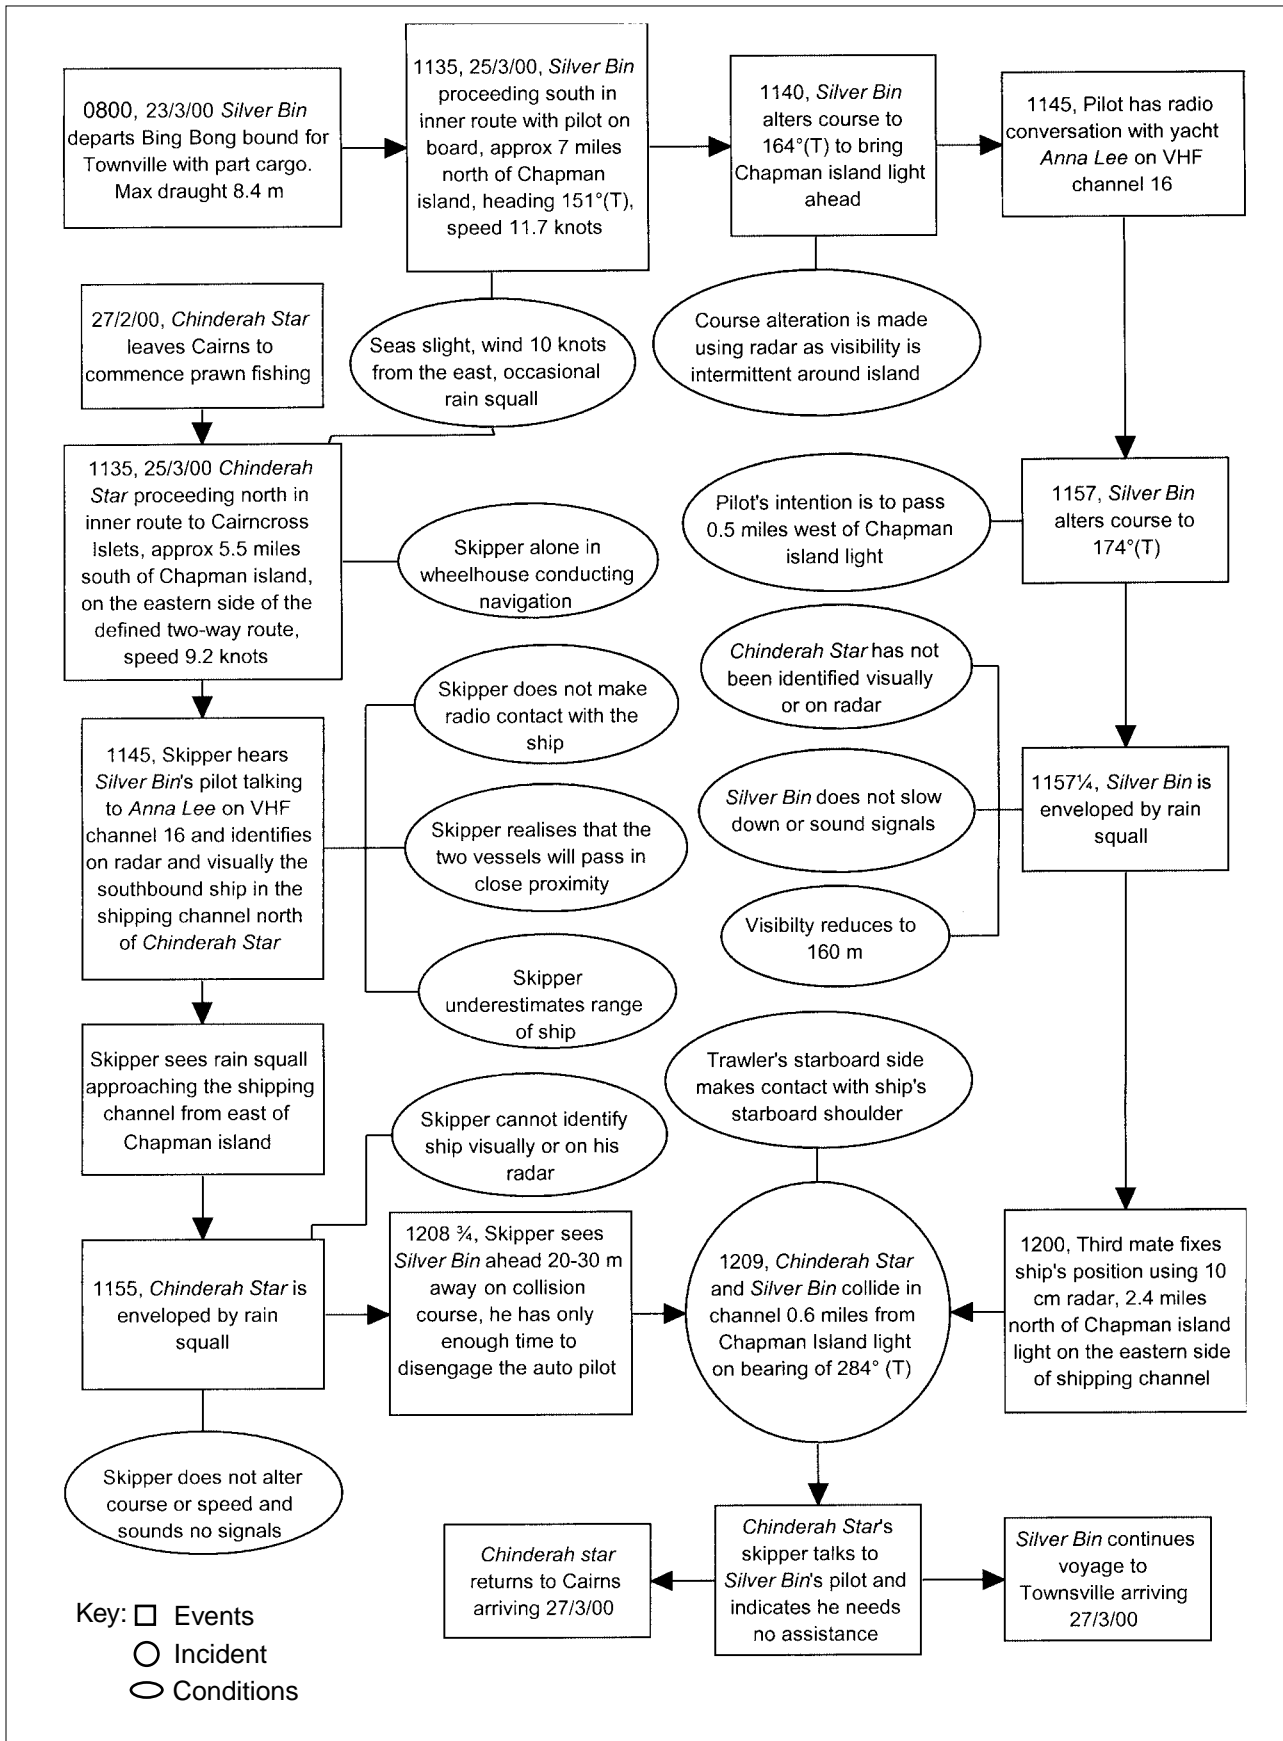
**FIGURE 8:**  
**Silver Bin/Chinderah Star collision events and causal factors chart**

Figure 8 is an excerpt from the events and causal factors chart for the incident.
