MARINE SAFETY INVESTIGATION

Independent investigation into the  
collision between the British flag motor vessel

# Ariake

# Redcliffe

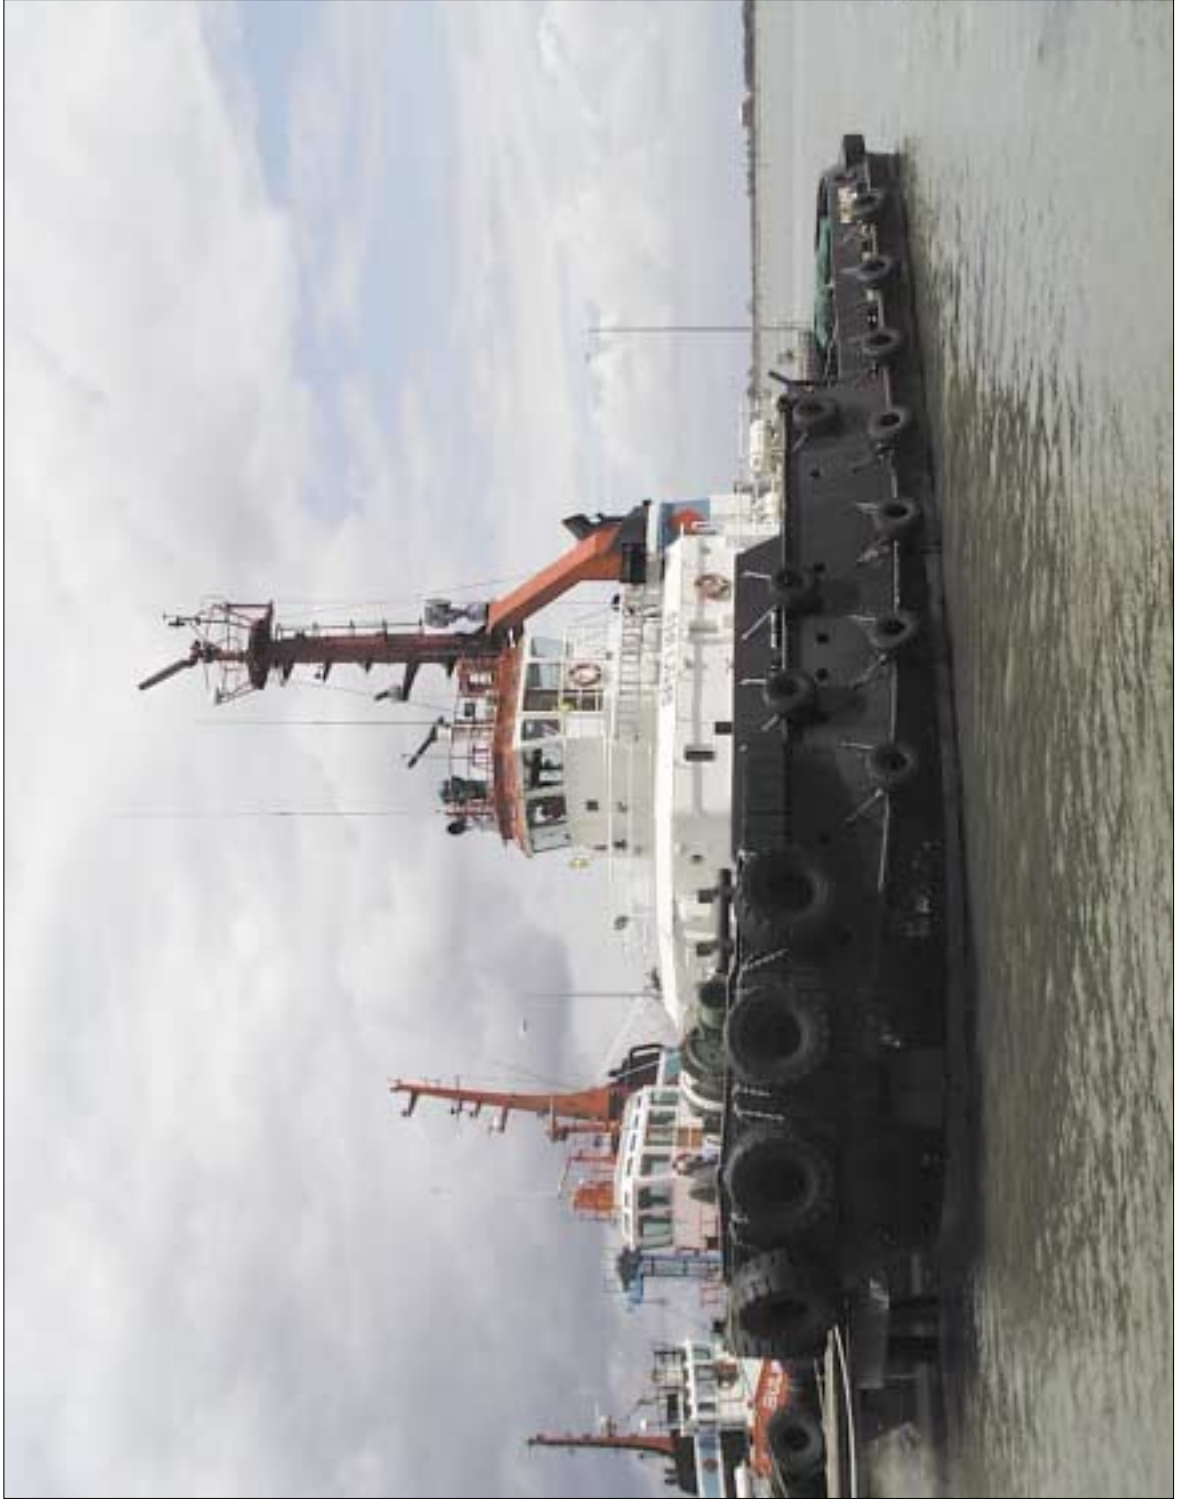
**FIGURE 1**  
*Redcliffe at Whyte Island tug base*

The motor tug *Redcliffe*, (fig. 1), (formerly *W J Trotter*), was built by Carrington Slipway in Newcastle, and entered service in 1986 for Queensland Tug and Salvage Co. Pty Ltd of Brisbane. Queensland Tug and Salvage Co. Pty Ltd is a subsidiary of Howard Smith Towage. *Redcliffe* is classed ✱A1 E Towing Service, with ✱AMS<sup>3</sup> and ✱ACCU<sup>4</sup> notations, with the American Bureau of Shipping. The tug is 33.92 m in length, has a beam of 10.82 m, a moulded depth of 5.39 m and a light displacement of 613 tonnes.

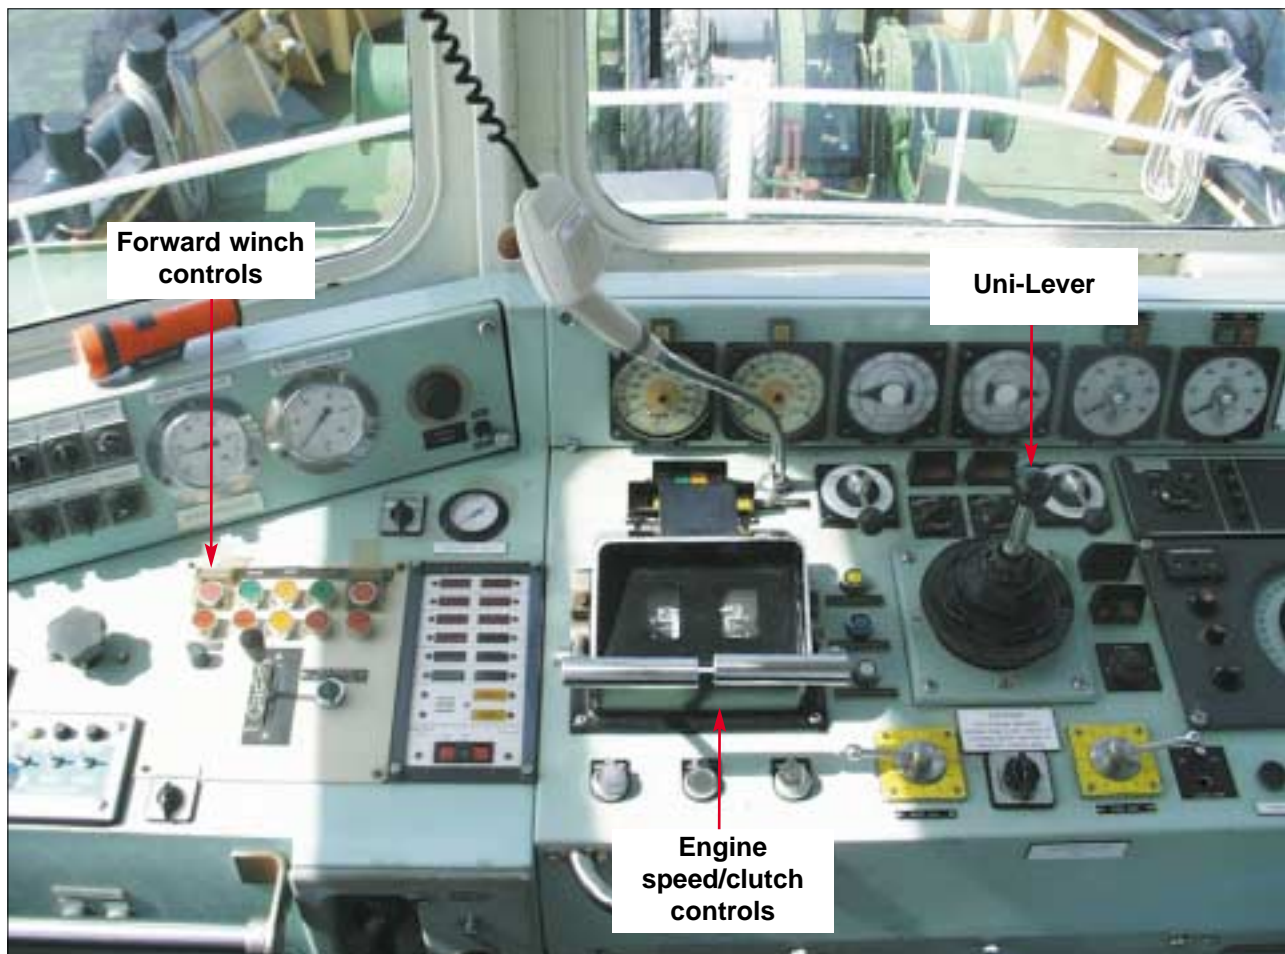
**FIGURE 2**  
*Redcliffe's* forward bridge control

In normal circumstances, the rotation of the stern drive units, and the consequent vectoring of the propeller thrusts, is effected by a sophisticated control system with a joystick ('Uni-Lever') input. The 'Uni-Lever' is mounted on the forward console of the tug wheelhouse (fig. 2), and can be used to control the direction of the tug as well as its speed through the water for a given engine speed setting. The general principle is that the tug will move in the direction in which the 'Uni-Lever' is placed, with a combination of rotational and translational movement made possible by the control system vectoring the propeller thrusts in various ways.

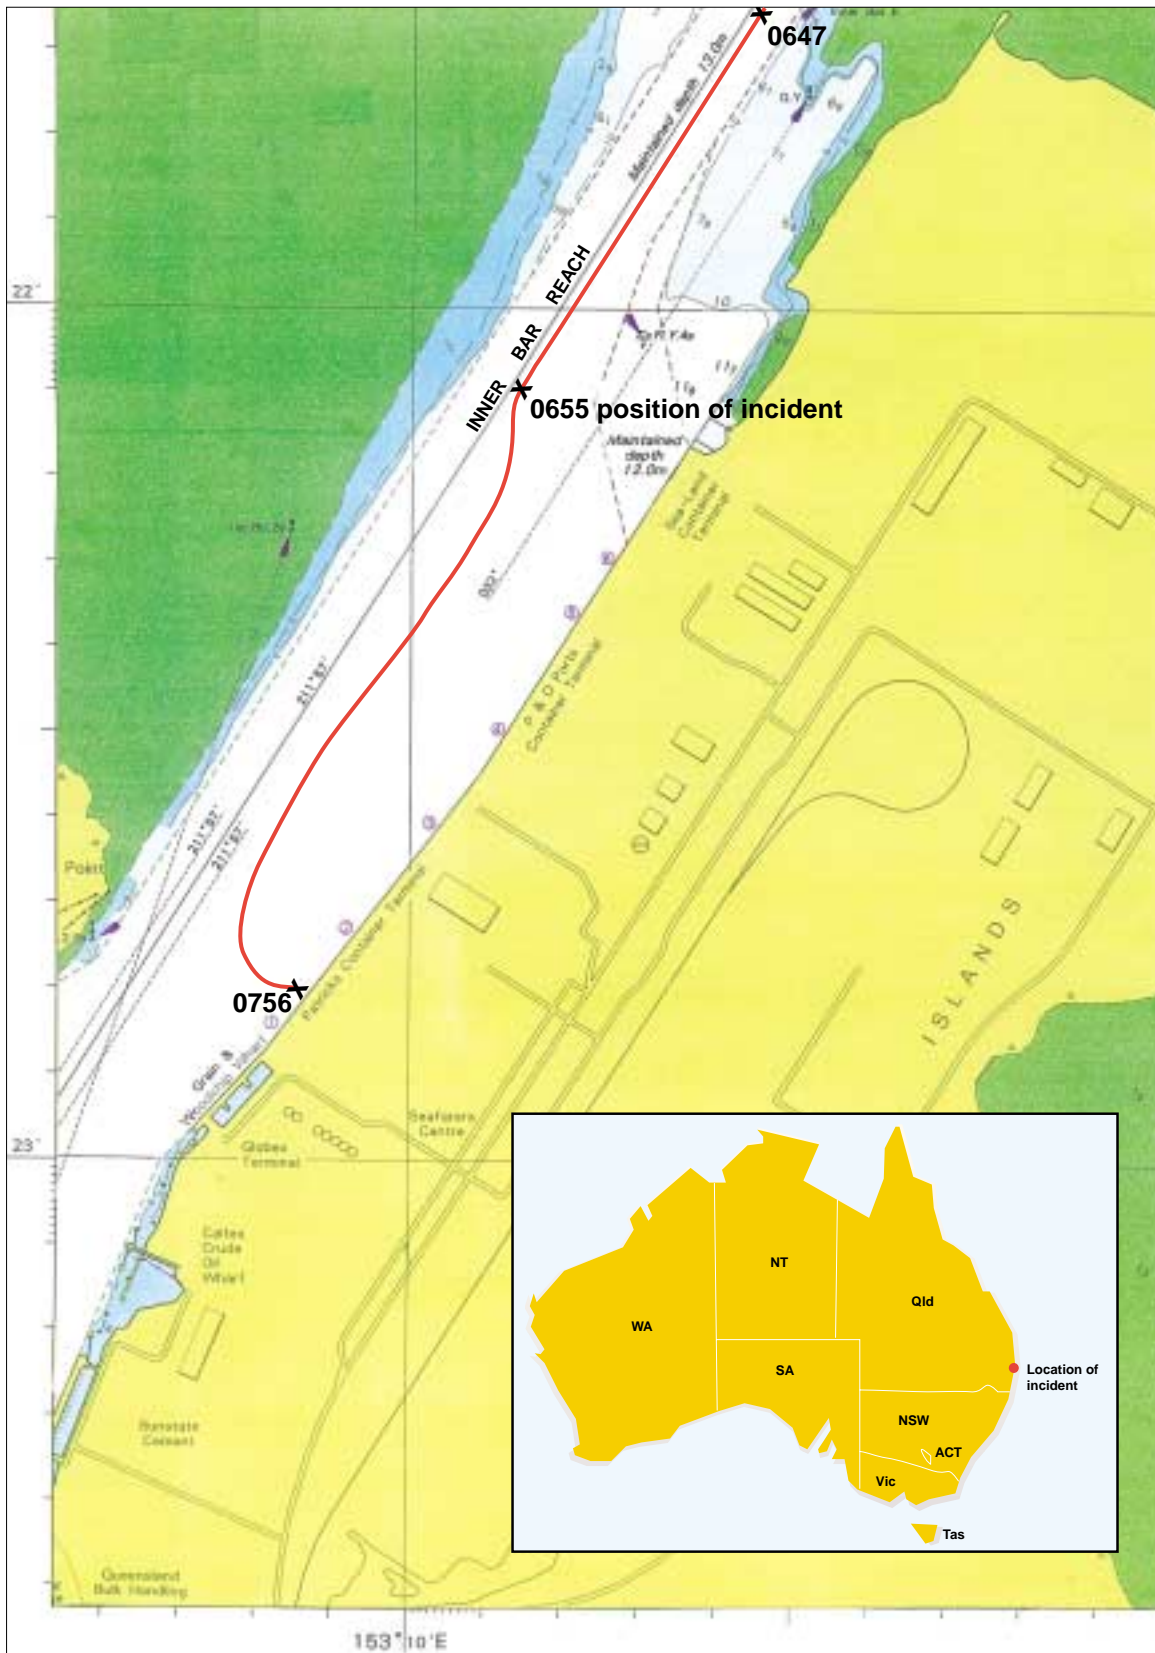
**FIGURE 3**  
**Ariake's approximate track to No. 1 berth Fisherman Islands**

*Ariake* passed the Inner Bar Beacons at 0647, (fig. 3).
