ATSB TRANSPORT SAFETY REPORT
Aviation Occurrence Investigation A0-2010-019
Preliminary

Collision with terrain, VH-ANB

Darwin Aerodrome, Northern Territory

22 March 2010

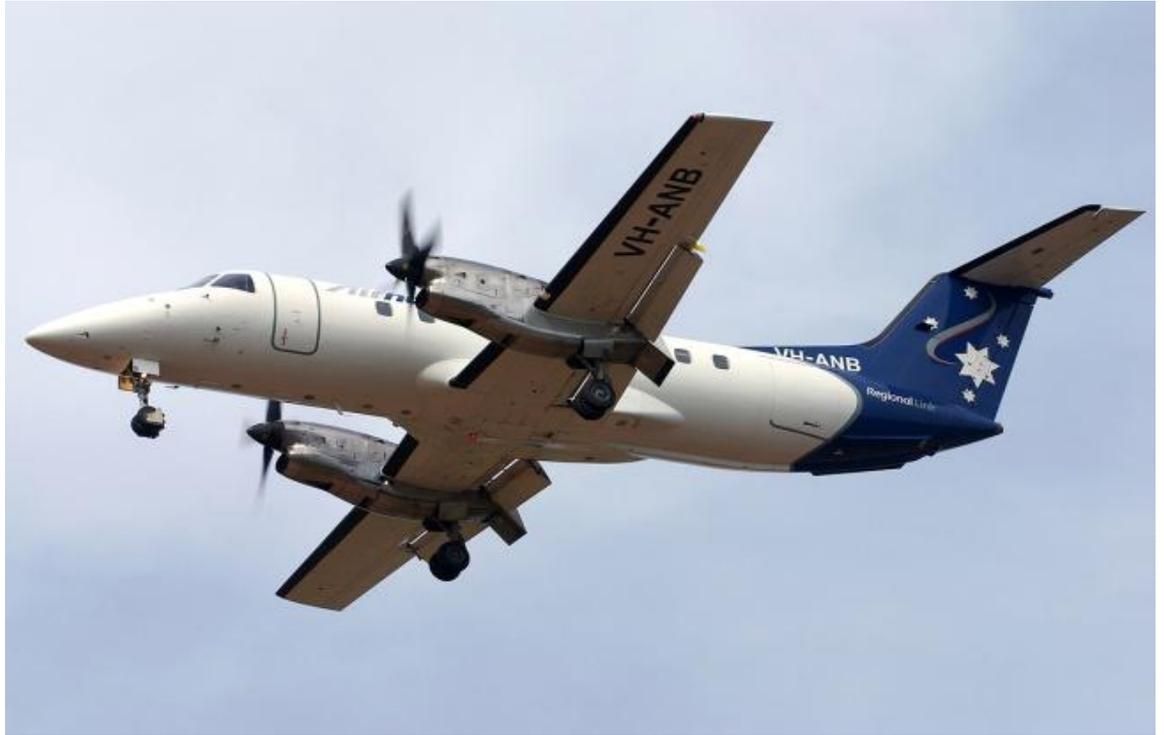
Figure 2: VH-ANB³

The Brasilia is a 30-passenger seat, twin-turbopropeller aircraft manufactured in Brazil. There were 21 of these aircraft on the Australian register at the time of the accident that were operated by regional airlines. Brasilia ANB, serial number 120-116 (Figure 2), was manufactured in 1989 and was first registered in Australia on 2 August 1993. At the time of the accident it had
