TECHNICAL ANALYSIS INVESTIGATION REPORT

Report No. 24/05

**Examination of failed thrust bearings from a
Teledyne Continental Motors GTSIO520M engine**

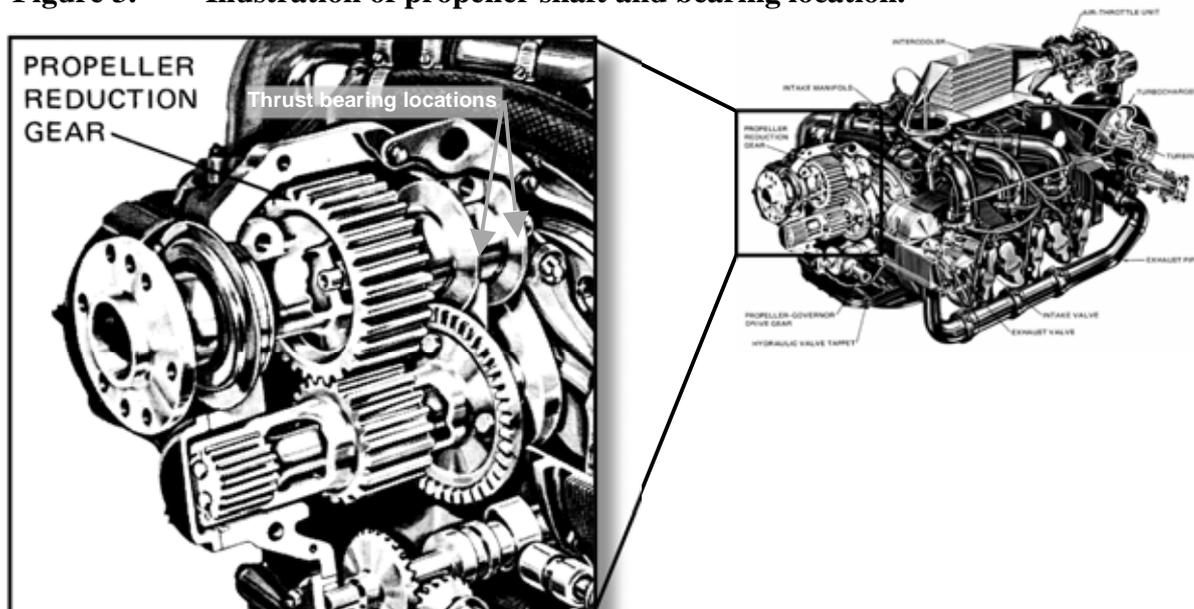
As installed, the thrust bearings comprised two sets of semicircular opposing plates, located against flange elements at the rear of the propeller shaft (figure 3¹). The rear bearings, carrying the primary propeller thrust loads, had sustained extensive mechanical and thermal damage, whereas the forward bearings showed little evidence of abnormal service and were visibly sound (figures 4, 5). The undamaged (forward) bearing set carried the rear surface identification '646260 G'. Damage to the rear bearings prevented the recognition of any similar markings on those items.

Figure 3. Illustration of propeller shaft and bearing location.
