ATSB TRANSPORT SAFETY INVESTIGATION REPORT
Marine Occurrence Investigation No. 237
Final

**Independent investigation into the collision
between the Australian recreational vessel**

Norma Jean

Seatow 61

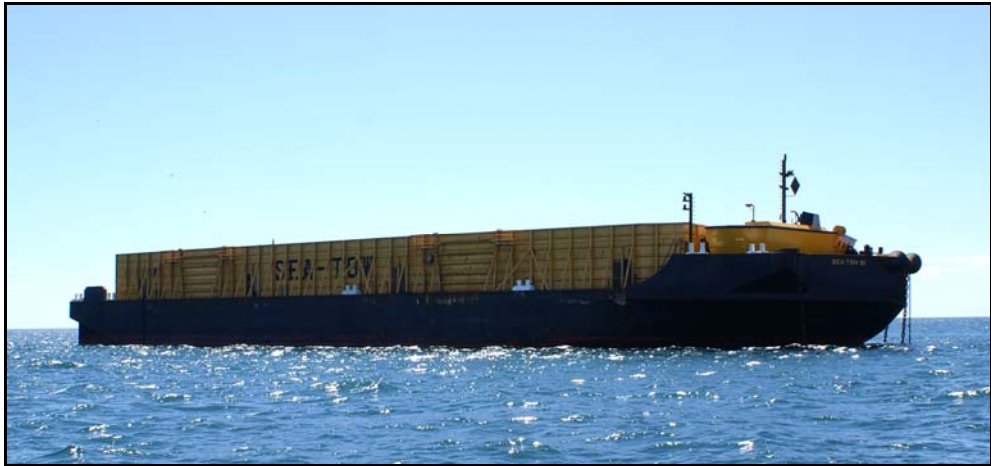
Figure 1: *Seatow 61* at anchor off Carnarvon

Seatow 61 (Figure 1) is an unmanned ‘dumb barge’⁴ that is registered in New Zealand. It is owned and operated by Sea-Tow, New Zealand, which operates a fleet of five tugs, five barges and two self propelled landing barges.

Seatow 61 was built in 2003 by the Taizhou Sanfu Ship Engineering Company in Jiangsu, China. It has an overall length of 85.43 m, a beam of 24.38 m and a depth of 5.52 m. The barge has a deadweight of 6000 tonnes at its maximum draught of 4.48 m. When empty, the barge has draughts of about 1.4 m forward and 0.9 m aft.

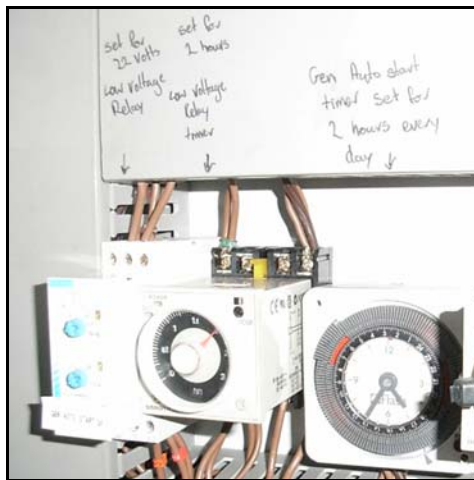
Figure 2: Generator control devices

In the event that the battery voltage dropped below 22 Volts, a voltage detector relay initiates a start sequence for the small generator and a timer is set so that the small generator runs to recharge the batteries for a period of two hours (Figure 2).

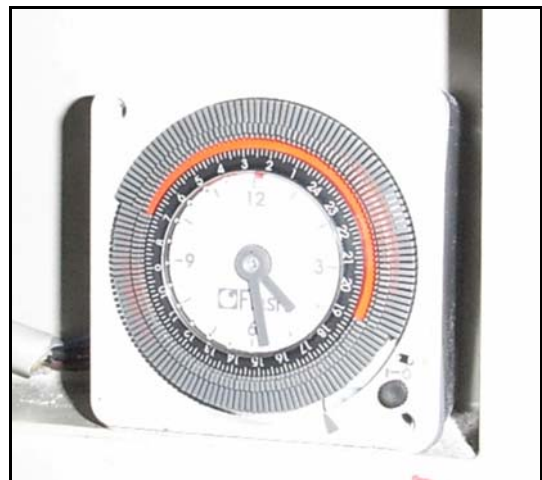
Figure 3: Navigation light timer

The navigation lights are switched on and off by a timer (Figure 3). On the day of the accident, the anchor lights were set to turn on at 1900 and turn off at 0710.

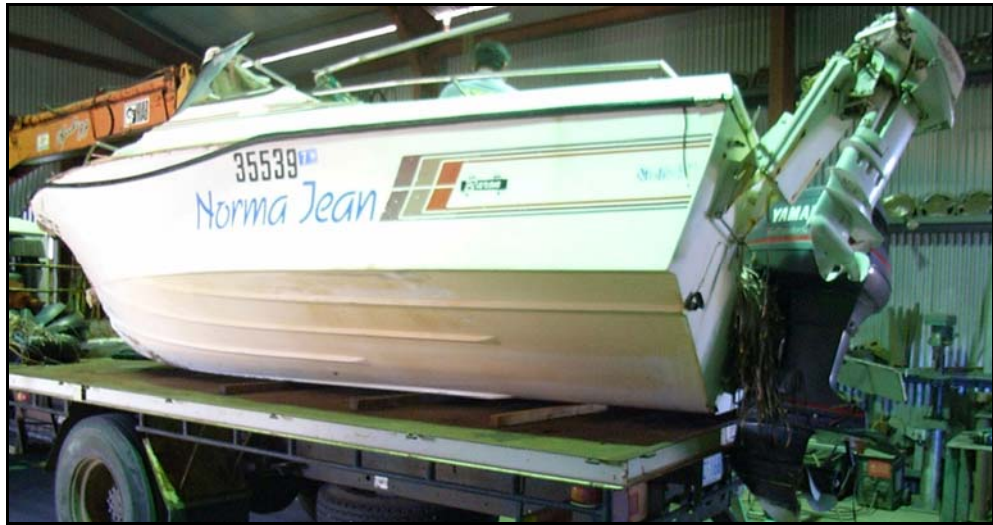
Figure 7: Norma Jean after salvage

Norma Jean (Figure 7) was a privately owned, 5.54 m long, 'Baron Sportsman' type recreational vessel. The glass fibre reinforced plastic (GRP) boat was built in 1975 and registered with the WA DPI in Western Australia.

A MSBU surveyor assessed the damage to *Norma Jean* at the request of the police and a copy of this report was also provided to the ATSB.

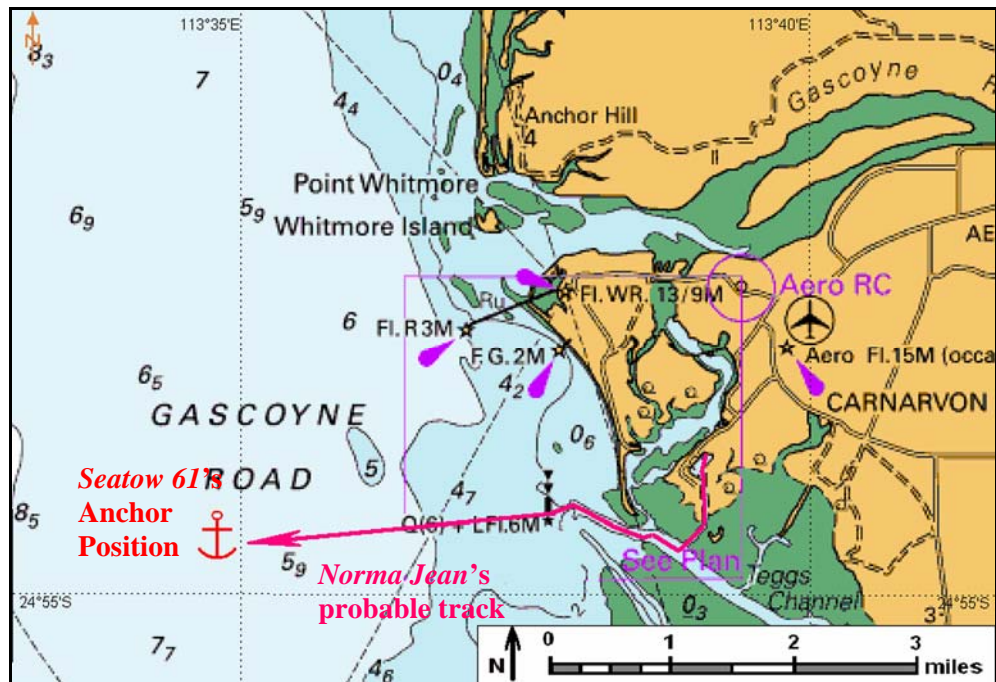
Figure 9: Section of navigational chart Aus 747

Kurutai's master also contacted a local tug operator within Shark Bay with a view to getting advice on the best channel to use to enter Shark Bay. He was advised that the tug should enter Shark bay via Geographe Channel. He received some general local information and was advised that Gascoyne Road (Figure 9), about three to four miles from Carnarvon, was a suitable anchorage.

When *Norma Jean*'s skipper called the BoM office the night before the accident, he advised them that he intended to cross Shark Bay towards 'The Gap'. The course required to reach 'The Gap' from the Teggs Channel entrance beacon passed directly through the area where *Seatow 61* was anchored (Figures 9 and 16).
