Main landing gear failure – Melbourne Aerodrome

20 October 2009

Abstract

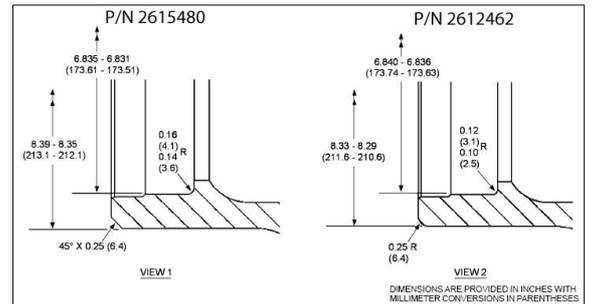
Figure 9: Comparison of revised (left) and prior (right) inboard wheel half assemblies (from CMM 32-40-14 Rev 7)

The wheel manufacturer introduced the inboard wheel half (P/N 2615480) in 2005, as a revision to wheel assemblies P/N 2612311-1, to address a prior issue of bearing cups working loose. Loose bearing cups could result in mechanical damage,

which may allow the hub to fracture or the bearing to fail. The revised inboard wheel half incorporated an increased interference fit³ between the wheel bearing bore and bearing cup/sleeve assembly, and slight geometry changes to the hub to make it stiffer (Figure 9). These changes commenced as of wheel serial number B7900.
