### **History of the flight**

On 13 April 2005 at approximately 1130 Eastern Standard Time, the pilot of a Robinson Helicopter Company model R22 Beta, registered VH-HXU, was conducting cattle mustering operations near Mareeba, Qld, when he felt a significant airframe vibration and elected to conduct an immediate precautionary landing. Upon inspection with the engine still running, the pilot reported observing the clutch assembly shaking excessively, followed by the sudden fracture of the clutch shaft at the connection to the main rotor gearbox. The pilot was the only occupant of the helicopter and was not injured. There was no other damage to the helicopter.

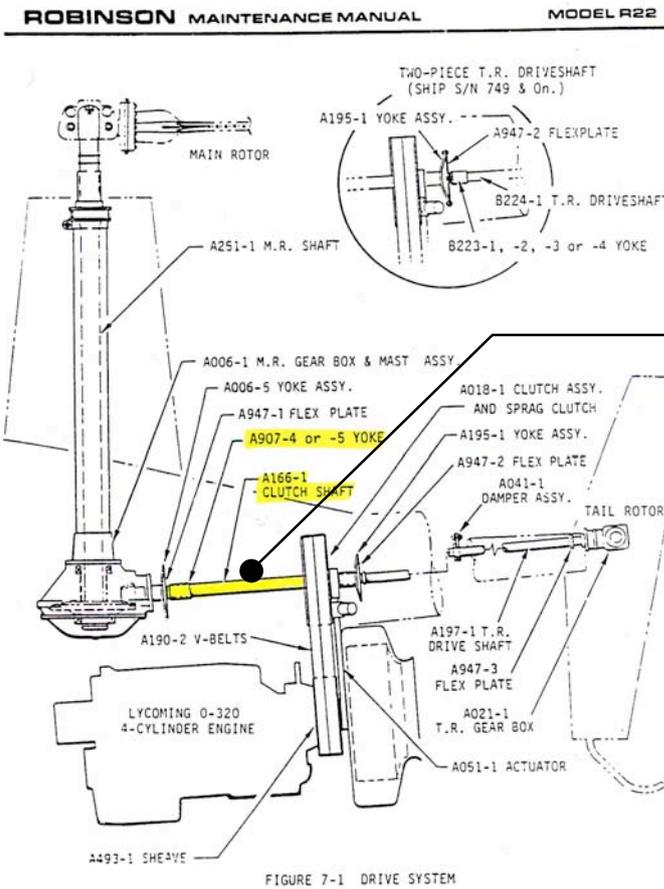
Figure 1 Illustration of the R22 clutch and main rotor drive assembly

Figures 1 and 2, taken from the R22 helicopter illustrated parts catalog, show the main rotor drive system, including the clutch assembly, shaft and yoke components. The ATSB examined the following components from the assembly:
