ATSB TRANSPORT SAFETY INVESTIGATION REPORT  
Marine Occurrence Investigation No. 224  
Final

Independent investigation into the collision between the  
Panamanian registered bulk carrier

**Global Peace**

**Tom Tough**

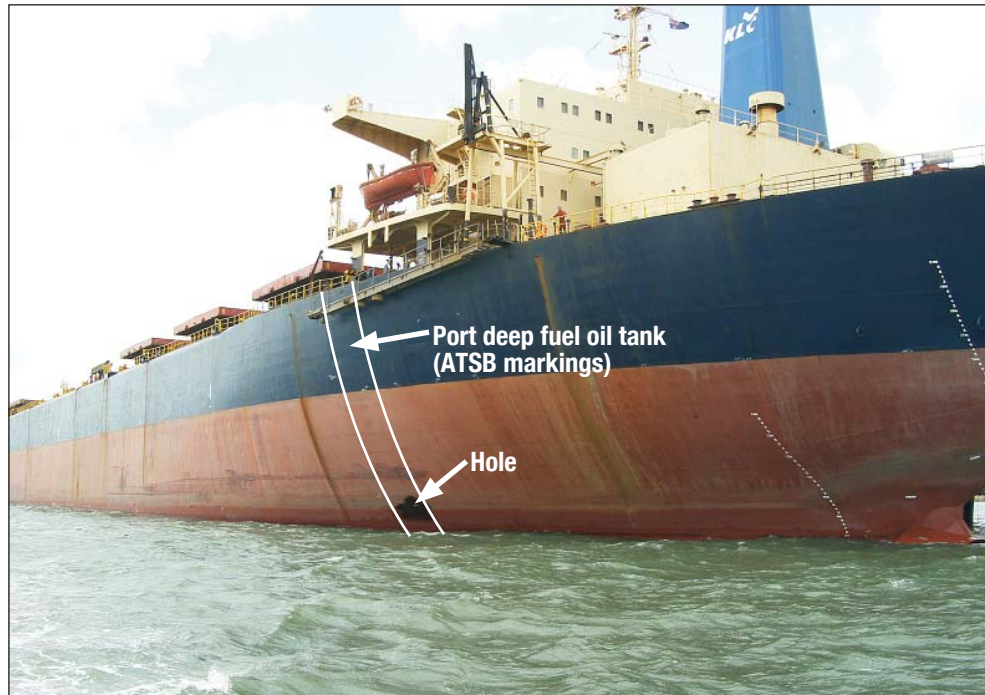
**Figure 2: *Global Peace* with the location of the port deep fuel oil tank indicated**

The port and starboard deep fuel oil tanks each have a capacity of 451 cubic metres, and on 24 January 2006 the port deep fuel oil tank contained about 150 cubic metres of heavy fuel oil.

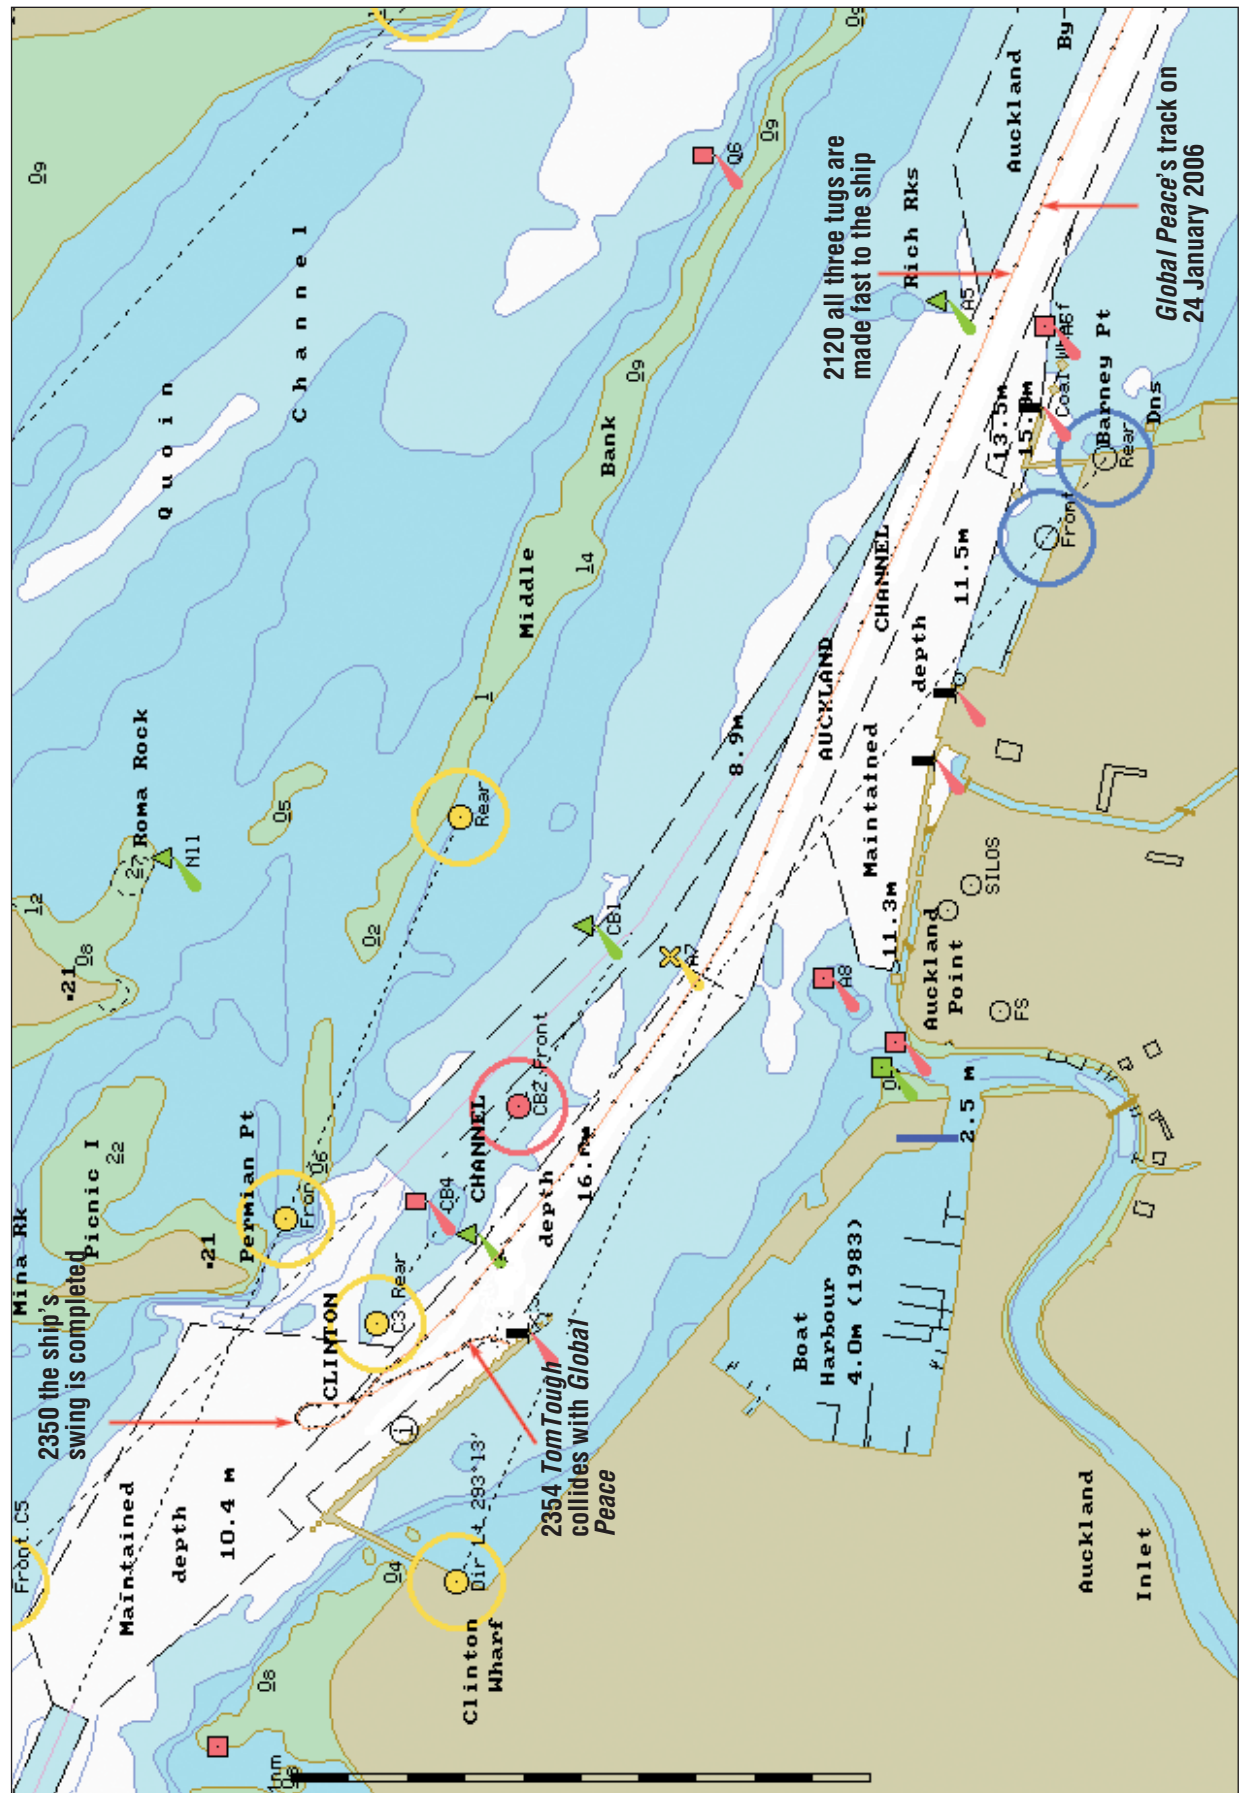
Figure 9: Section of chart AUS245 showing *Global Peace's* track on 24 January

When the ship was in position to swing (Figure 9), adjacent to Clinton berths one and two, the pilot ordered the forward tugs to 'push up' while the aft tug, *Tom Tough*, was ordered to 'pull the stern to port'. All three tugs were ordered to operate at 50 per cent thrust. The pilot used dead slow astern, and then slow astern main engine revolutions to assist with the turn.

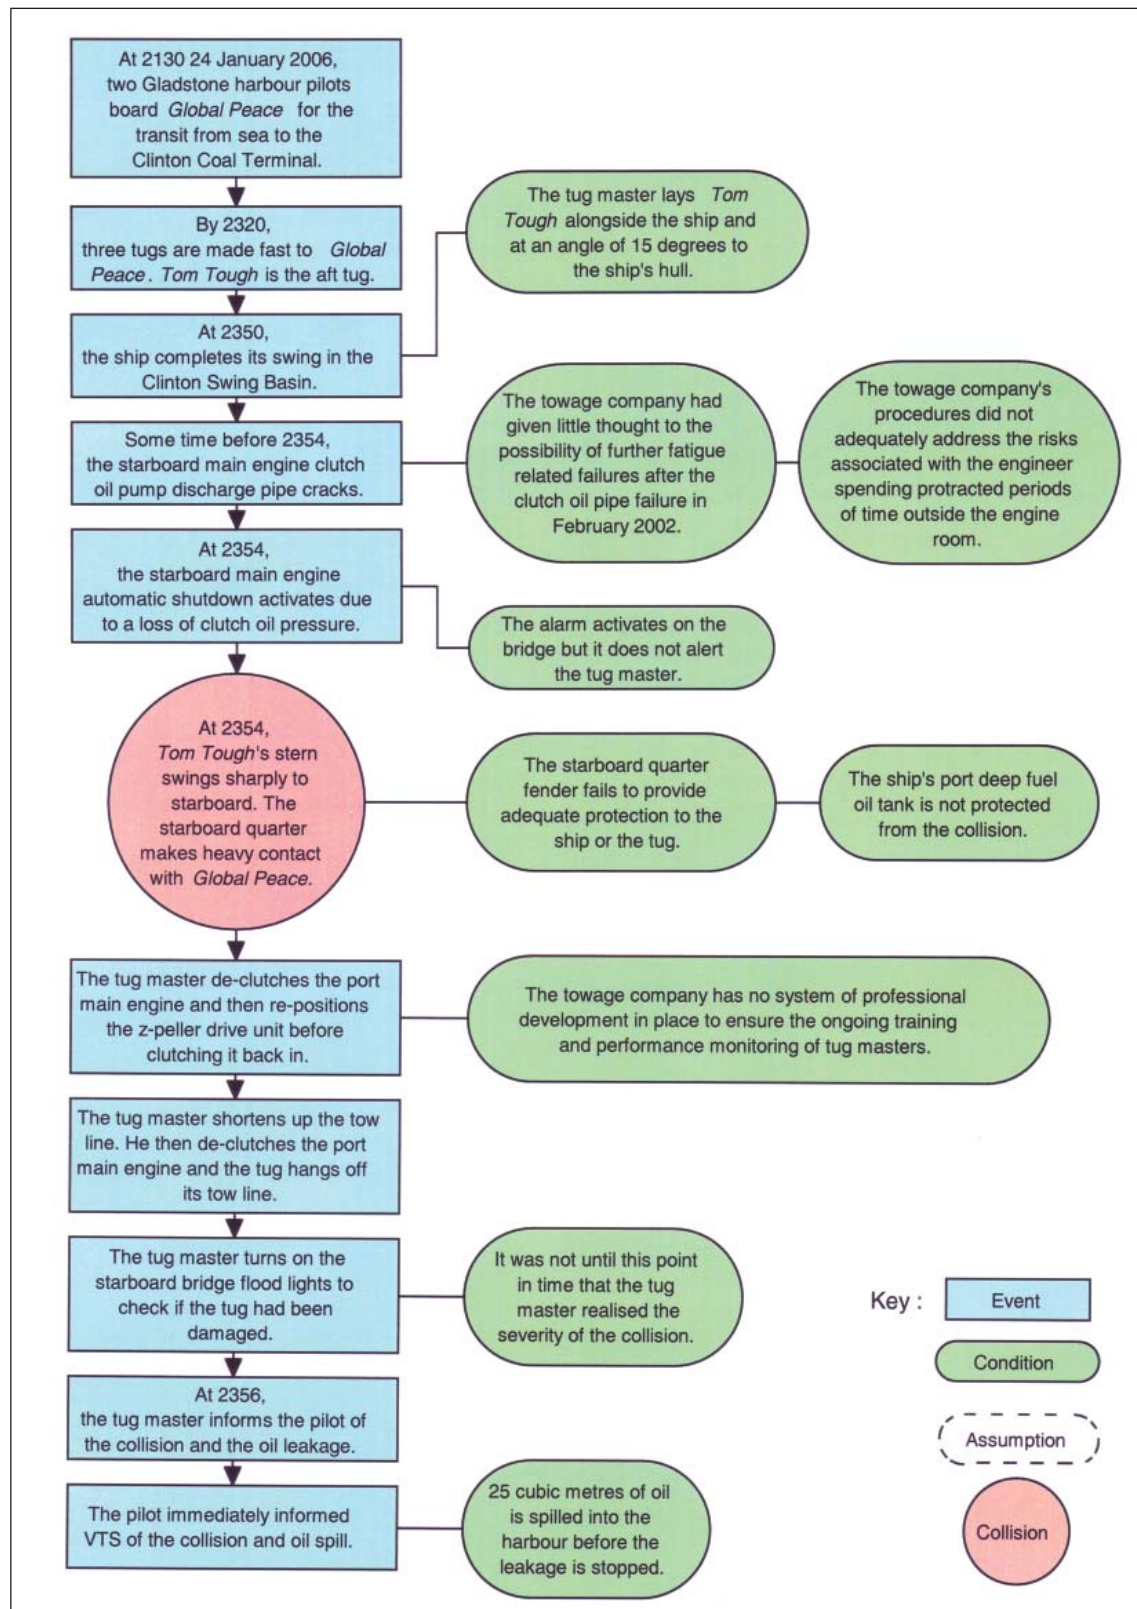
Figure 16: Events and causal factors chart

- The failure of the starboard main engine clutch oil discharge pipe resulted in the system being emptied of oil. The resultant loss of system pressure activated the engine shutdown.
- When the starboard main engine shut down, the tug's stern swung sharply to starboard and the tug's starboard quarter made heavy contact with the ship.

- The tug's aft fender arrangement did not provide adequate protection to the tug or the ship.
- The towage company had given little thought to the possibility of further fatigue related failures after the failure of the clutch oil pump discharge pipe fitted to the port main engine in February 2002.

- Adsteam Harbour should review their current maintenance and reporting systems with a view to implementing procedures that consider the causes of failures and the likelihood and risks associated with similar failures in the future.
