ATSB TRANSPORT SAFETY INVESTIGATION REPORT

Aviation Occurrence Report – 200605307

Erratic Airspeed Indications

Boeing 717-200

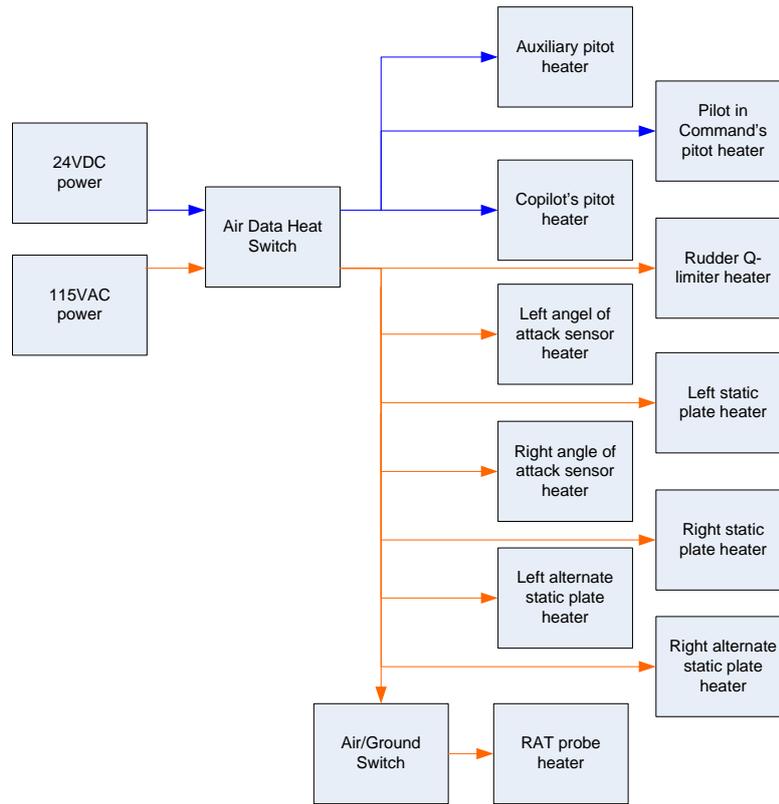
Figure 3: Air data heating system

Air data sensors were electrically heated during flight to prevent ice formation. The air data heat switch controlled the heating of the sensors, including the pitot probes, static plates, Ram Air Temperature (RAT)⁸ sensor, and angle of attack transducers (Figure 3). The single air data heat switch operated all the air data sensor heaters⁹. As part of the pre-flight checklist, the crew was required to turn the air data heat switch ON.
