ATSB TRANSPORT SAFETY INVESTIGATION REPORT  
Rail Occurrence Investigation Report 2006002  
Final

Derailment of  
**XPT Passenger Train ST22**

Harden, New South Wales

9 February 2006

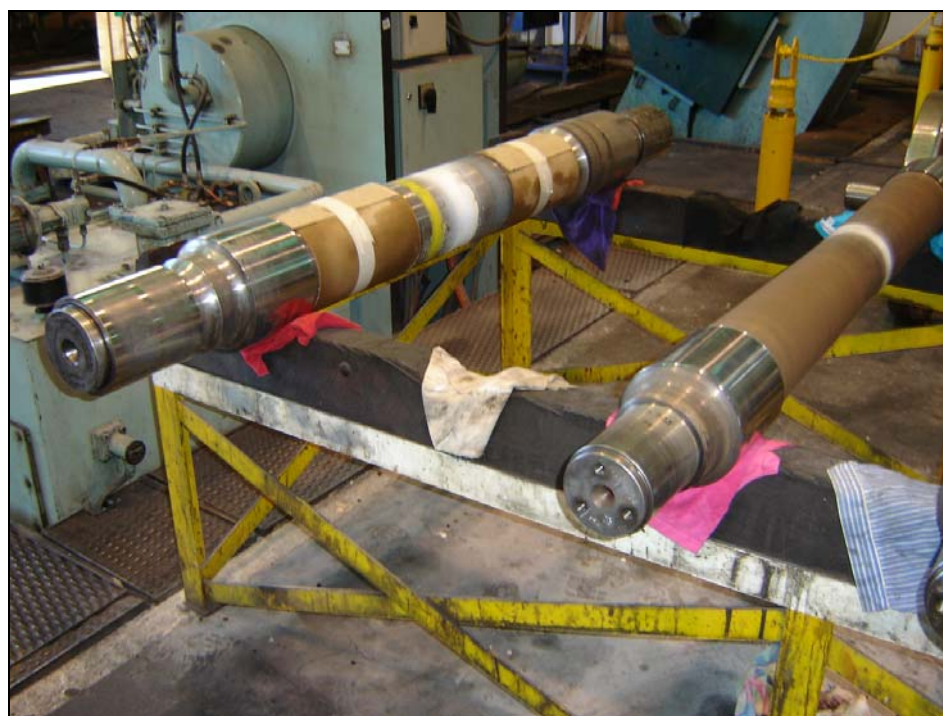
**Figure 4: Axles on wooden storage racks**

Note: Crack indications found in shaded areas.

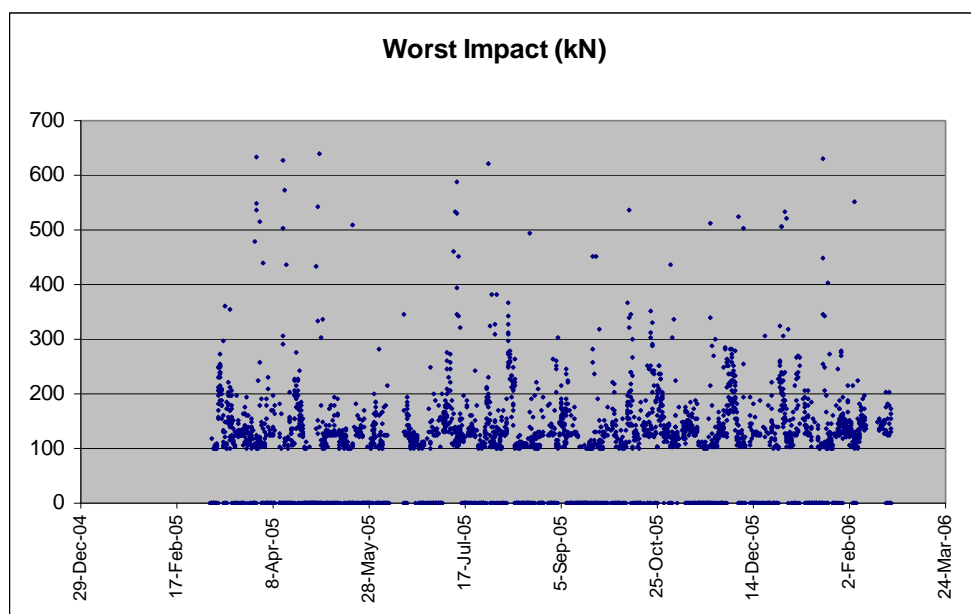
**Figure 11: Overview of XPT power car WILD records**

The information recorded at Moss Vale between March 2005 and February 2006 was examined by the investigation team. The records contained about 13,250 wheel passes of XPT vehicles, including about 3,630 wheel passes of XPT power cars. Figure 11 shows an overview of WILD records for XPT power cars passing Moss Vale.

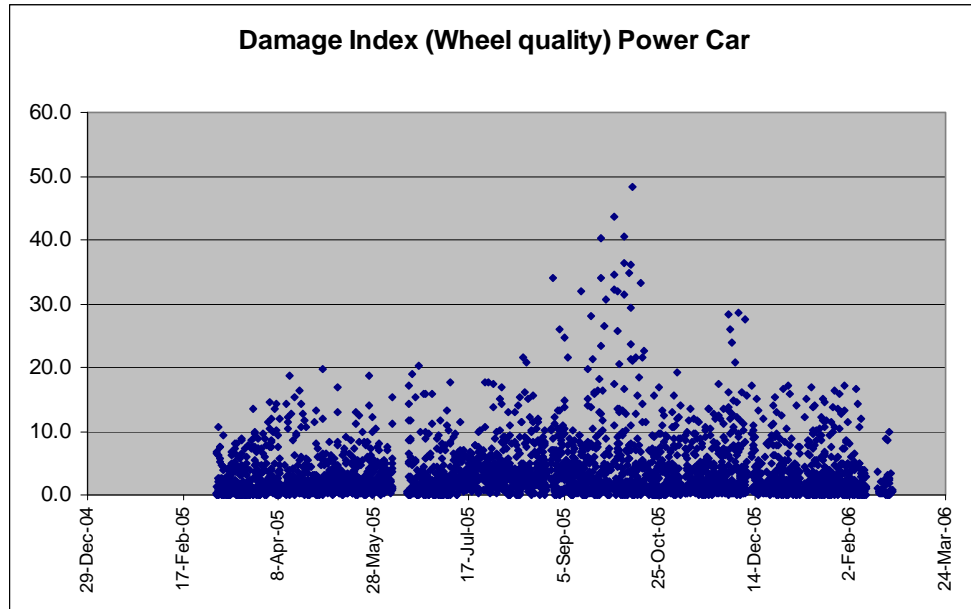
**Figure 12: Damage index of XPT power car wheels**

Each passing wheel impact is measured in units of kilo Newtons (kN). To help with data usability and clarity ARTC apply a mathematical formula to the WILD kN reading to form a numeric scale called a damage index or wheel quality figure. Figure 12 shows the damage index for XPT power car wheels at the same location for the same period.

An examination of the WILD data revealed a cluster of relatively high damage index readings between September and October 2005. These readings, along with the measurements (kN) for each XPT power car wheel, were compared with XPT power cars known to have cracked axles. No correlation was found between high level readings for WILD data and damage index and the cracked axles. Although some cracked axles registered high WILD readings, a large number of serviceable axles also registered high readings.

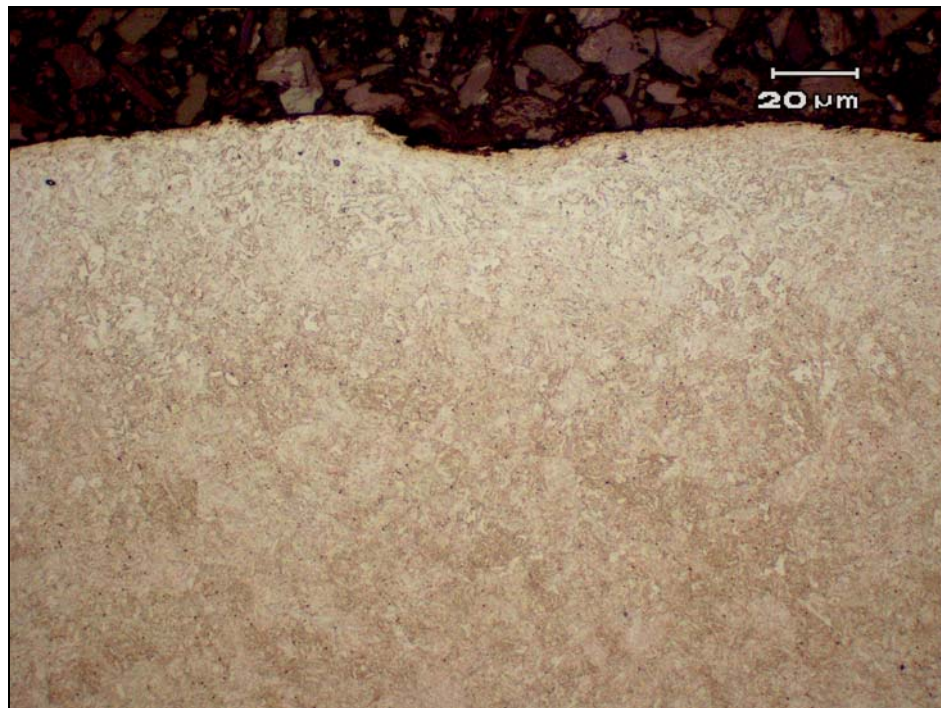
**Figure 14: Metallographic section of steel from an XPT axle showing a tempered martensite microstructure**

In order to examine the microstructure of the material used in the manufacture of XPT axles listed in Table 2, sections of steel both perpendicular and horizontal close to the plane of the fatigue crack were removed and prepared using metallographic techniques. The examination revealed the microstructure of each axle to be mainly comprised of tempered martensite, shown in Figure 14. The microstructure was considered typical for an alloy that had undergone quench and tempering heat treatment.

Some decarburisation of the steel was observed to penetrate approximately 0.1 - 0.2 mm from the surface of each axle. The depth of decarburisation was considered slight and had probably been produced from exposure to a mild oxidising atmosphere during manufacture. Otherwise, the steel comprising each steel section was considered homogenous and clean with no evidence of any sub-surface material defects or inclusions that could have contributed to the axle failures.

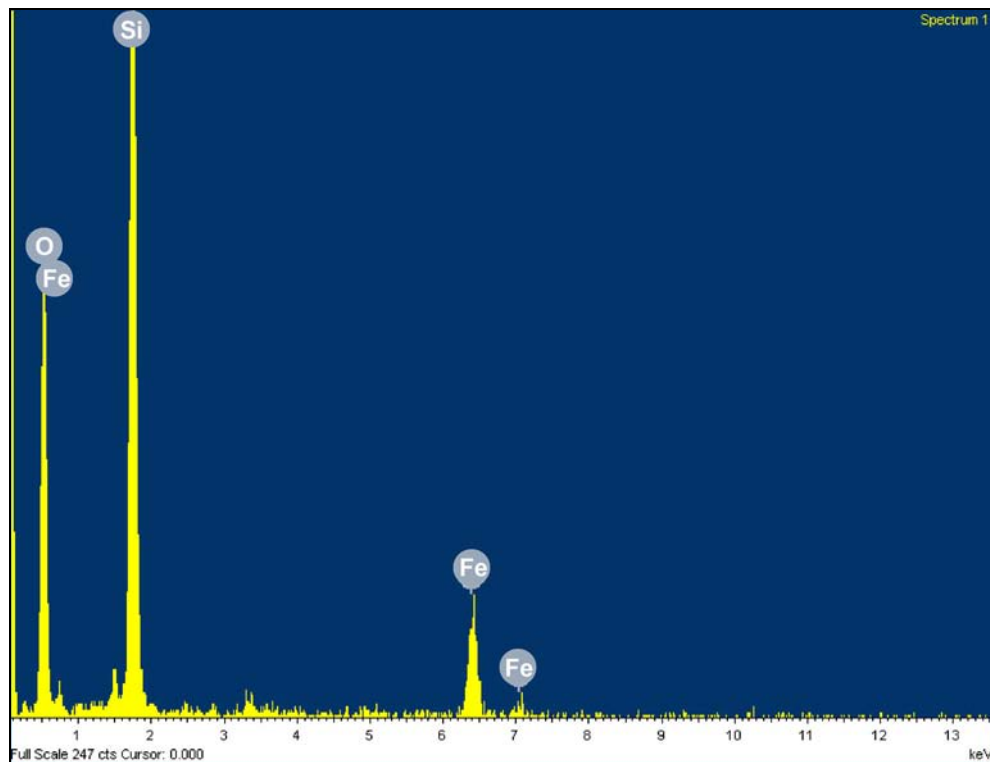
Figure 20: EDS chemical spectra of the embedded crystalline material

The analysis revealed the composition of the embedded material to be largely silicon (Si) and oxygen (O). See Figure 20 for a representative EDS chemical spectrum. The chemistry of the embedded material was consistent with a rock or mineral aggregate, such as the type used in track ballast.

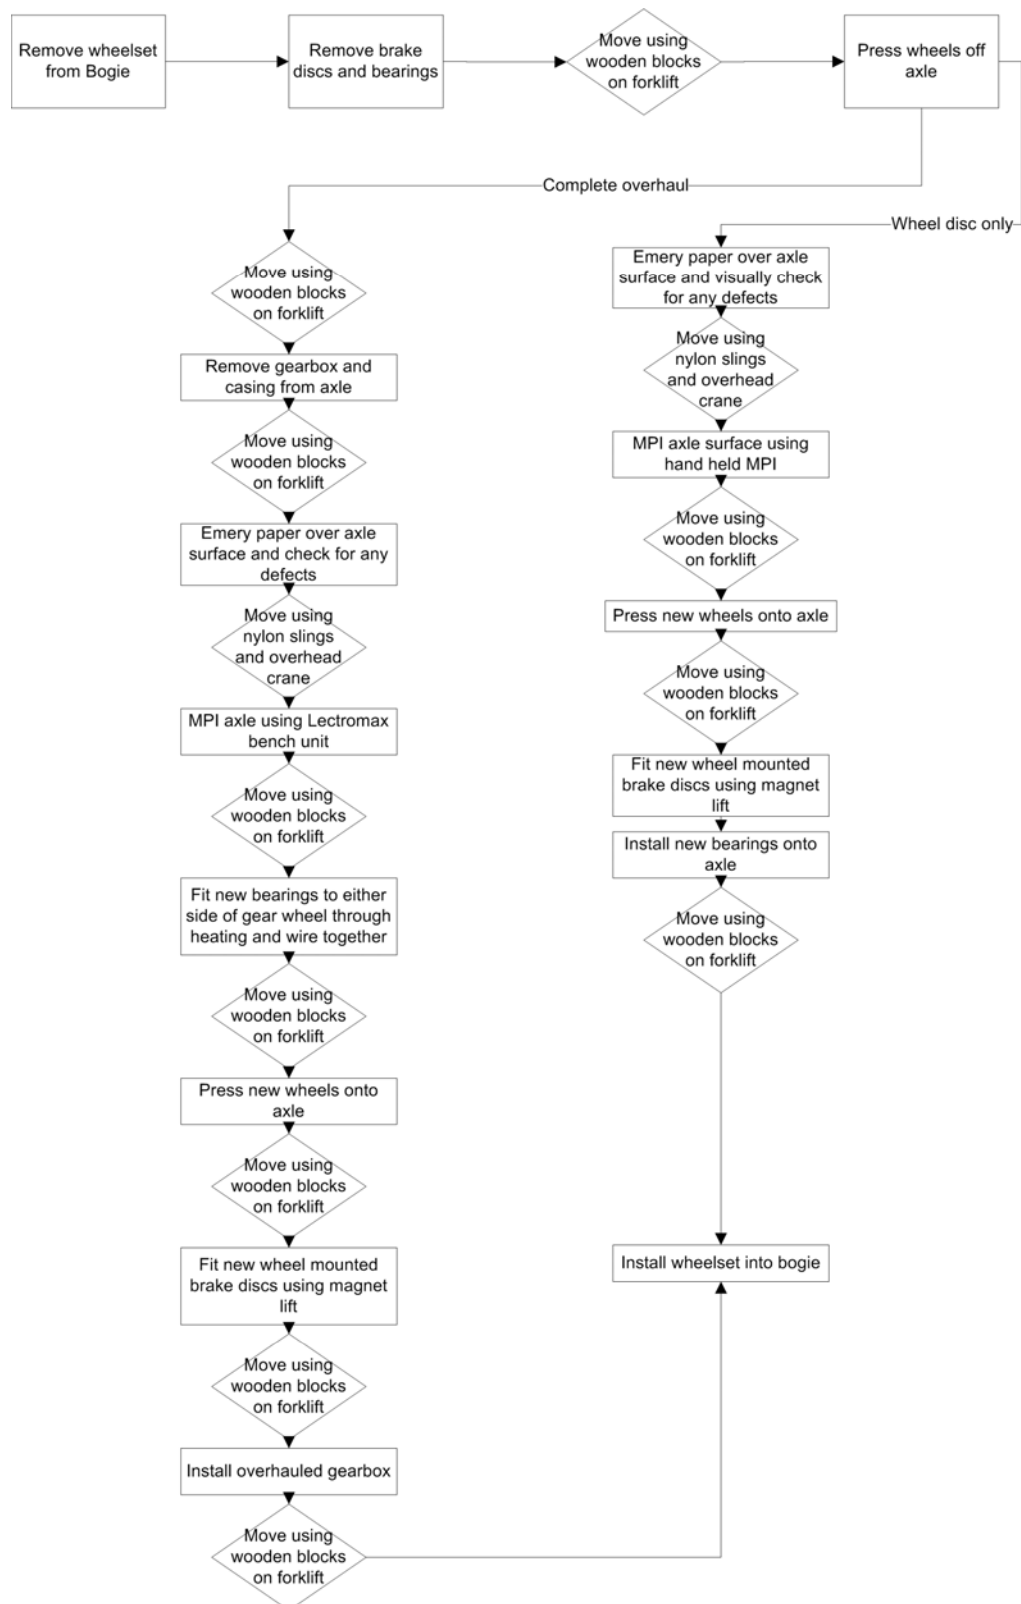
**Figure 21: Wheelset overhaul process**

Power car wheelsets are overhauled as part of a bogie exchange program where the complete bogie is removed from the XPT power car at the Sydenham maintenance centre and sent to the Chullora facility for disassembly and overhaul, shown in Figure 21.

No parts of the process were identified that could have contributed to mechanical damage to the radius relief and run-out areas. No major change to the process has occurred in the past 3 years, the last major change being the implementation of a magnet lift to install the wheel mounted brake discs (approximately 2001).

Previously, this was performed by manual lifting which may have been a source of damage to the axle if the disc was rested or dropped there. The current method supports the disc utilising a crane and it is supported until the bolts are installed minimising the risk of dropping the discs.

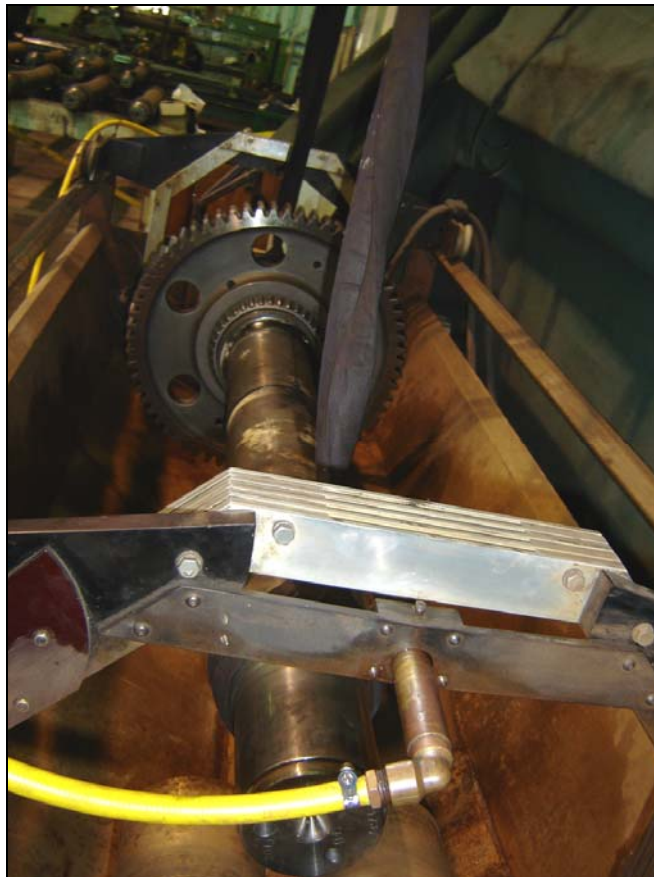
**Figure 22: Lectromax MPI bench with axle in-situ**

The XPT axles were subjected to various crack tests during overhaul depending on the type of service. For a wheelset overhaul, (replacement of wheels and bearings where the gearbox remained mounted on the axle), the exposed portions of the axle were visually inspected followed by a MPI inspection of the axle barrel, wheelseats and the bearing journal and abutments. In this instance a MPI was performed using hand-held equipment as it was not possible to fit the axle into the workshop's Lecromax MPI bench with the gearbox mounted on the axle.

The Lectromax MPI test bench (shown in Figure 22), used to inspect axles during overhaul, was audited for compliance with Australian Standard AS1171 (Non-destructive testing - Magnetic particle testing of ferromagnetic products, components and structures) and the applicable RailCorp standards. The audit concluded that:
