ATSB TRANSPORT SAFETY INVESTIGATION REPORT
Rail Occurrence Investigation 2006/014
Final

Collision between
Rigid Tipper Truck/Tri-axle Trailer
and
The Overland Passenger Train, 4AM8

Wingeeel, Victoria

15 November 2006

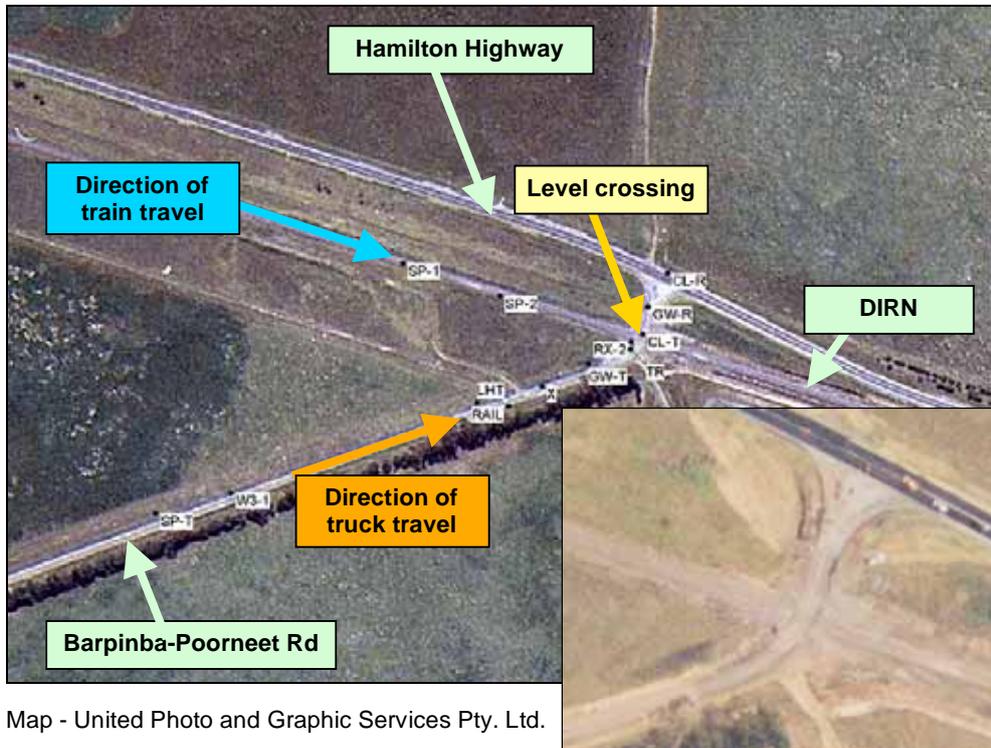
Figure 3: Satellite photograph - Approach to Barpinba-Poorneet Road level crossing. Inset – Expanded view of level crossing.

The Barpinba-Poorneet Road level crossing is located 50 m off the Hamilton Highway and approximately 11 km east of Cressy. When travelling in a north-east direction, the road converges towards the Adelaide to Melbourne rail line at an angle of about 38 degrees but turns sharply into the level crossing in the last 20 m (Fig. 3) to intersect the rail line at an angle close to 70 degrees. After passing over the level crossing it joins with the Hamilton Highway.

Travelling in a north-easterly direction along the Barpinba-Poorneet Road, (Fig. 3) the visibility of the rail line is fairly good, however the road converges towards the Adelaide to Melbourne rail line at an acute angle, approximately 38 degrees and only turns sharply into the level crossing over the last 20 m. The angle of approach is such that the driver of a motor vehicle must turn their head sharply to the left and their vision is likely to be obscured by the 'A' and 'B' pillars of the vehicle. Further, the cab design of trucks is visually restrictive when compared with a passenger car and vision to the left, adjacent the 'B' pillar⁹ is quite constrained. This is a common characteristic of many trucks and restricts the viewing angle.

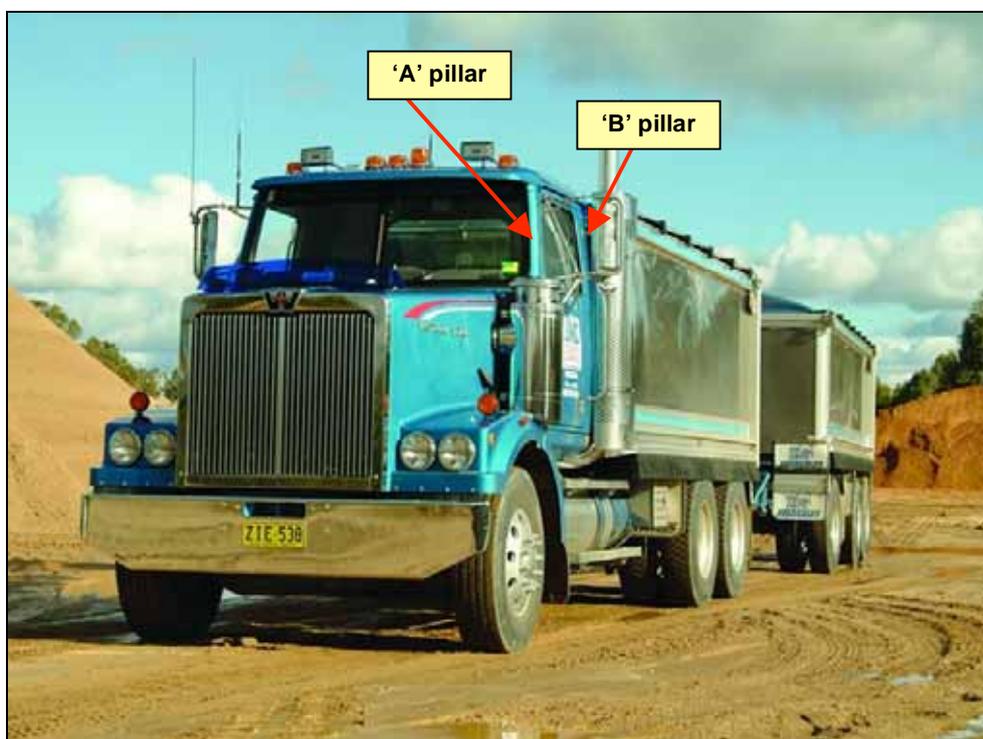
Figure 5: Western Star rigid tipper truck/ tri-axle trailer combination.

The truck and trailer combination involved in the accident consisted of a Western Star 4870 tandem tip truck towing a Westside body tri-axle tip trailer having an overall length of 15.7 m. The statutory gross mass for a configuration of this type, ie six axle truck and trailer with steel spring suspension is 42.5 tonnes.

⁹ The roof of a truck is supported by pillars. They are known as 'A' pillars and 'B' pillars, see Fig. 5. The 'A' pillars are at the front. They are located where the windshield meets the front side windows/doors. The 'B' pillars, are located between the back of the front side windows and the rear of the cab of the truck.
