Aviation Occurrence Investigation – AO-2007-055

Procedures related event – Melbourne Airport, VIC

4 November 2007

Boeing Company 777 - 2D7

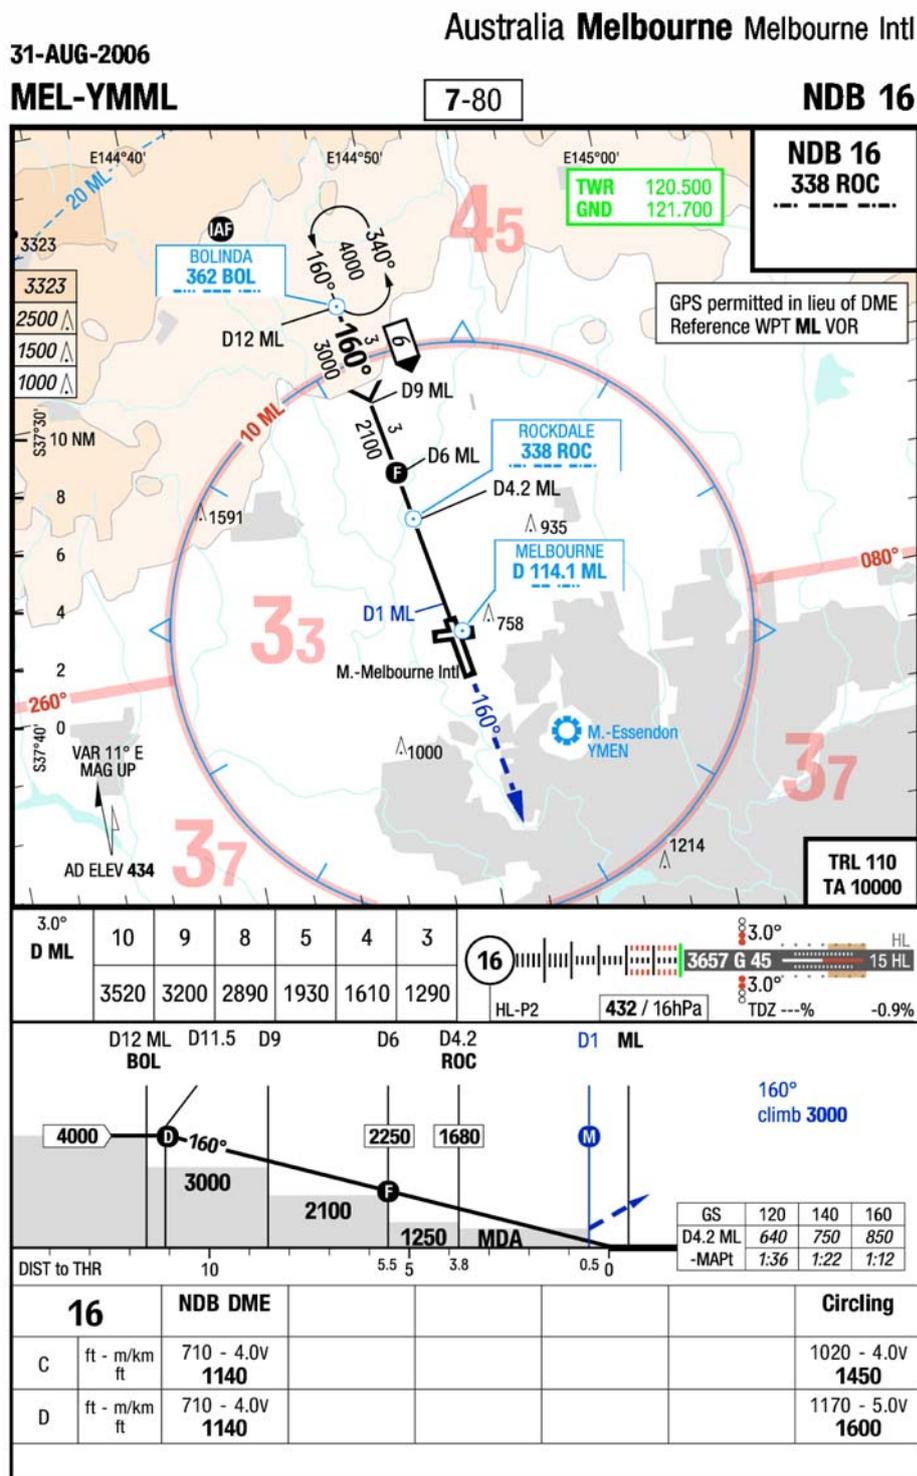
Figure 1: Melbourne Runway 16 NDB approach chart

The navigation database in the aircraft's flight management computers (FMCs) contained the runway 16 ILS approach and included the Bolinda and Rockdale NDBs associated with that approach (Figure 1). The database did not contain the runway 16 NDB approach. The copilot reported that he entered into the FMCs the final approach fix waypoint at 6 DME with an altitude constraint of 2,100 ft above mean sea level (AMSL). Other segment minimum safe altitude constraints associated with the NDB approach were not entered into the FMCs.

When the aircraft was about 1 NM from the Bolinda NDB (Figure 1), the crew selected 1,190 ft on the autopilot flight director system (AFDS) mode control panel (MCP).⁸ This altitude was 50 feet above the published minimum descent altitude for the approach.⁹ The aircraft overflew the Bolinda NDB at 1306:31 while level at 4,000 ft and the copilot reported that at that time he was unsure whether ATC had cleared the crew to conduct the NDB approach. Remaining level at 4,000 ft, the copilot sought confirmation from the pilot in command that they were cleared for the approach before commencing further descent.

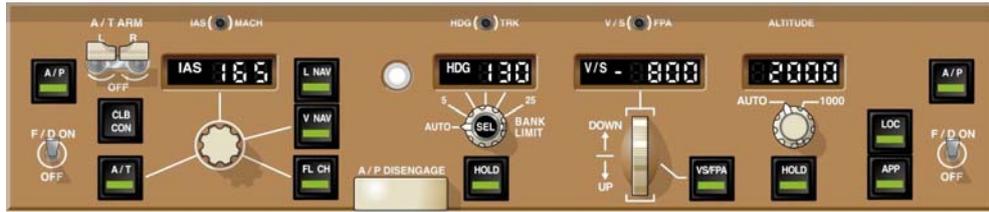
Figure 3: Mode control panel

The 777 automatic flight control system consisted of the autopilot flight director system (AFDS) and the auto-throttle system. Both the AFDS and the auto-throttle were controlled using the mode control panel (MCP) and the two flight management computers (FMCs). The crew used the MCP to select and activate AFDS modes, and to select altitudes, speeds and climb/descent profiles (Figure 3).

Alternatively, the aircraft's vertical flight path could also be controlled by other AFDS modes, such as flight level change. These other vertical modes did not interface with the FMCs and relied solely on MCP selections by the crew. As a result, any speed restrictions and altitude constraints entered by the crew into the FMCs did not alter the aircraft's flight path in these other modes.
