ATSB TRANSPORT SAFETY INVESTIGATION REPORT

Aviation Occurrence Investigation – 200701033

**Loss of Control
Clyde North, Victoria
23 February 2007**

Van's Aircraft Inc. RV-4, VH-ZGH

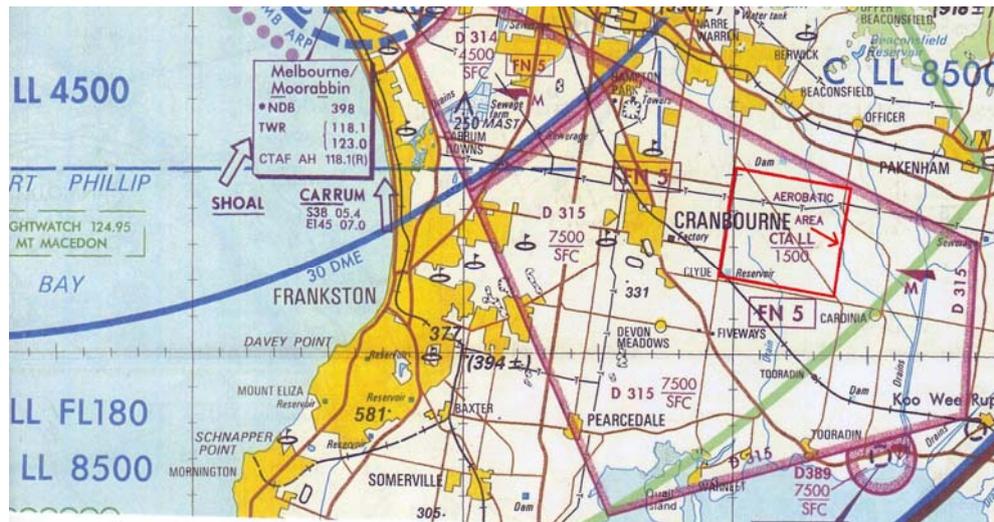
Figure 1: Moorabbin aerobatic area in red box. The accident site is indicated by the red arrow.

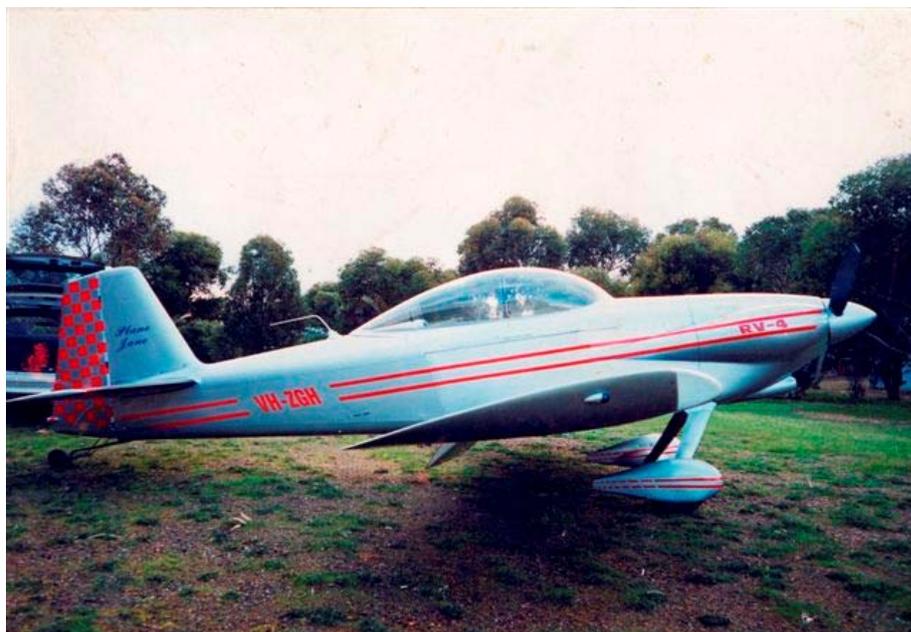
Figure 5: VH-ZGH

VH-ZGH was an amateur-built aircraft constructed in Australia in December 1994 and had accumulated an estimated 474.6 flying hours at the time of the accident. It was powered by a Lycoming AIO-360-H1A engine, driving a constant-speed propeller. The maximum fuel capacity was 118 litres of Avgas carried in two wing tanks.
