**Piper PA-23-250 Aztec, VH-WAC  
1 km WSW Mareeba Aerodrome, Qld.  
1 October 2003**

**INVESTIGATION REPORT  
BO/200304091**

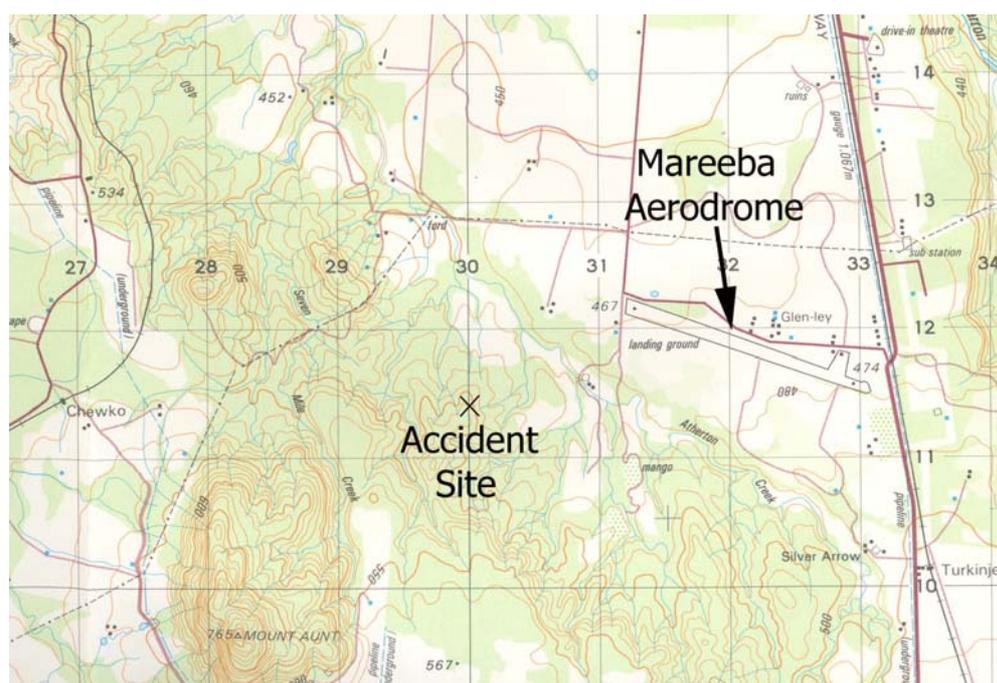
**Figure 1. Location of accident site relative to aerodrome**

The accident site was located on a lightly timbered ridge, 1.5 km west-southwest of the Mareeba aerodrome reference point, at an altitude of 1,640 ft above mean sea level and 80 ft above aerodrome elevation (refer figure 1).
